FIELD INSPECTION

Project Name:	Mountain Valley Pipeline	Inspector:	Marshall Willis
Inspection Date:	Thursday, February 21, 2019	Project Contact:	Brian Clauto
Spread H: Franklin County	STA 13315+32 – 13273+02 STA 13344+00 – 13403+28	Weather (Wet/Dry/Rain):	Wet

FIELD INSPECTION PHOTO LOG

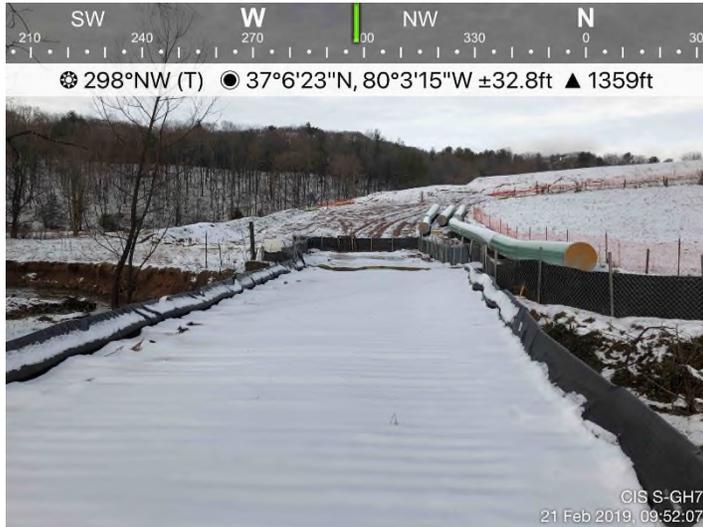
Fig. 1: CIS S-GH7 – Controls in place.

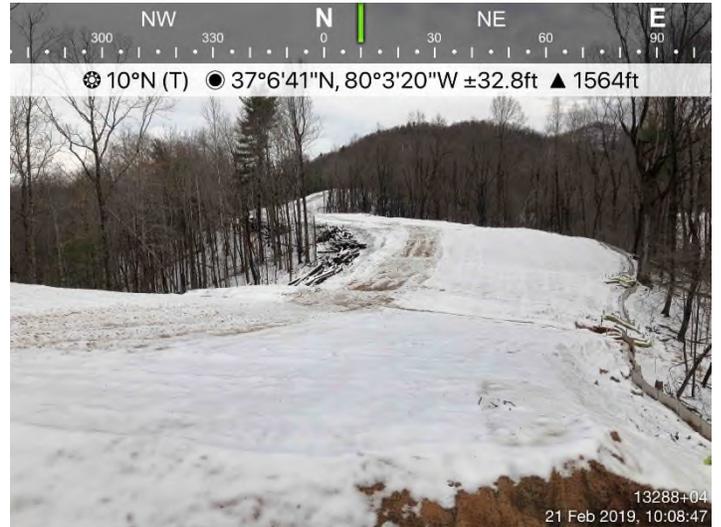
Fig. 2: STA 13288+04 – Area stabilized.

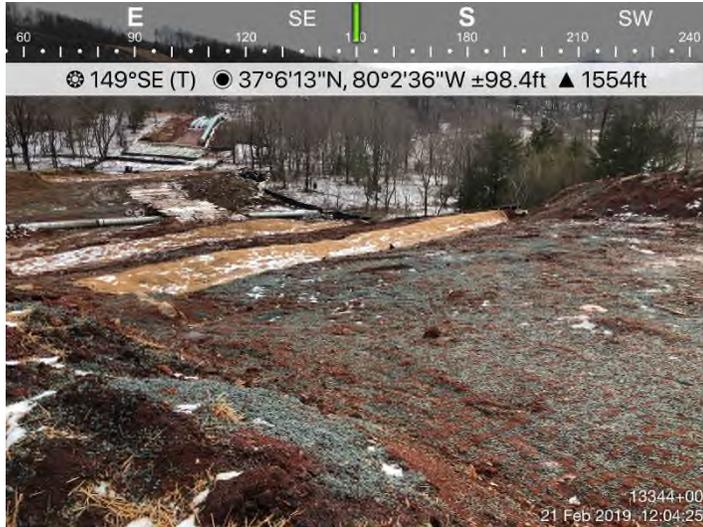
Fig. 3: STA 13344+25 – Area stabilized.

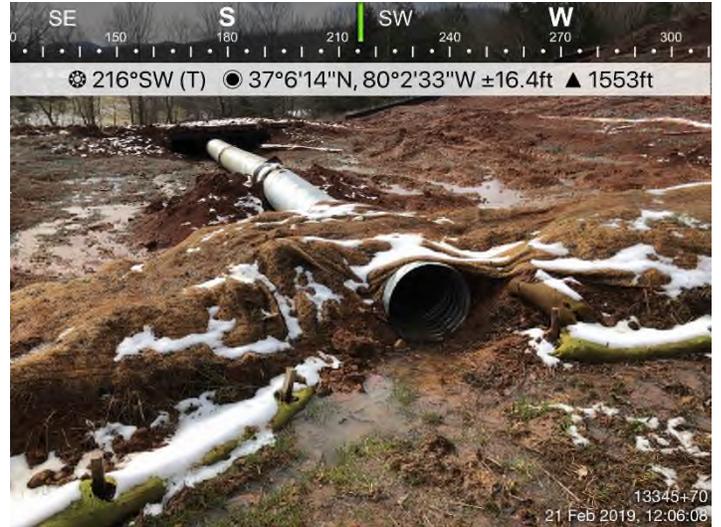
- Streams / wetlands inspected included: S-GH7, S-RR8, S-RR9 and S-RR11.
- CWD does not have inlet protection at STA 13345+70.
- CWD does not have inlet protection at CIS S-RR8.

Fig. 4: STA 13345+70 – Inlet protection needed.

Recommended Corrective Action: Maintain and install all controls per the approved plan and specs.

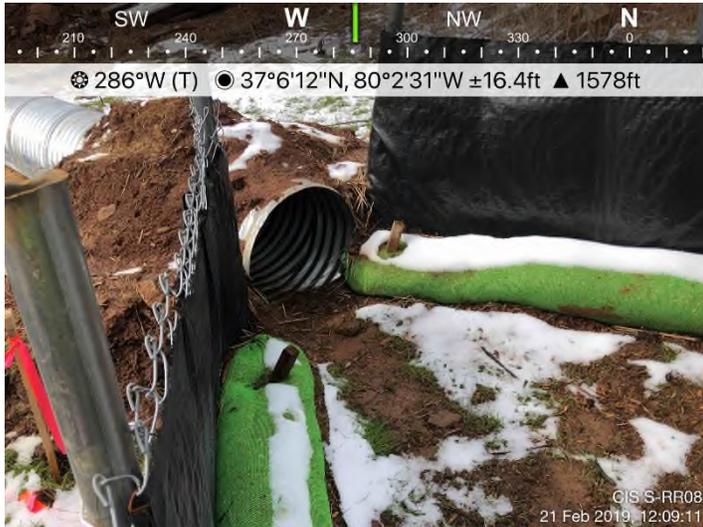
Fig. 5: CIS S-RR8 – Inlet protection needed.

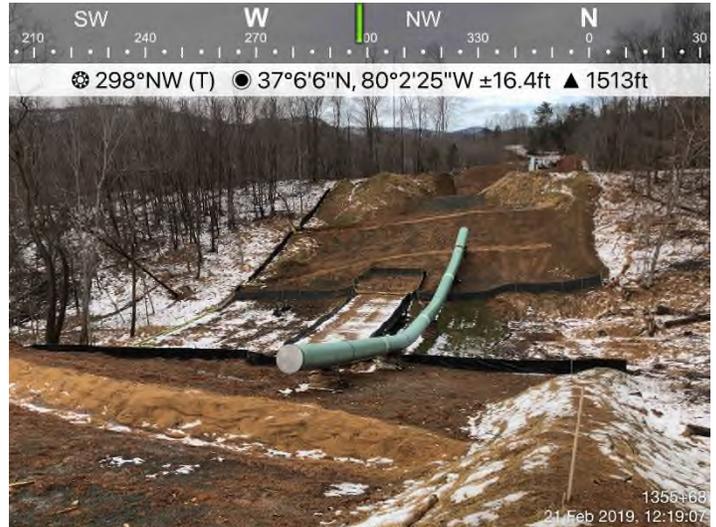
Fig. 6: STA 13355+68 – Area stabilized.

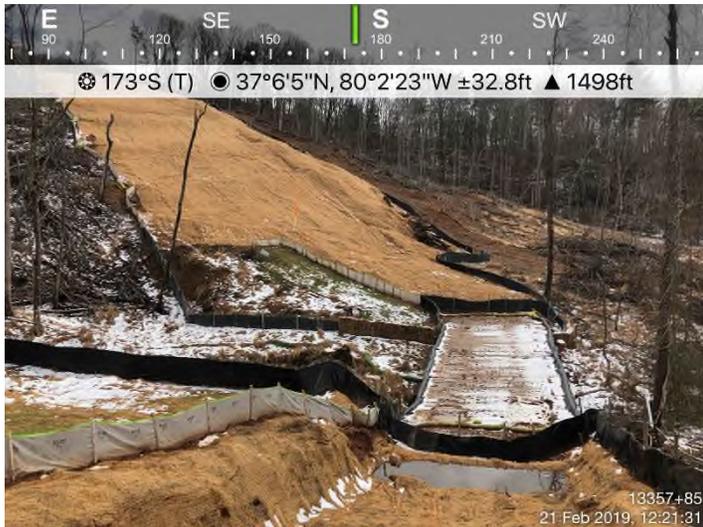
Fig. 7: STA 13357+85 – S-R11 controls in place. Area stabilized.

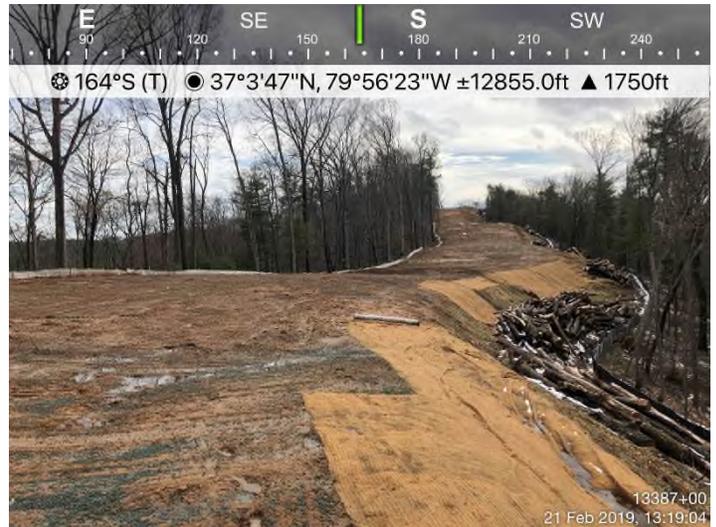
Fig. 8: STA 13387+00– Area stabilized.
