## FIELD INSPECTION

<b>Project Name:</b>	Mountain Valley Pipeline	<b>Inspector:</b>	Matthew Grant
<b>Inspection Date:</b>	Tuesday, February 26, 2019	<b>Project Contact:</b>	Brian Clauto
<b>Spread: Montgomery County MP 227 St#12035+19 &amp; 12031+56 MP 228 St#12076+95</b>	Spread H	<b>Weather (Wet/Dry/Rain):</b>	Dry

## FIELD INSPECTION PHOTO LOG

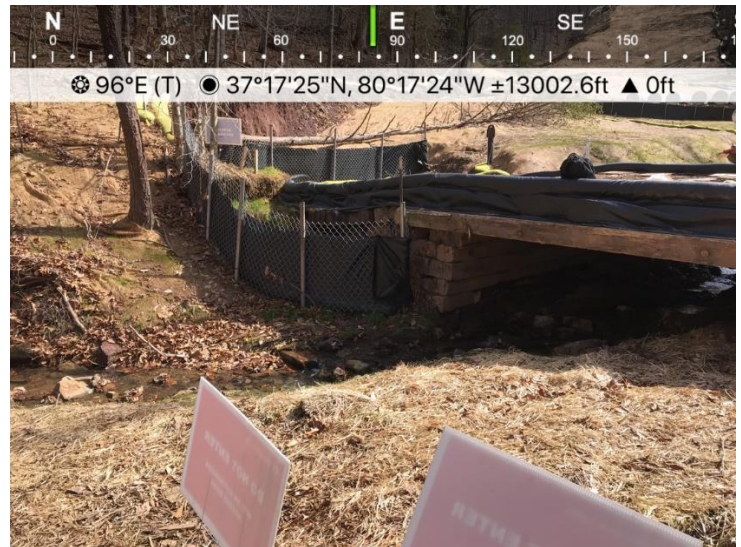
- Fig. 2 Area near designated stream S-G40 has been temporarily stabilized and controls are in place.

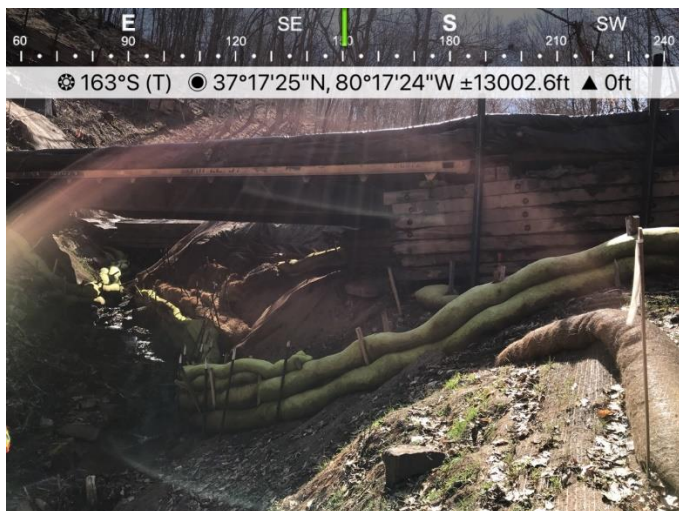
- Inspected designated streams included: S-G36, S-G38, and S-G40. All ECD were in place near all the streams, no impacts were observed at the time of the inspection.
- At designated stream S-G39 triple stack at stream bank required re installation and had been previously reported in extended corrective actions required, crews were on site for the repair on 2-27-19. No impacts were observed at the time of the inspection.

- Fig. 3 Area near designated stream S-G39 has been temporarily stabilized and triple stack was noted for repair.

**Recommended Corrective Action:** Maintain all controls per the annual standards and specs.

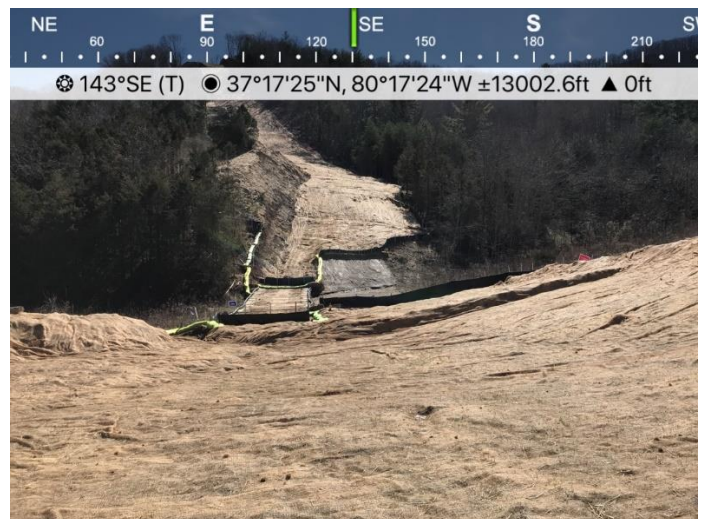
- Fig. 4 Area near designated stream S-G38 has been temporarily stabilized and controls are in place.
