FIELD INSPECTION REPORT

Project Name:	Mountain Valley Pipeline	Inspector:	Matthew Grant
Inspection Date:	Thursday, February 27, 2020	Project Contact:	Brian Clauto,
Spread H: Franklin	MP 251-252 MP253.8- 253.9 ATWS 1412, 1055 AR FR 293.01	Weather:	Dry

FIELD INSPECTION PHOTO LOG

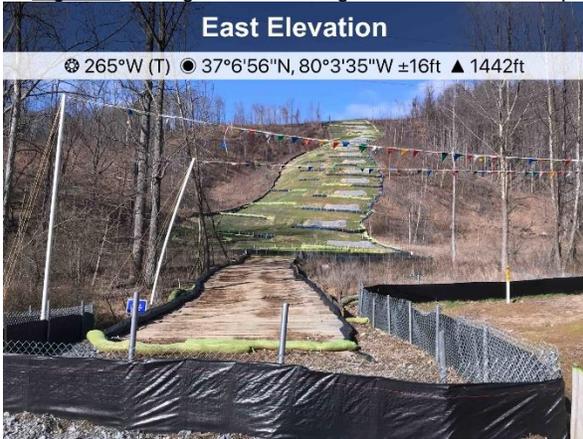
<p>Figure 1: Designated crossing S-II4, ECD's are in place.</p> <div style="text-align: center;"> <p>East Elevation</p> <p>☉ 265°W (T) ☉ 37°6'56"N, 80°3'35"W ±16ft ▲ 1442ft</p>

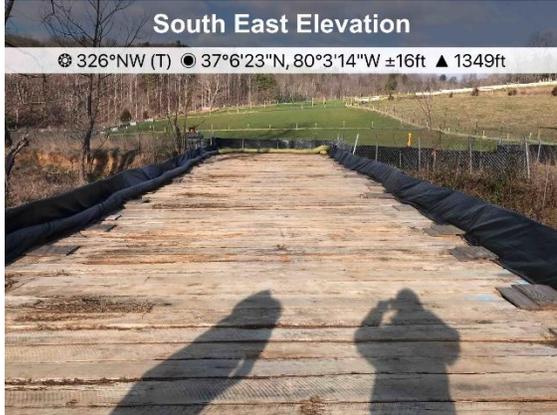
</div>	<p>Figure 2: Designated crossing S-GH7, ECD's are in place.</p> <div style="text-align: center;"> <p>South East Elevation</p> <p>☉ 326°NW (T) ☉ 37°6'23"N, 80°3'14"W ±16ft ▲ 1349ft</p>

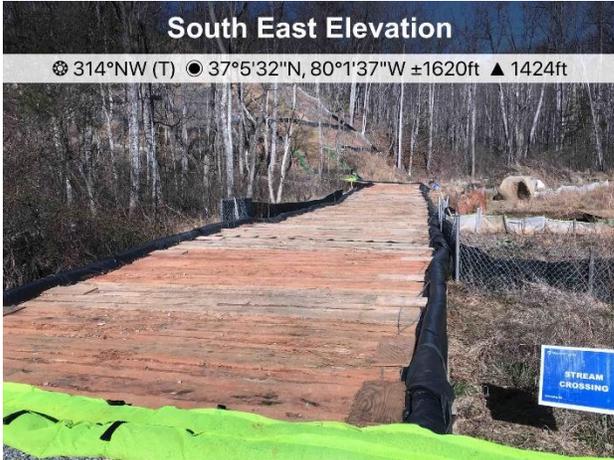
</div>
<p>Figure 3: Designated crossings S-IJ1 & W-IJ2, ECD's are in place.</p> <div style="text-align: center;"> <p>South East Elevation</p> <p>☉ 314°NW (T) ☉ 37°5'32"N, 80°1'37"W ±1620ft ▲ 1424ft</p>

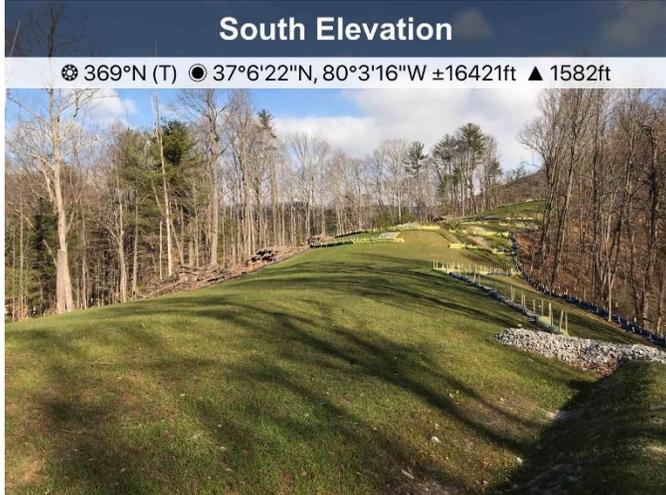
</div>	<p>Figure 4: Near MP25.3 ECD's are in place and the area is well stabilized.</p> <div style="text-align: center;"> <p>South Elevation</p> <p>☉ 369°N (T) ☉ 37°6'22"N, 80°3'16"W ±16421ft ▲ 1582ft</p>
