FIELD INSPECTION REPORT

Project Name:	Mountain Valley Pipeline	Inspector:	Matthew Grant
Inspection Date:	Wednesday, February 5, 2020	Project Contact:	Brian Clauto
Spread H: Montgomery	AR-MN 276.03 MLV AR- 27 ATWS 724	Weather:	Rainy

FIELD INSPECTION PHOTO LOG

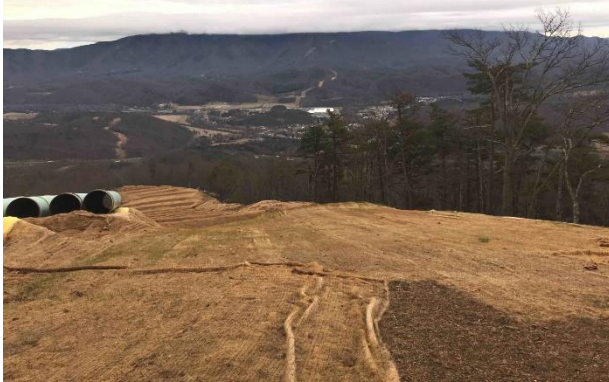
<p>Figure 1: Near MP 232.4 areas has been stabilized with blanket matting.</p> <p style="text-align: center;">North West Elevation</p> <p style="text-align: center;">☉ 150°SE (T) ● 37°15'21"N, 80°13'35"W ±16ft ▲ 2585ft</p>

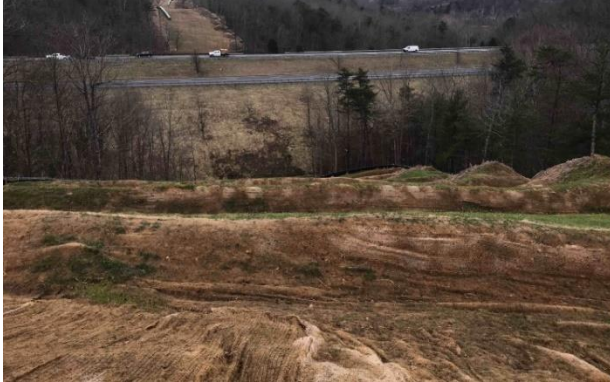
<p>Figure 2: Near MP 234 area remains stabilized with ECD blanket matting.</p> <p style="text-align: center;">North West Elevation</p> <p style="text-align: center;">☉ 137°SE (T) ● 37°14'46"N, 80°12'38"W ±32ft ▲ 1426ft</p>

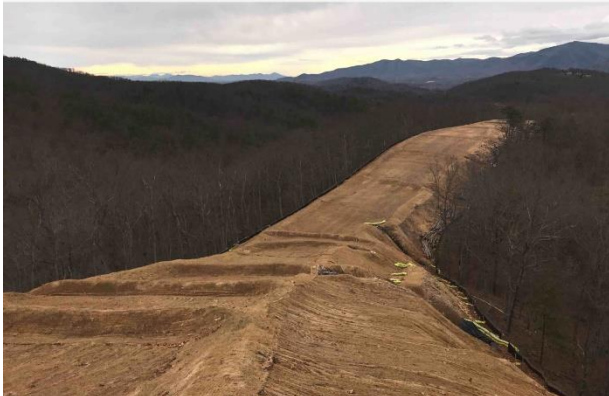
<p>Figure 3: Near MP 233.4 are remains stabilized with ECD blanket matting.</p> <p style="text-align: center;">South Elevation</p> <p style="text-align: center;">☉ 424°N (T) ● 37°15'10"N, 80°12'53"W ±32ft ▲ 1740ft</p>
