FIELD INSPECTION REPORT

Project Name:	Mountain Valley Pipeline	Inspector:	Matthew Grant
Inspection Date:	Thursday, February 6, 2020	Project Contact:	Brian Clauto,
Spread H: Montgomery	MP 231.04-230.8 ATWS 703, 704A, 1375, 1446 AR MN 274 & MN 275	Weather:	Wet

FIELD INSPECTION PHOTO LOG

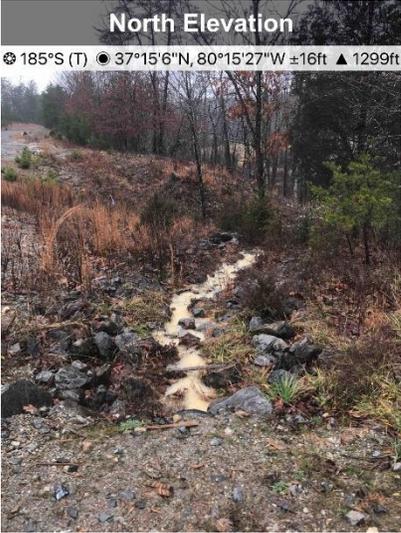
- Comments: Inspected the following resources: S-C21, S-001
- ECD's were in place and functioning at the designated crossings.
- During the inspection, the railway ditch was releasing turbid water at the juncture of designated stream S-001 and S-C21.

<p>▪ Figure 1: Off AR MN274 at the railway ditch crossing, turbid water is being released into S-C21.</p> <div style="border: 1px solid black; padding: 5px; margin-bottom: 5px;"> <p style="text-align: center;">North Elevation</p> <p style="text-align: center;">☉ 185°S (T) ● 37°15'6"N, 80°15'27"W ±16ft ▲ 1299ft</p>

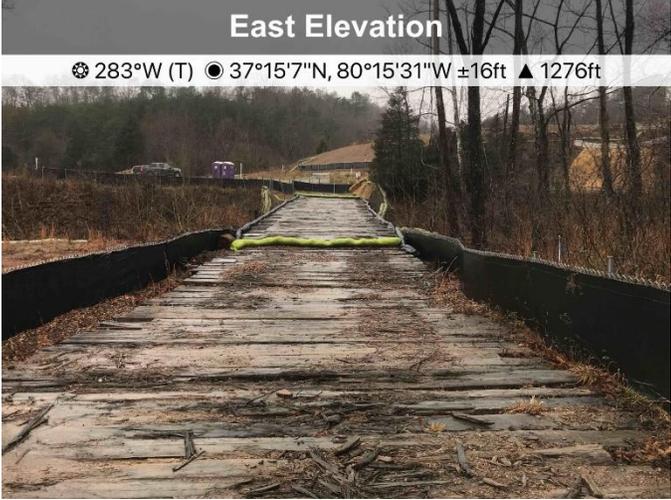
</div>	<p>▪ Figure 2: At designated crossing S-C21, ECD's were in place.</p> <div style="border: 1px solid black; padding: 5px; margin-bottom: 5px;"> <p style="text-align: center;">East Elevation</p> <p style="text-align: center;">☉ 283°W (T) ● 37°15'7"N, 80°15'31"W ±16ft ▲ 1276ft</p>

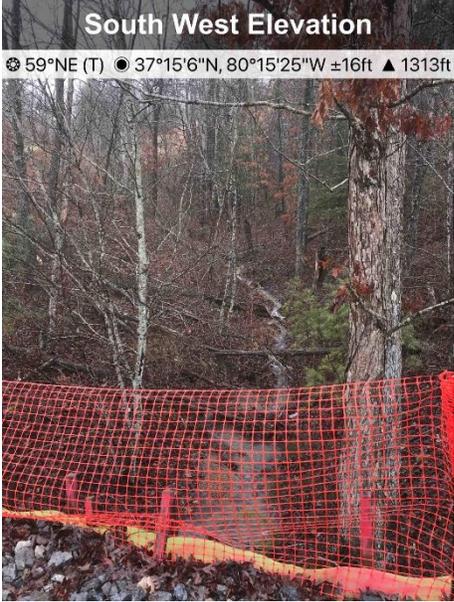
</div>
<p>▪ Figure 3: Designated stream S-001 before railroad ditch crossing.</p> <div style="border: 1px solid black; padding: 5px; margin-bottom: 5px;"> <p style="text-align: center;">South West Elevation</p> <p style="text-align: center;">☉ 59°NE (T) ● 37°15'6"N, 80°15'25"W ±16ft ▲ 1313ft</p>

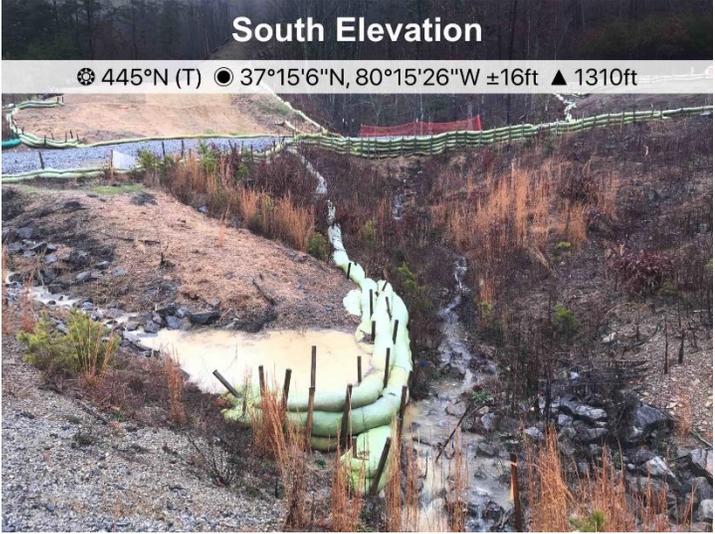
</div>	<p>▪ Figure 4: Near the railroad ditch and confluence of S-001, ECD's were in place.</p> <div style="border: 1px solid black; padding: 5px; margin-bottom: 5px;"> <p style="text-align: center;">South Elevation</p> <p style="text-align: center;">☉ 445°N (T) ● 37°15'6"N, 80°15'26"W ±16ft ▲ 1310ft</p>
