FIELD INSPECTION

Project Name:	Mountain Valley Pipeline	Inspector:	Marshall Willis
Inspection Date:	Tuesday, March 12, 2019	Project Contact:	Brian Clauto
Spread H: Franklin County	STA 13023+00 – 13072+23 MVP-FR-289/290 STA 13136+00 – 13145+00 MVP-FR-292	Weather (Wet/Dry/Rain):	Dry

FIELD INSPECTION PHOTO LOG

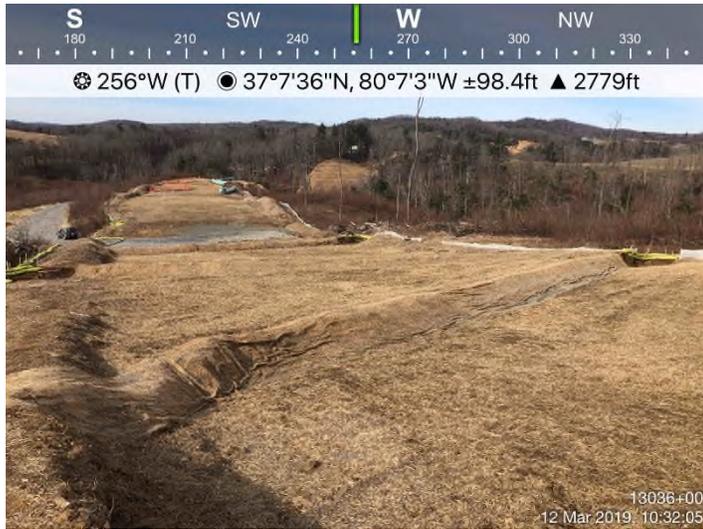
Fig. 1: STA 13036+00 – Area adequately stabilized. Controls in place.

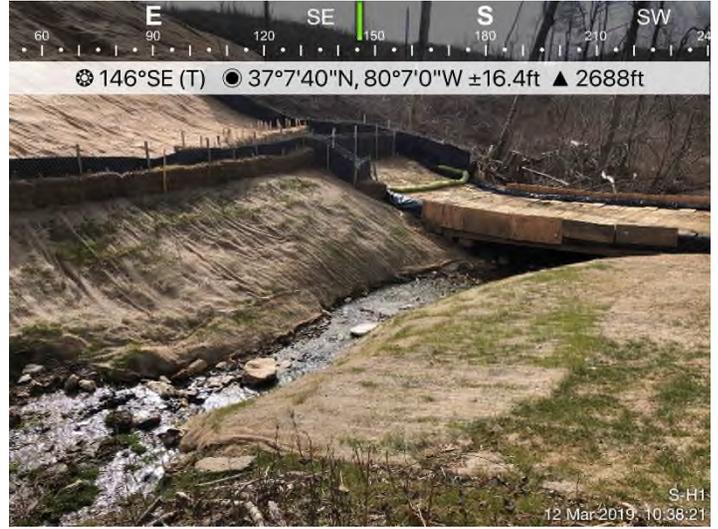
Fig. 2: S-H1 – Controls in place.

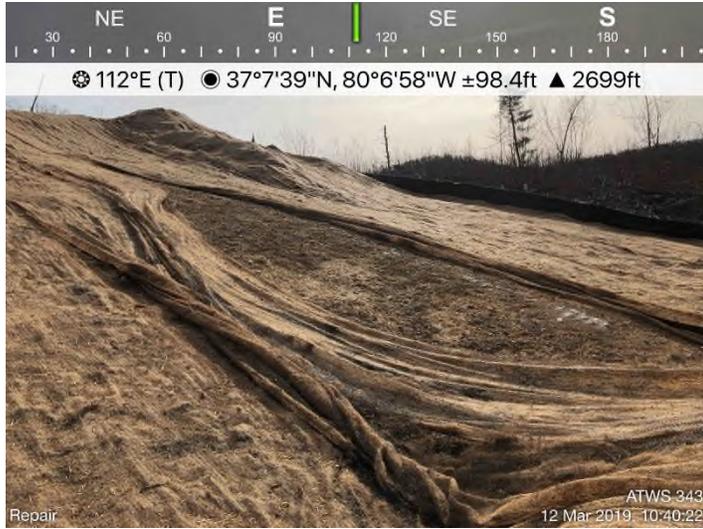
- ATWS 343: Repair fabric.
- STA 13058+00: Repair SSF.
- STA 13060+00: Repair SSF.
- STA 13066+48: CFS undermined.

Fig. 3: ATWS 343 – Maintenance needed on fabric.

Recommended Corrective Action: Maintain and install all controls per the approved plan and specs.

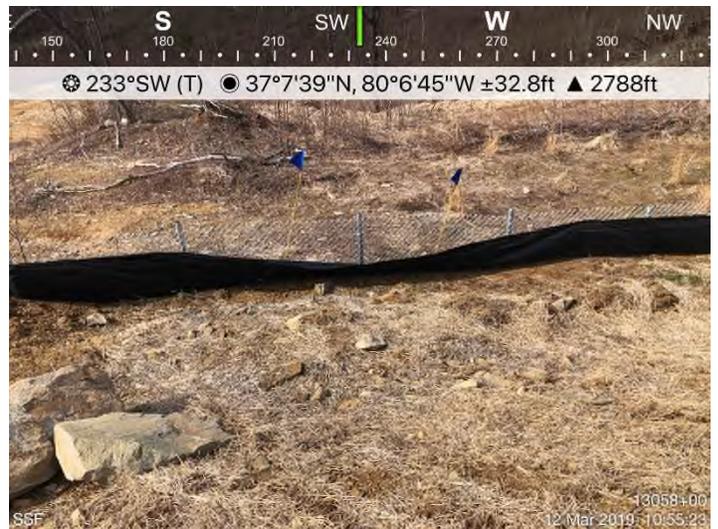
Fig. 4: STA 13058+00 – Maintenance needed on SSF.

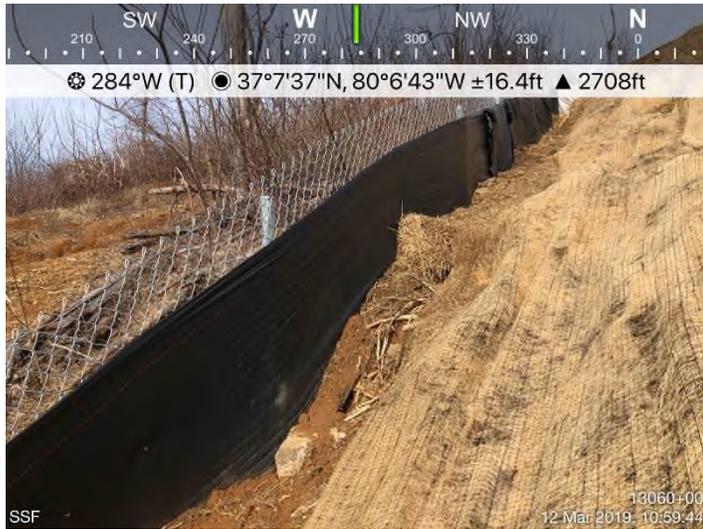
Fig. 5: **STA 13060+00** – Maintenance needed on SSF.

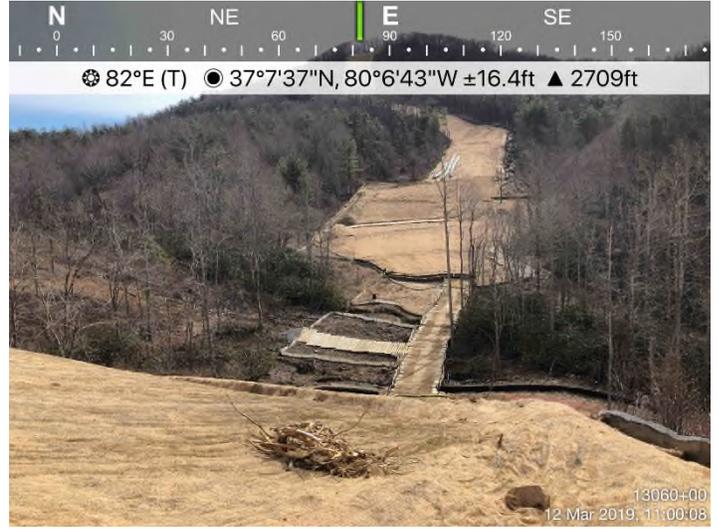
Fig. 6: **STA 13060+00** – Area adequately stabilized. Controls in place.

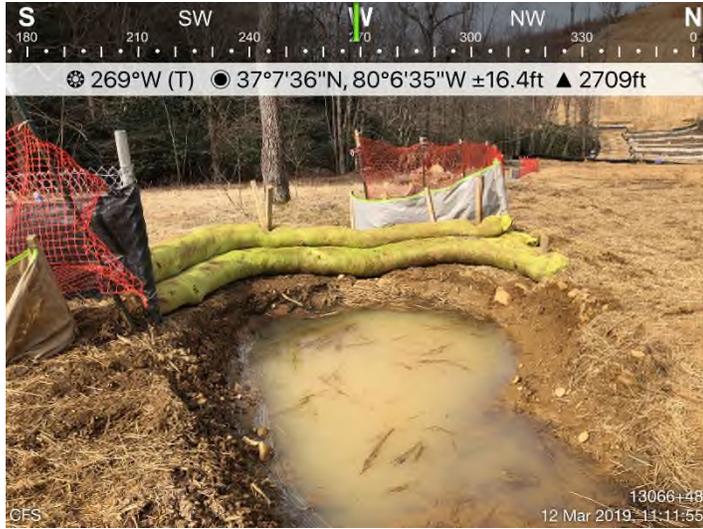
Fig. 7: **STA 13066+48** – CFS undermined. Maintenance needed.

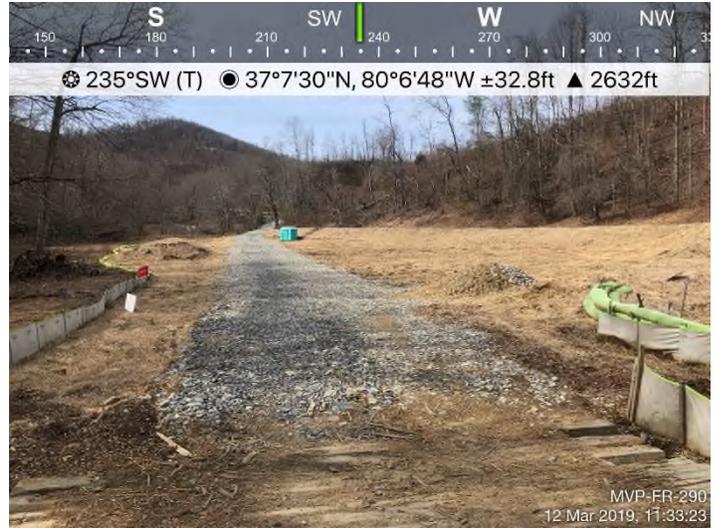
Fig. 8: **MVP-FR-290** – Area adequately stabilized. Controls in place.

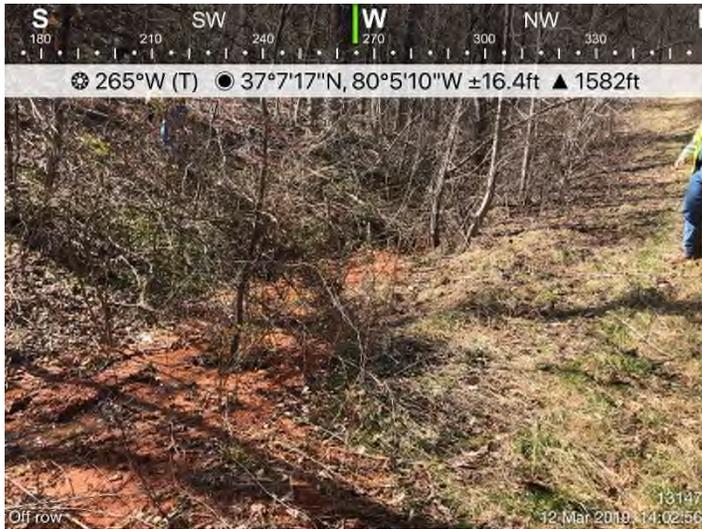
Attended a site meeting with Mr. Foley (landowner) and Ronald Wilson (Franklin County). Landowner was concerned that ROW activities at approx. STA 13143+00 may have diverted flow from a stream, causing a bank failure outside of the ROW and sediment deposition along Mr. Foley's property and subsequently clogging a downstream culvert. Site inspection concluded that only clearing had been conducted in this area, with no land disturbance to date. Onsite stream delineation flags for S-D14 and S-D17 showed that the stream (S-D17) has not been diverted since the start of the MVP project but may have been incidentally diverted prior to ROW activities or through past land use.

Fig. 9: Mr. Foley's Property – Sediment deposition/clogged culvert off ROW.

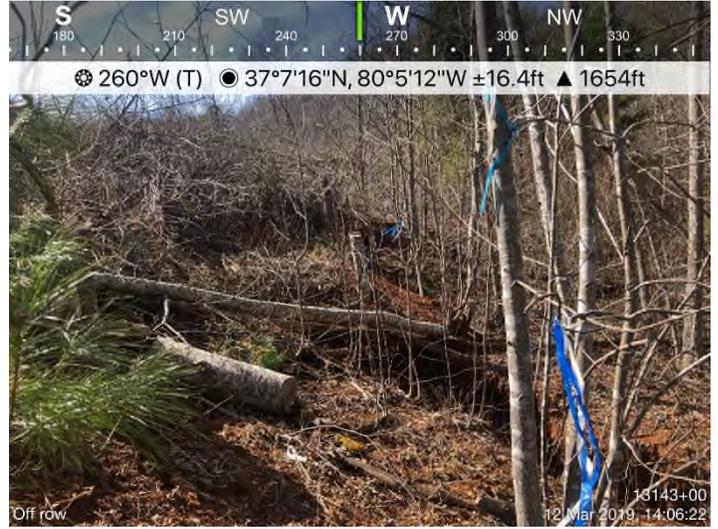
Fig. 10: STA 13143+00 – ROW limit at bank failure at S-D17.

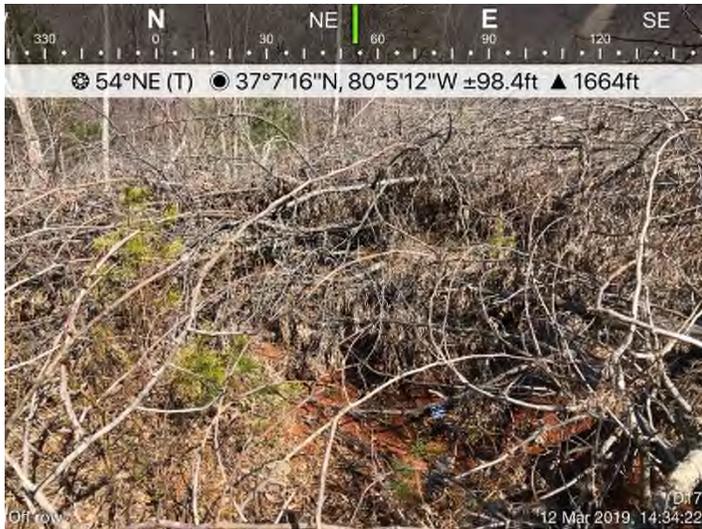
Fig. 11: S-D17 – Inside ROW at S-D17 adjacent to bank failure.

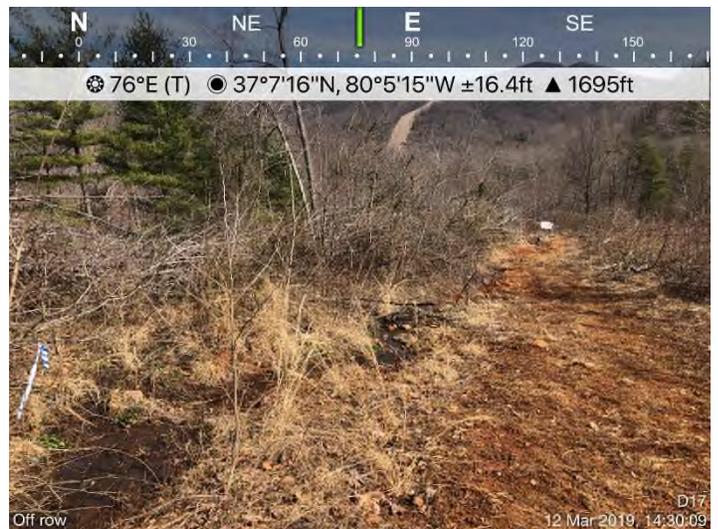
Fig. 12: S-D17 – Stream running down old roadbed above bank failure.
