FIELD INSPECTION

Project Name:	Mountain Valley Pipeline	Inspector:	Marshall Willis
Inspection Date:	Tuesday, March 19, 2019	Project Contact:	Brian Clauto
Spread H: Montgomery County Roanoke County	STA 12054+00 – 12140+00 STA 12451+61 – 12460+00	Weather (Wet/Dry/Rain):	Dry

FIELD INSPECTION PHOTO LOG

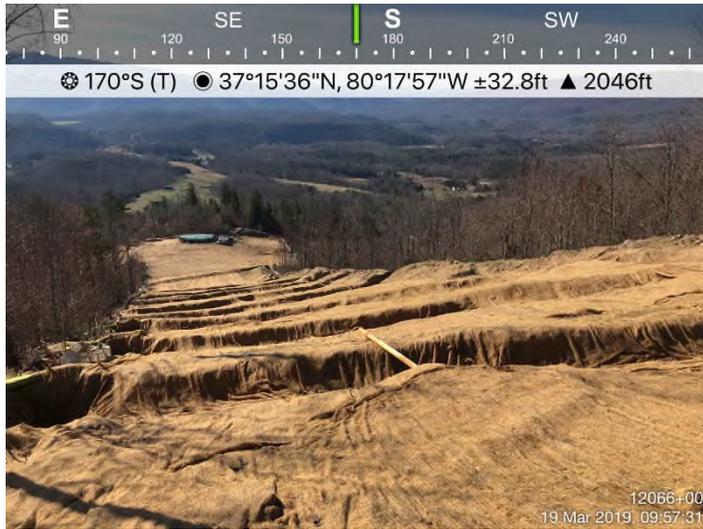
Fig. 1: STA 12066+00 – Area adequately stabilized. Controls in place.

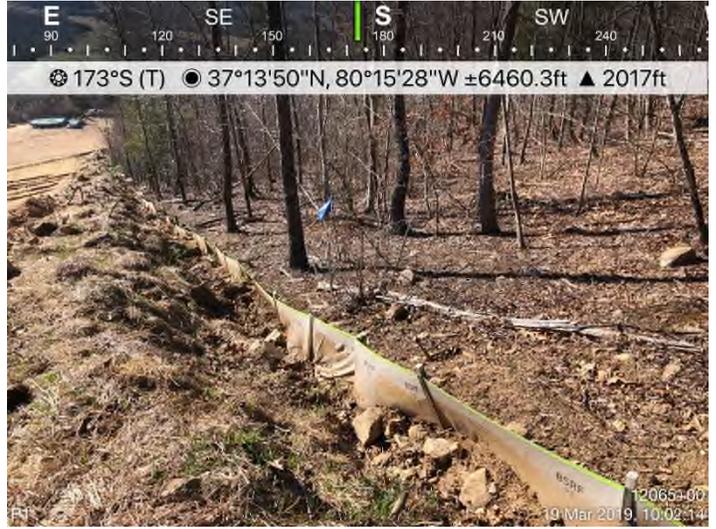
- STA 12065+00: P1 undermined at several locations along perimeter.
- STA 12092+80: CWD does not have inlet protection.
- STA 12098+44: Repair CFS at CIS S-MM13.
- STA 12100+00: Perimeter CWD berm failing.

Fig. 2: STA 12065+00 – P1 undermined in several locations.

Recommended Corrective Action: Maintain and install all controls per the approved plan and specs.

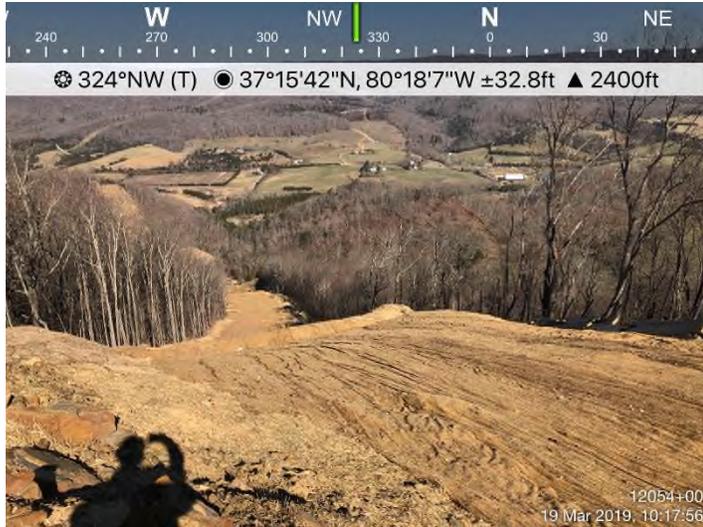
Fig. 3: STA 12054+00 – Area adequately stabilized. Controls in place.

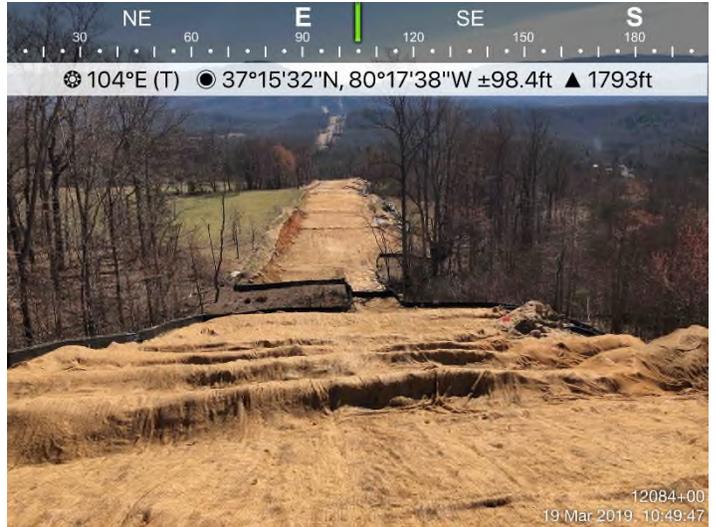
Fig. 4: STA 12084+00 – Area adequately stabilized. Controls in place.

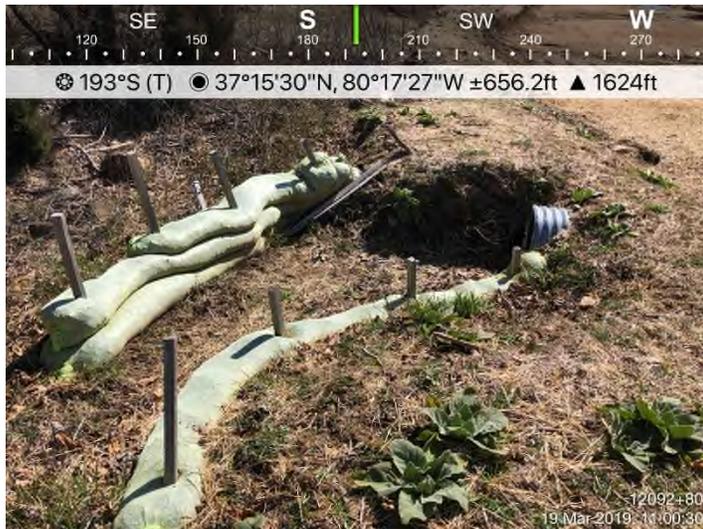
Fig. 5: STA 12092+80 – Inlet protection needed at CWD.

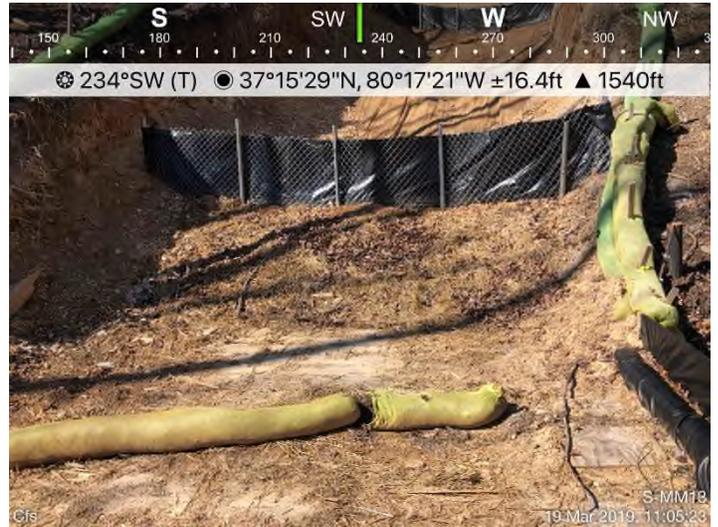
Fig. 6: STA 12098+44 – Repair CFS at S-MM13.

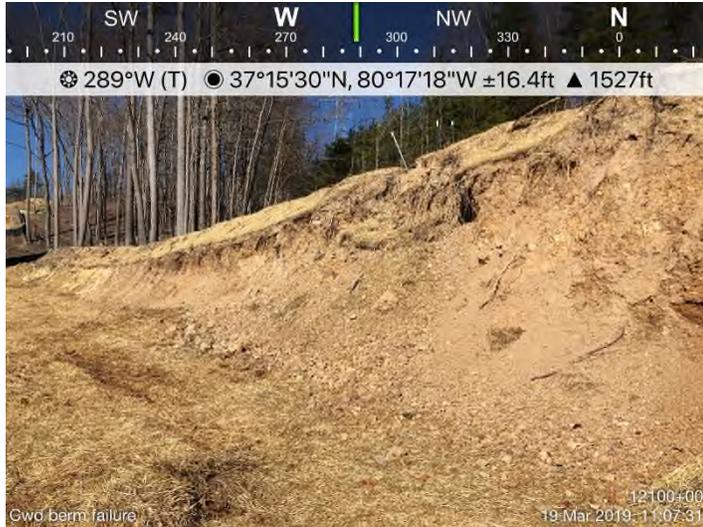
Fig. 7: STA 12100+00 – Perimeter CWD berm failing.

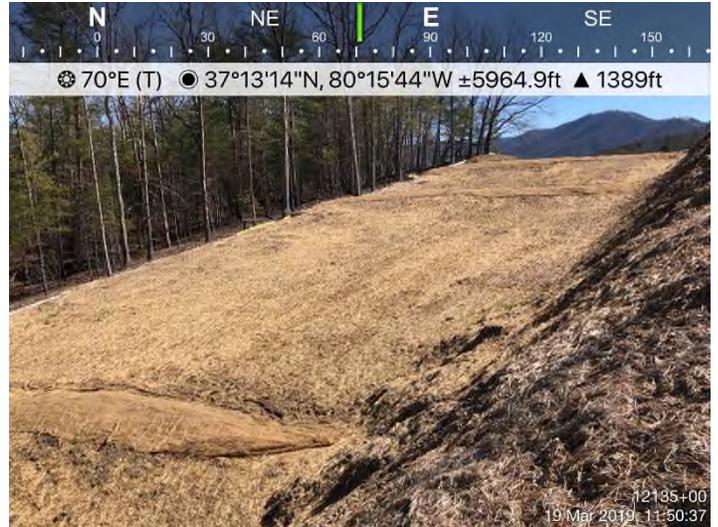
Fig. 8: STA 12135+00 – Area adequately stabilized. Controls in place.
