FIELD INSPECTION

Project Name:	Mountain Valley Pipeline	Inspector:	Marshall Willis
Inspection Date:	Friday, March 22, 2019	Project Contact:	Brian Clauto
Spread H: Montgomery County	STA 12144+47 – 12188+34 STA 11993+00 – 12015+84	Weather (Wet/Dry/Rain):	Dry

FIELD INSPECTION PHOTO LOG

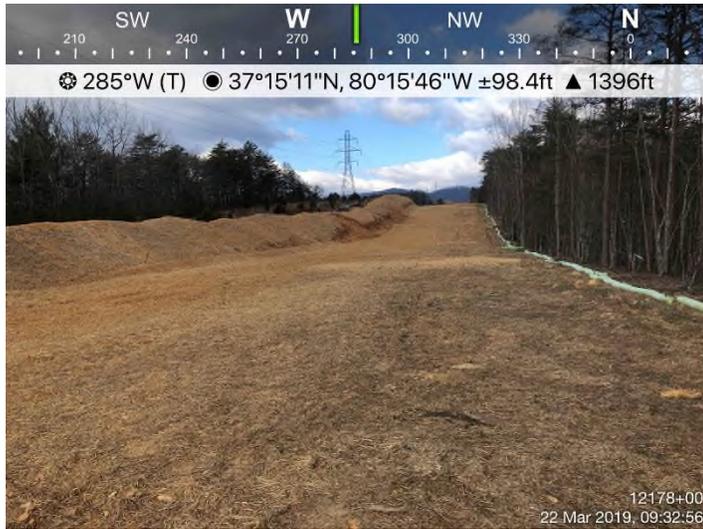
Fig. 1: STA 12178+00 – Area adequately stabilized. Controls in place.

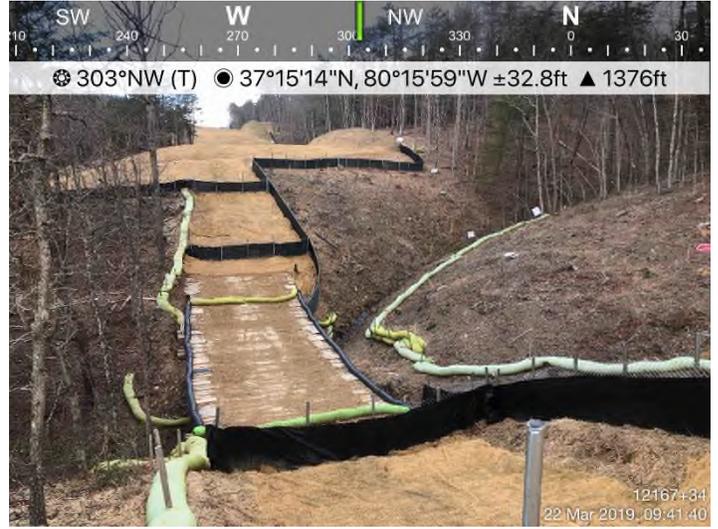
Fig. 2: STA 12167+34 – Area adequately stabilized. Controls in place.

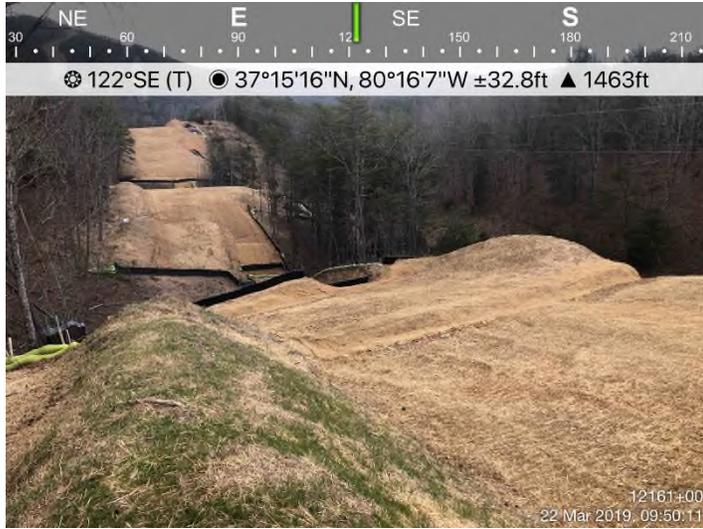
Fig. 3: STA 12161+00 – Area adequately stabilized. Controls in place.

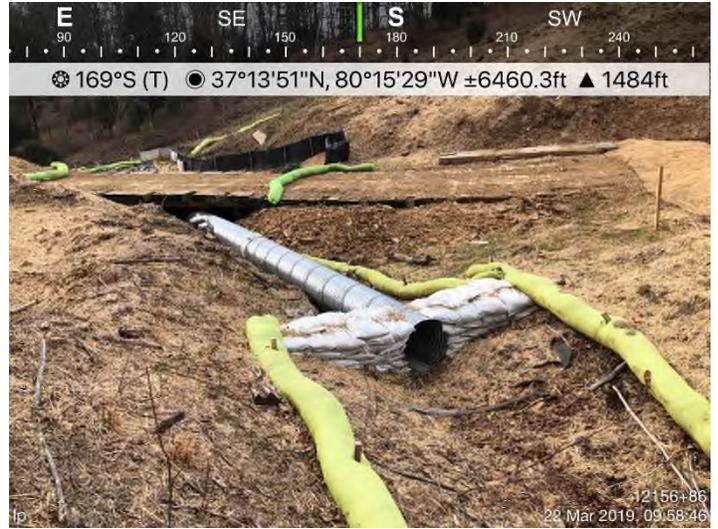
- STA 12156+86: CWD does not have inlet protection.
- STA 12168+75: Re-stake geo-fabric.

Fig. 4: STA 12156+86 – CWD needs inlet protection.

Recommended Corrective Action: Maintain and install all controls per the approved plan and specs.

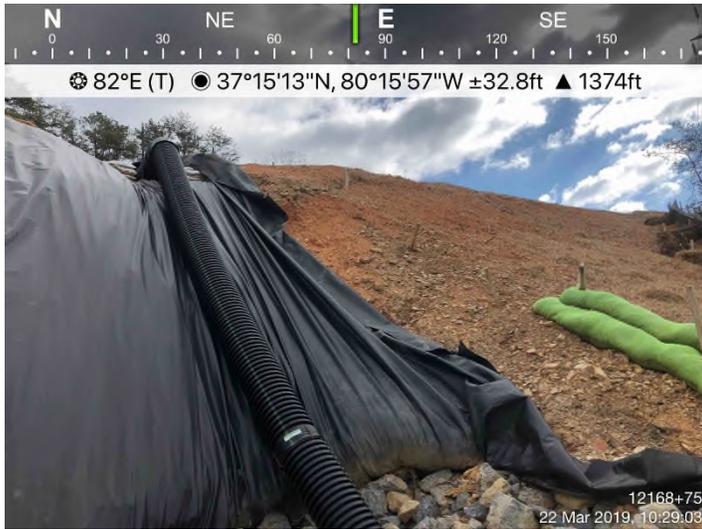
Fig. 5: STA 12168+75 – Re-stake fabric.

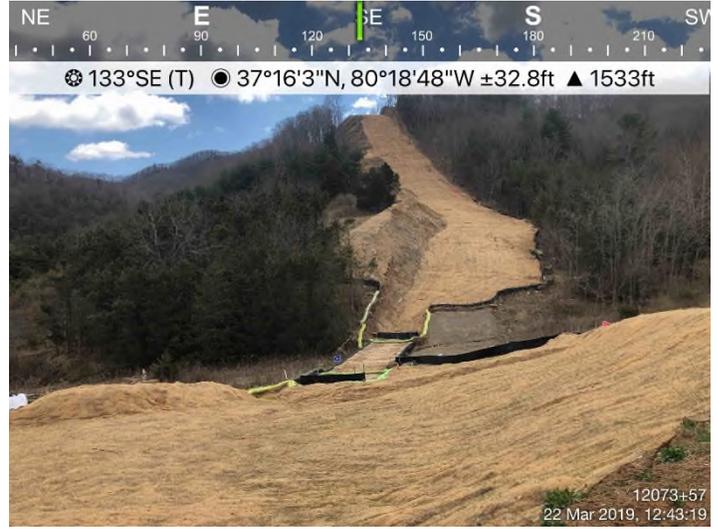
Fig. 6: STA 12073+57 – Area adequately stabilized. Controls in place.

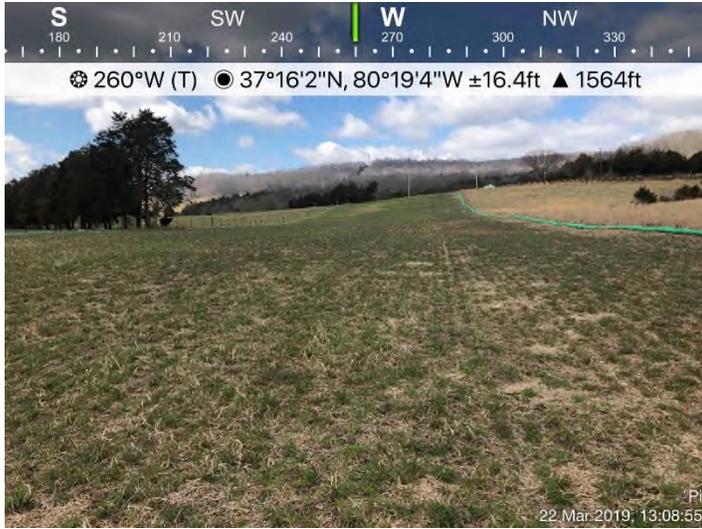
Fig. 7: STA 12006+00 – Area adequately stabilized. Controls in place.

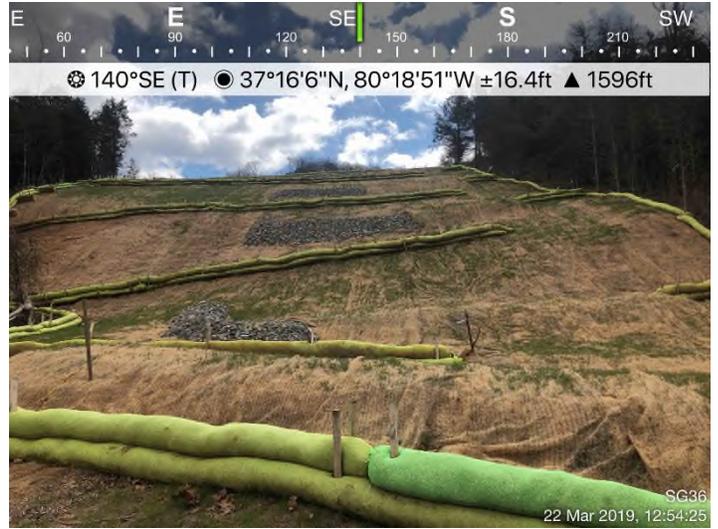
Fig. 8: STA 12008+53 – Area adequately stabilized. Controls in place.
