FIELD INSPECTION

| Project Name: | Mountain Valley Pipeline | Inspector: | Marshall Willis |
| Spread H: Franklin County | STA 13035+59 – 13115+97 MVP-FR-289/291 | Weather (Wet/Dry/Rain): | Dry |

FIELD INSPECTION PHOTO LOG

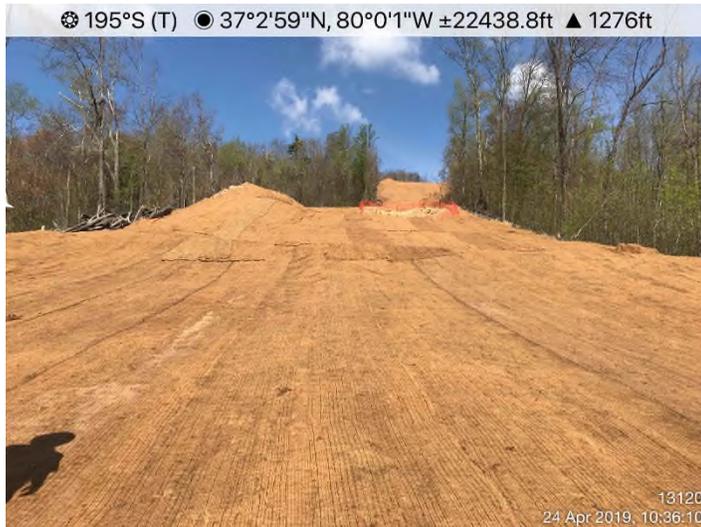
Fig. 1: **STA 13120** – Controls in place. Area stabilized with curlex fabric.

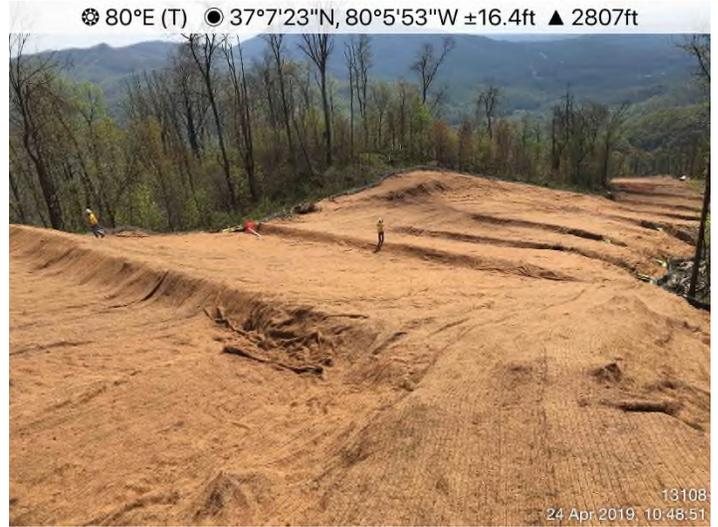
Fig. 2: **STA 13108** – Controls in place. Area stabilized with curlex fabric.

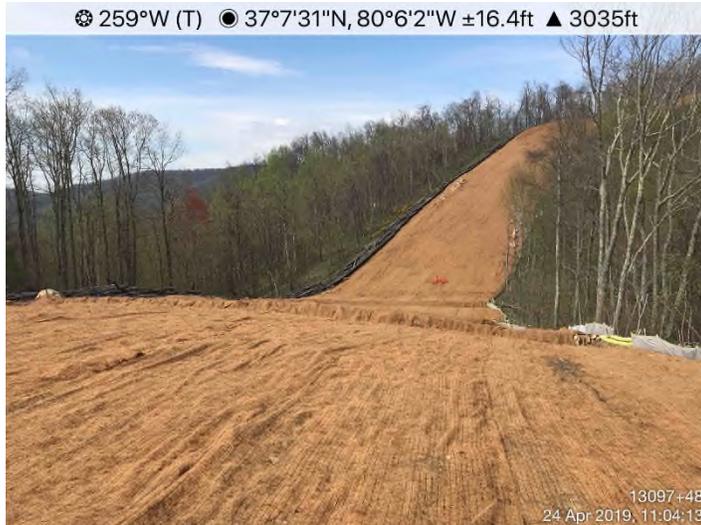
Fig. 3: **STA 13097+48** – Controls in place. Area stabilized with curlex fabric.

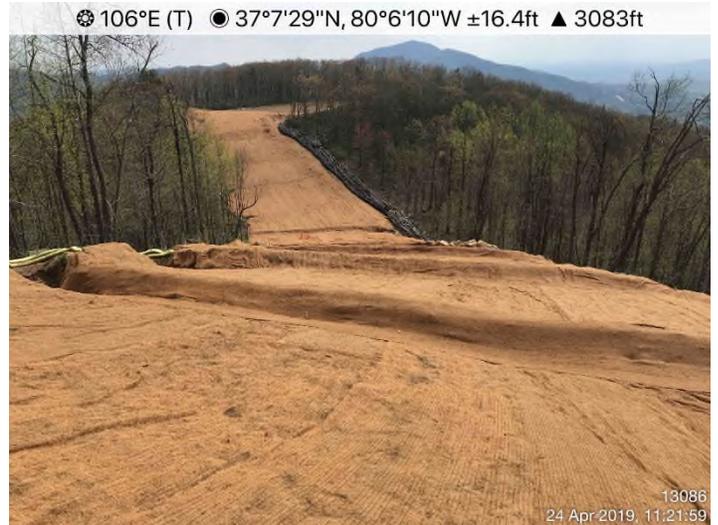
Fig. 4: **STA 13086** – Controls in place. Area stabilized with curlex fabric.

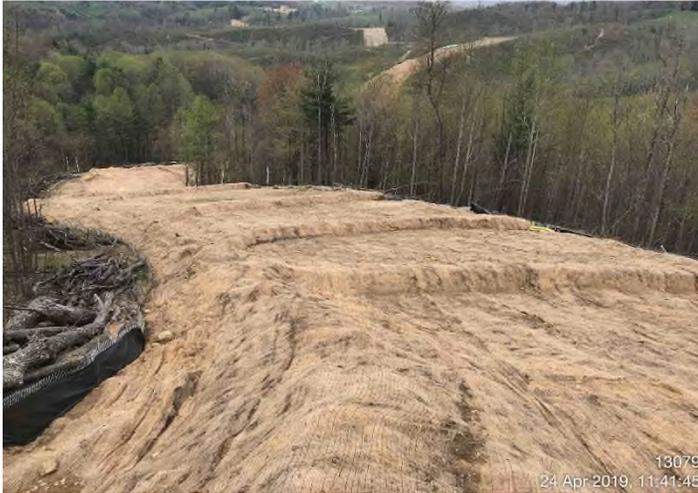
Fig. 5: **STA 13079** – Controls in place. Area stabilized with curlex fabric.

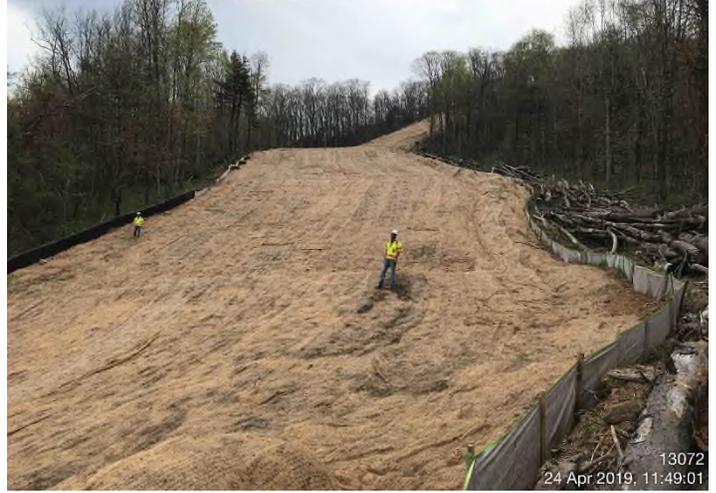
Fig. 6: **STA 13072** – Controls in place. Area stabilized with curlex fabric.

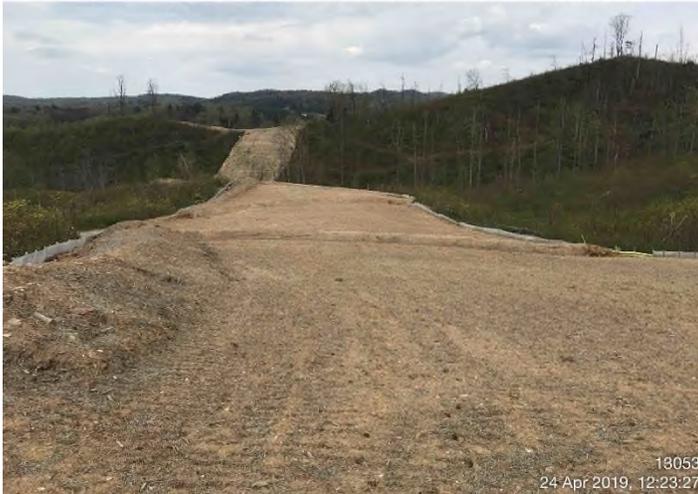
Fig. 7: **STA 13053** – Controls in place. Area stabilized with Earth Guard and straw.

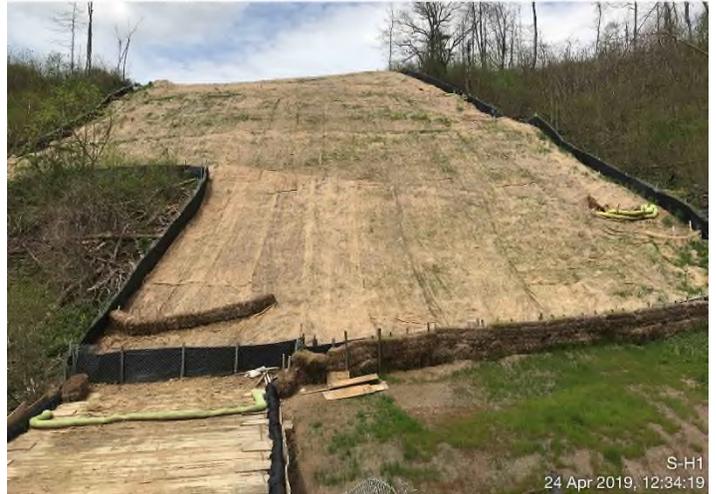
Fig. 8: **S-H1** – Controls in place. Area stabilized with curlex fabric.
