FIELD INSPECTION

Project Name:	Mountain Valley Pipeline	Inspector:	Matthew Grant
Inspection Date:	Monday, May 13, 2019	Project Contact:	Brian Clauto
Spread: Franklin County ARR0288 AR291 MP246-248 St13023-13120 MP251 St13265	Spread H	Weather (Wet/Dry/Rain):	Dry

FIELD INSPECTION PHOTO LOG

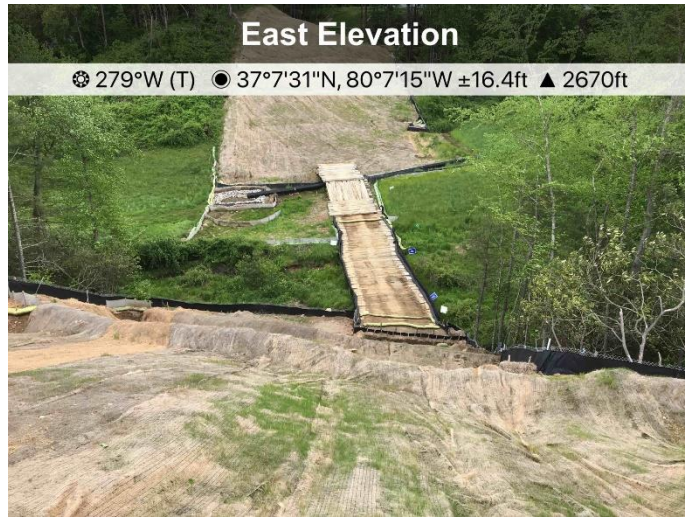
Fig. 1 Above designated stream G-24, ECD's in place

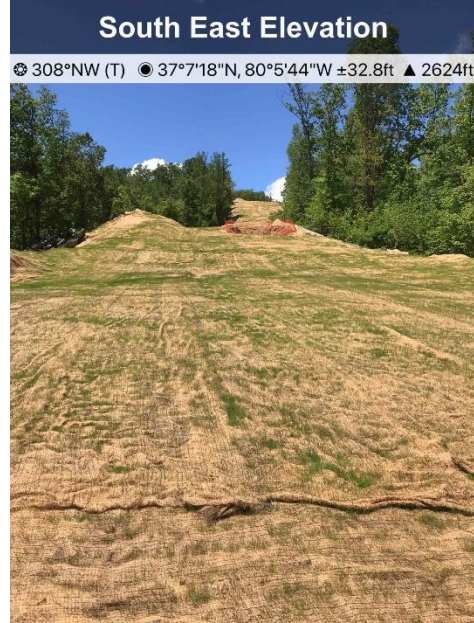
Fig. 2 St#13120+00 slope has been stabilized with blanket matting.

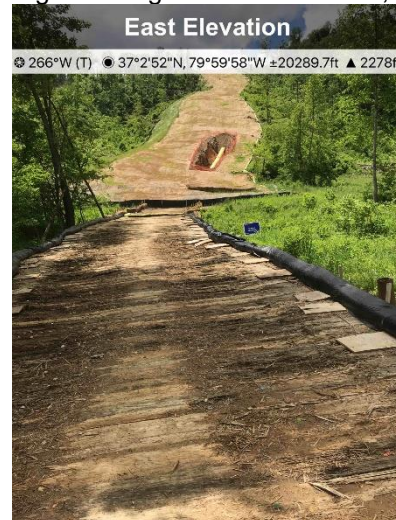
Fig. 4. Designated stream S-II4, ECD's in place
