## FIELD INSPECTION

<b>Project Name:</b>	Mountain Valley Pipeline	<b>Inspector:</b>	Marshall Willis
<b>Inspection Date:</b>	Wednesday, May 22, 2019	<b>Project Contact:</b>	Brian Clauto
<b>Spread H: Franklin County</b>	STA 13197+35 – 13318+21	<b>Weather (Wet/Dry/Rain):</b>	Dry

# FIELD INSPECTION PHOTO LOG

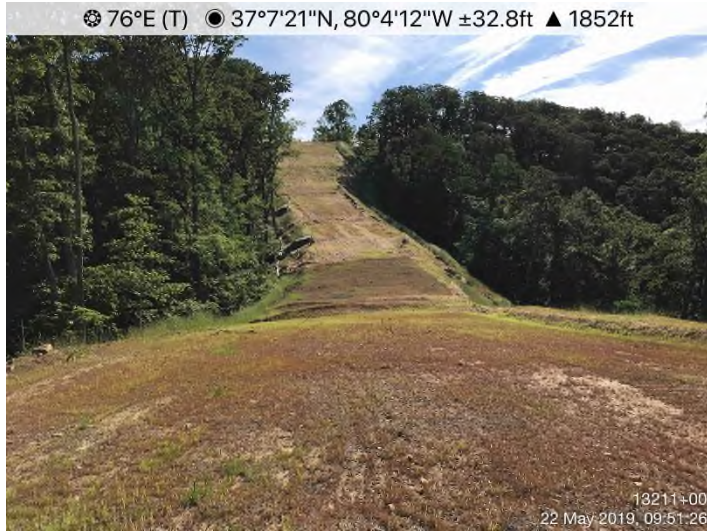
**Fig. 1: STA 13211+00** – Controls in place. Area stabilized with erosion fabric/Earth Guard.

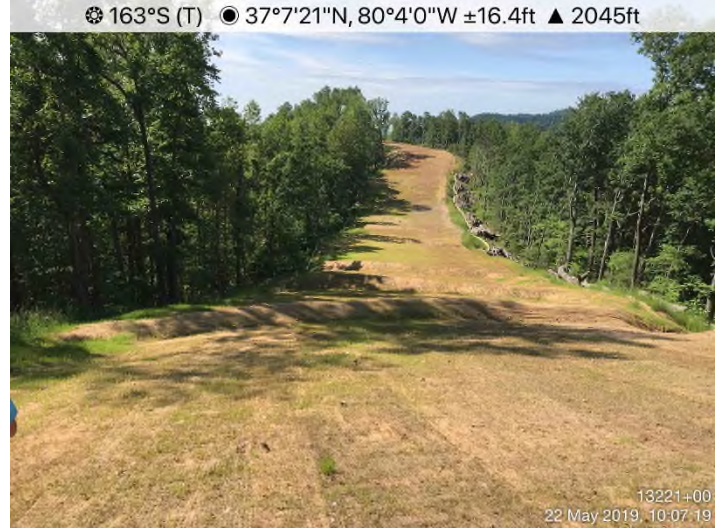
**Fig. 2: STA 13221+00** – Controls in place. Area stabilized with erosion fabric/Earth Guard.

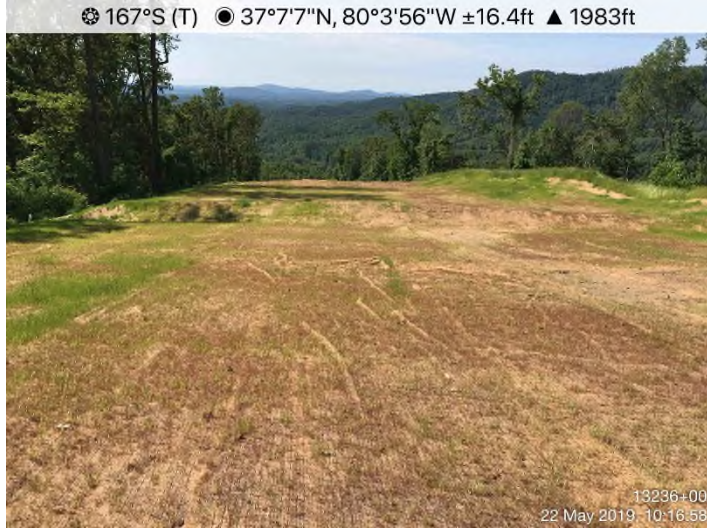
**Fig. 3: STA 13236+00** – Controls in place. Area stabilized with erosion fabric/Earth Guard.

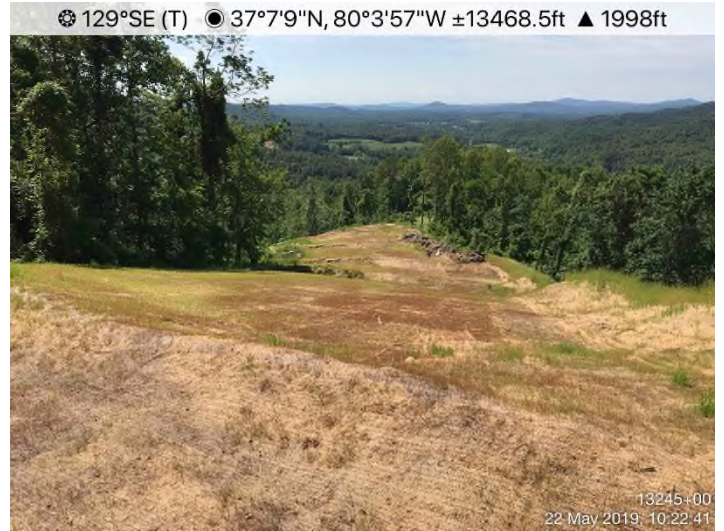
**Fig. 4: STA 13245+00** – Controls in place. Area stabilized with erosion fabric/Earth Guard.

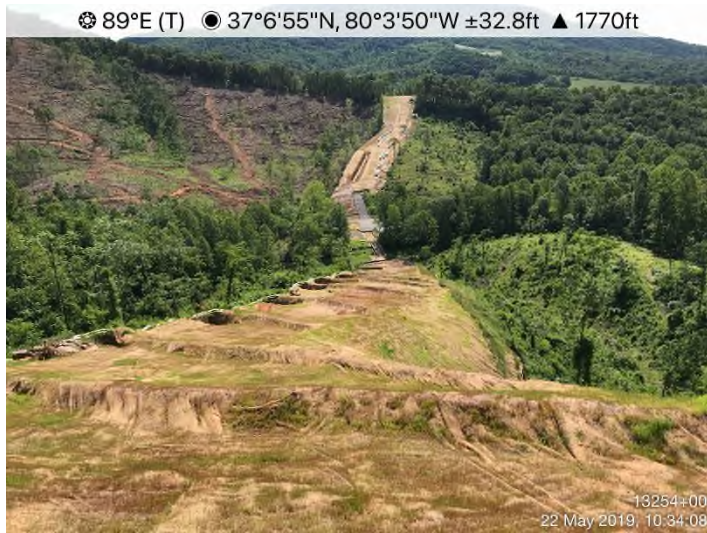
**Fig. 5: STA 13254+00** – Controls in place. Area stabilized with erosion fabric/Earth Guard.

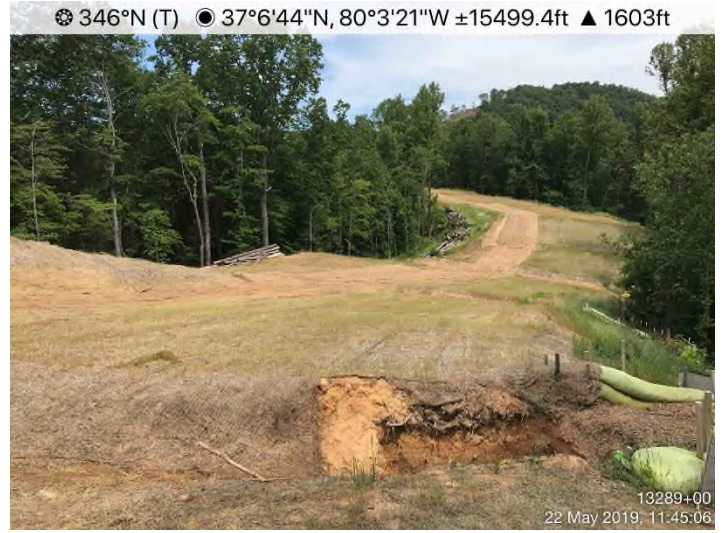
**Fig. 6: STA 13289+00** – Controls in place. Area stabilized with erosion fabric/Earth Guard.

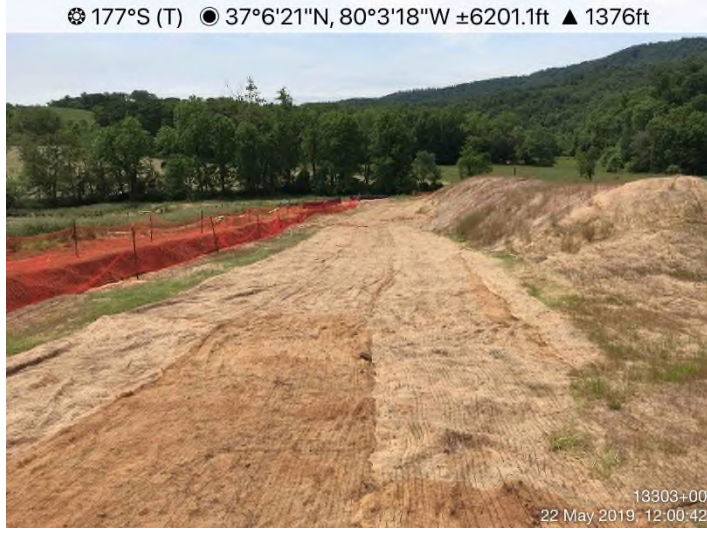
**Fig. 7: STA 13303+00** – Controls in place. Area stabilized with erosion fabric/Earth Guard.

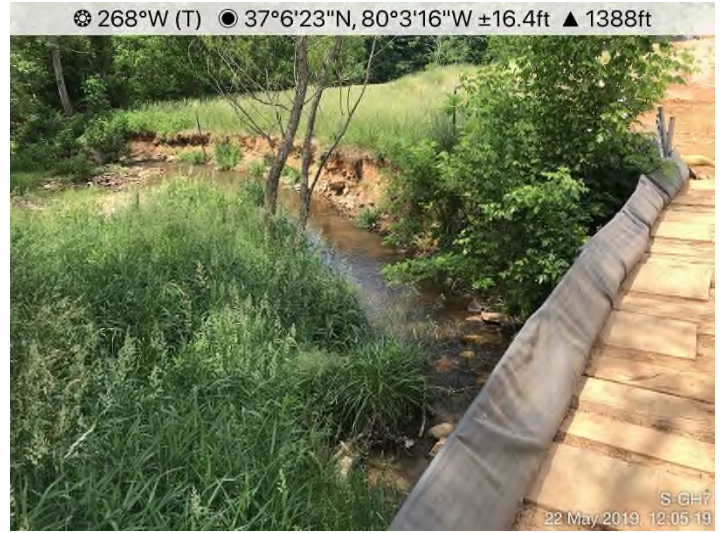
**Fig. 8: Stream S-GH7** – Controls in place.
