FIELD INSPECTION REPORT

Project Name:	Mountain Valley Pipeline	Inspector:	Marshall Willis
Inspection Date:	Wednesday, May 27, 2020	Project Contact:	Brian Clauto, Cory Chalmers
Spread H: Franklin County	STA 13306+16 – 13316+00 STA 13411+83 – 13415+51 ATWS 1412/1352	Weather:	Rainy

FIELD INSPECTION PHOTO LOG

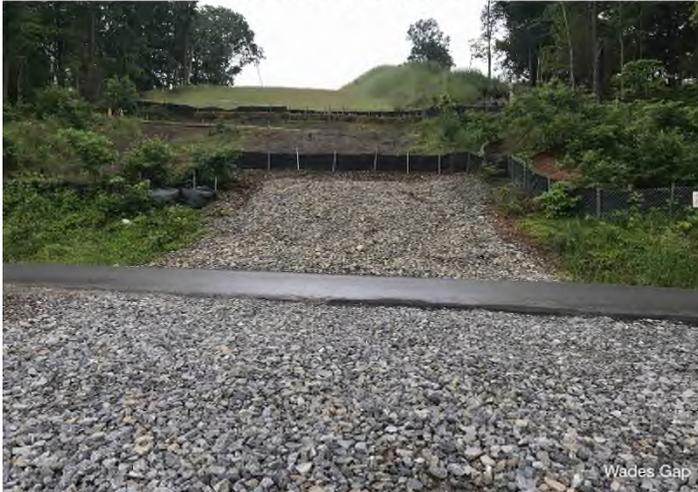
Figure 1: STA 11306+50 – Controls in place and functioning properly at the Wades Gap crossing.

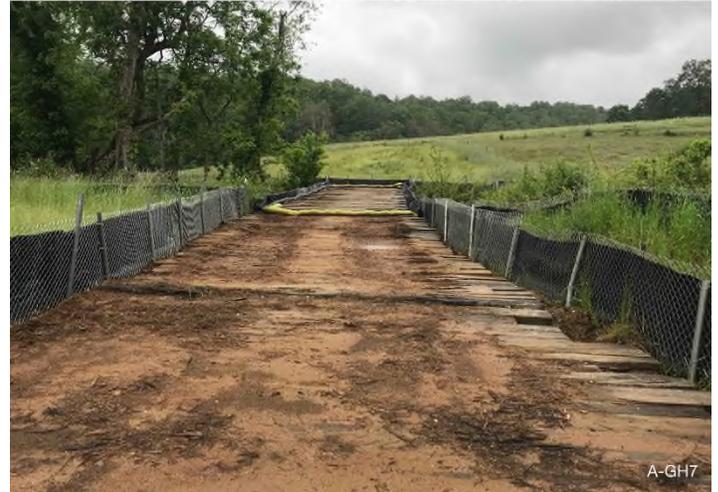
Figure 2: Stream S-GH7 – Controls in place and functioning properly around S-GH7 crossing. Area stabilized.

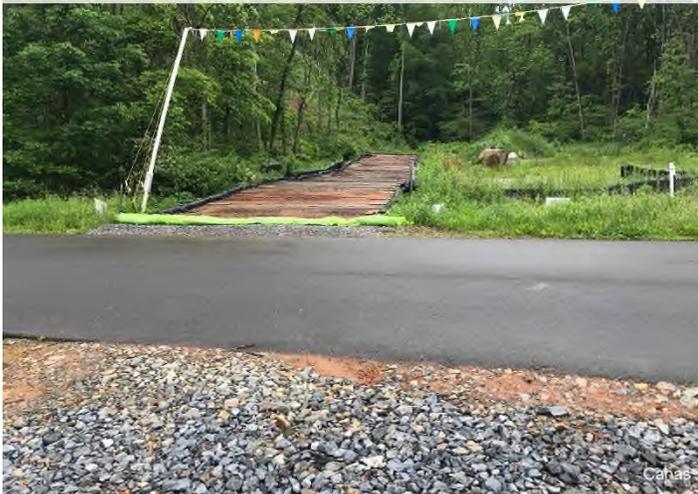
Figure 3: STA 11306+50 – Controls in place and functioning properly at the Cahas Road crossing.

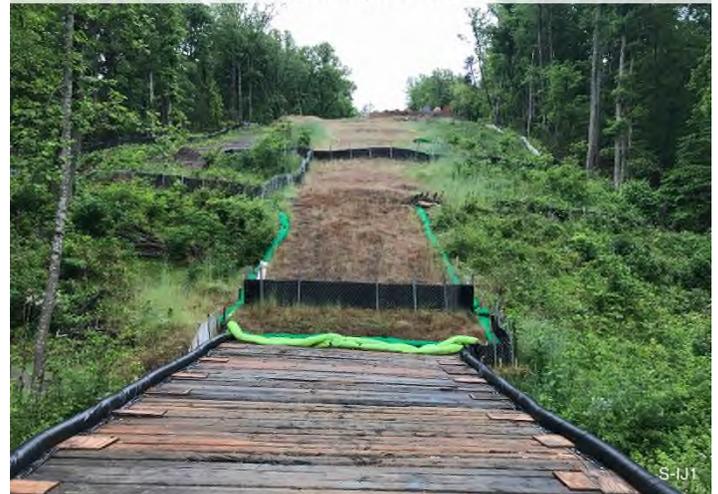
Figure 4: Stream S-IJ1 – Controls in place and functioning properly at stream S-IJ1 crossing. Area stabilized.
