FIELD INSPECTION REPORT

Project Name:	Mountain Valley Pipeline	Inspector:	Marshall Willis
Inspection Date:	Tuesday, May 5, 2020	Project Contact:	Brian Clauto, Cory Chalmers
Spread H: Montgomery County	STA 11996+69 – 12036+92 ATWS 473/473A/474/474A/1161 MVP-MN-268/268.01	Weather:	Rainy

FIELD INSPECTION PHOTO LOG

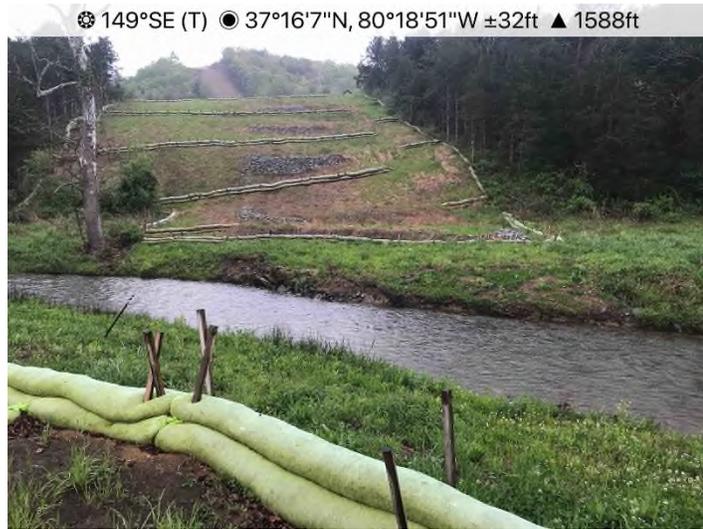
Figure 1: Stream S-G36 – Controls in place and functioning properly along the North Fork Roanoke River.

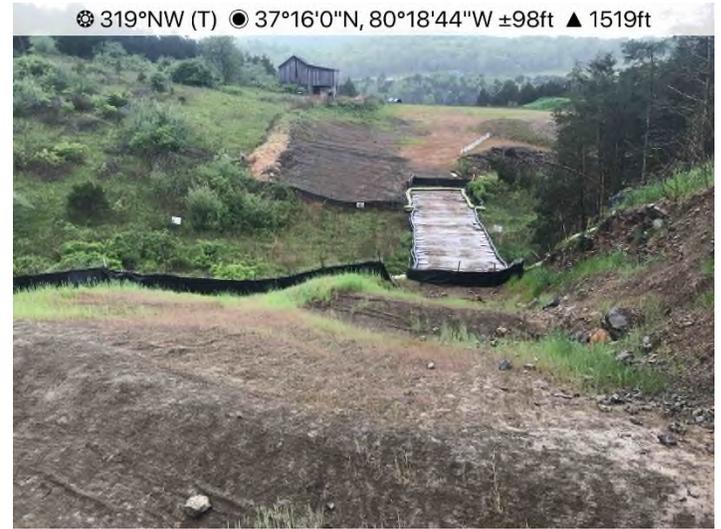
Figure 2: STA 12016+29 – Controls in place and functioning properly around S-G38.

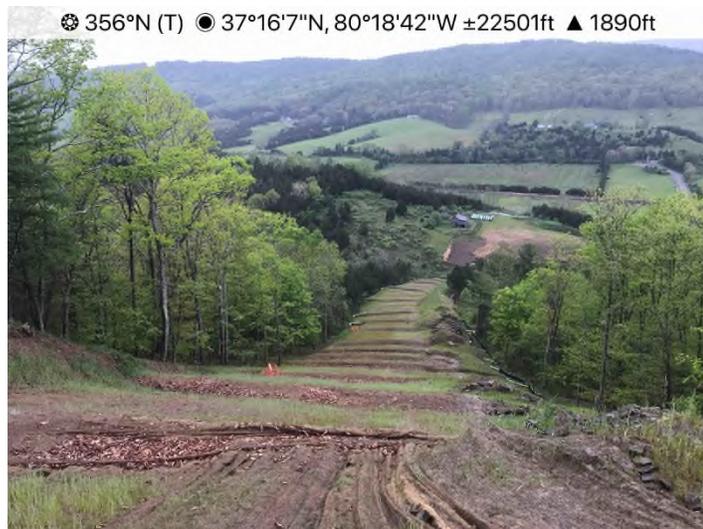
Figure 3: STA 12025+00 – Controls in place and functioning properly.

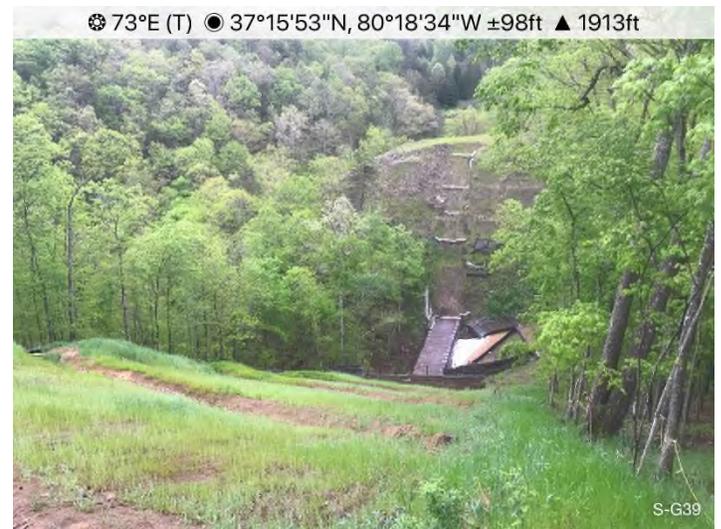
Figure 4: STA 12026+84 – Controls in place and functioning properly.
