FIELD INSPECTION

Project Name:	Mountain Valley Pipeline	Inspector:	Marshall Willis
Inspection Date:	Tuesday, June 18, 2019	Project Contact:	Brian Clauto
Spread H: Montgomery County Roanoke County	STA 12188+00 – 12209+00 STA 12600+00 – 12638+24 MVP-RO-279.01/279.02 MVP-MN-275	Weather (Wet/Dry/Rain):	Dry

FIELD INSPECTION PHOTO LOG

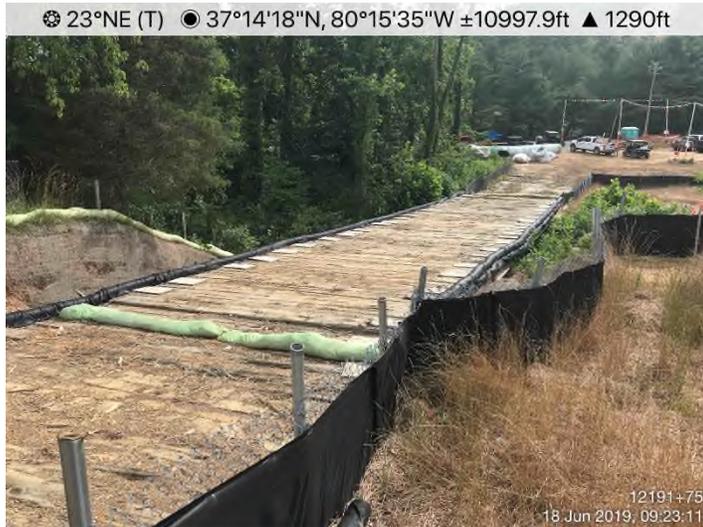
Fig. 1: Stream S-C21 – Controls in place.

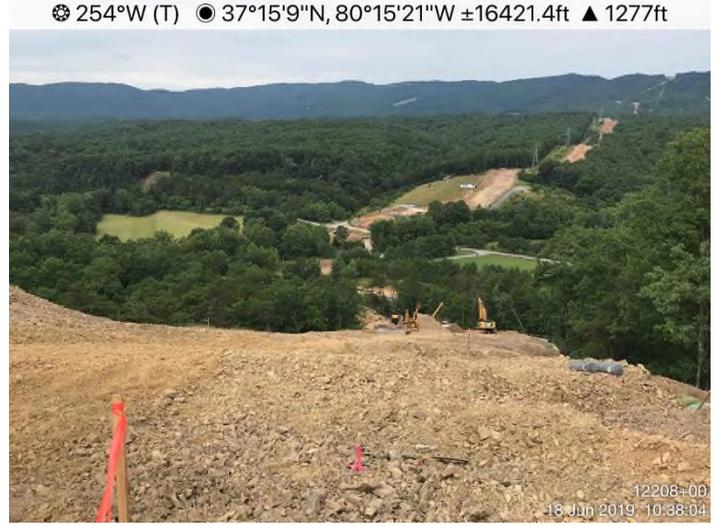
Fig. 2: STA 12208+00 – Controls in place. Active trenching, stringing and welding.

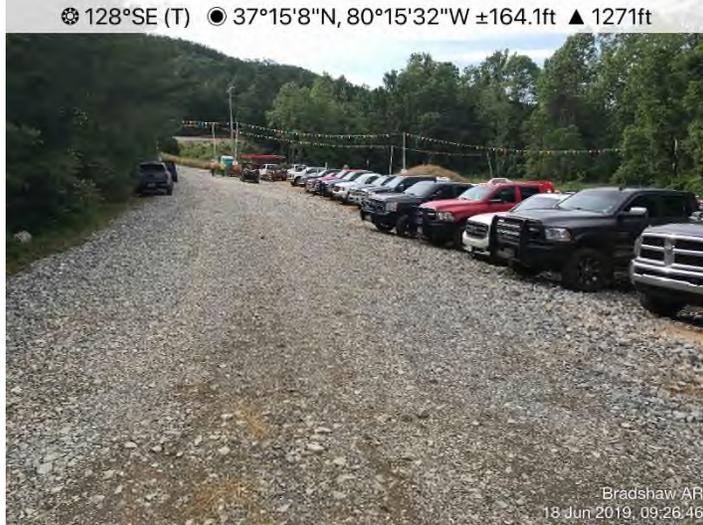
Fig. 3: MVP-MN-275 – Controls in place.

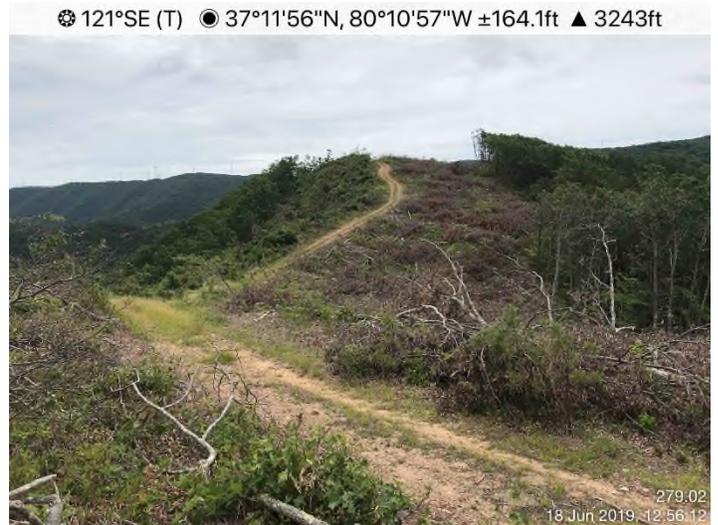
Fig. 4: MVP-RO-279.02 – No ground disturbance observed.
