FIELD INSPECTION REPORT

| Project Name: | Mountain Valley Pipeline | Inspector: | Marshall Willis |
| Inspection Date: | Tuesday, June 2, 2020 | Project Contact: | Brian Clauto, Cory Chalmers |
| Spread H: Montgomery County | STA 12072+50 – 12188+34 MVP-MN-270/271/273/274 ATWS 1163/1162/701/1167/1168 | Weather: | Dry |

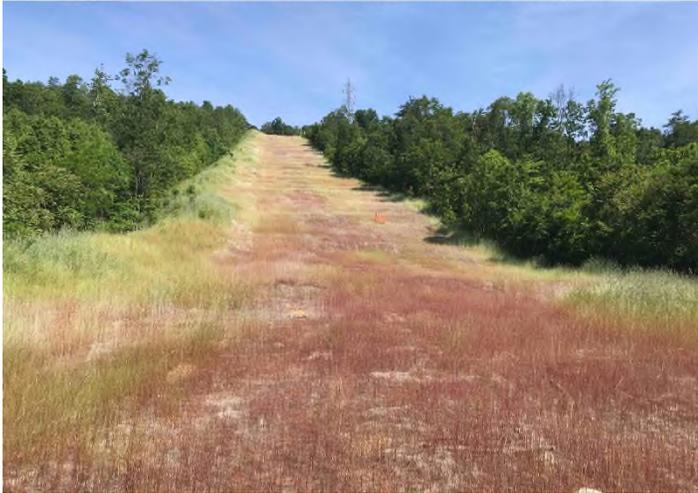
Figure 1: STA 12072+00 – Controls in place and functioning properly. Area stabilized.

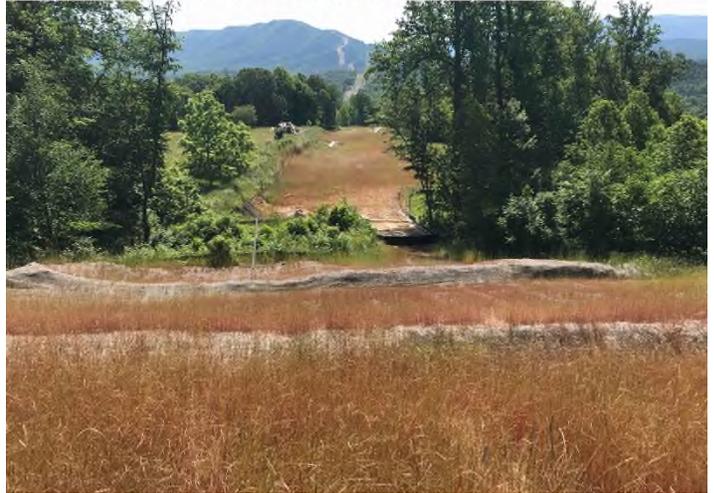
Figure 2: STA 12085+00 – Controls in place and functioning properly. Area stabilized.

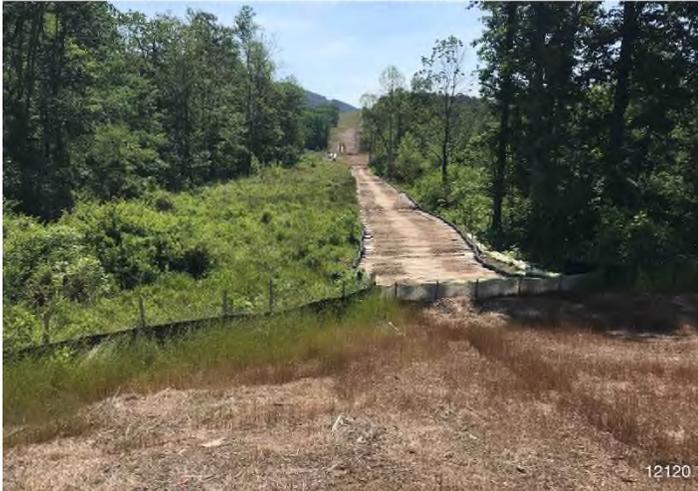
Figure 3: STA 12120+00 – Controls in place and functioning properly. Area stabilized.

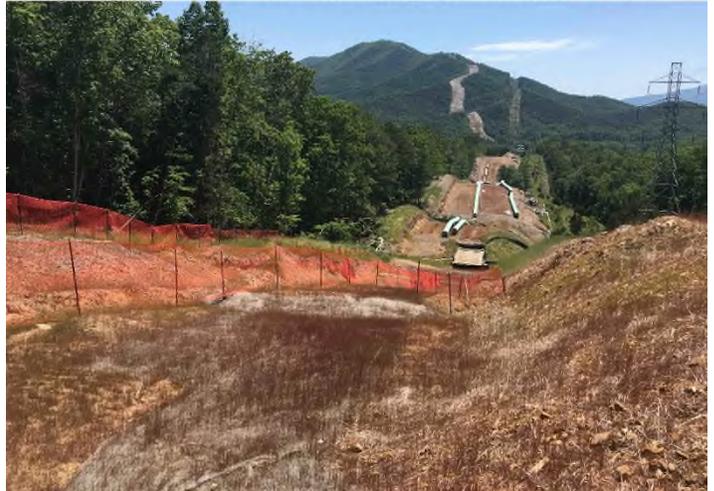
Figure 4: STA 12155+00 – Controls in place and functioning properly. Area stabilized.
