FIELD INSPECTION REPORT

Project Name:	Mountain Valley Pipeline	Inspector:	Marshall Willis
Inspection Date:	Tuesday, June 23, 2020	Project Contact:	Brian Clauto, Cory Chalmers
Spread H: Montgomery County	STA 12373+28 – 12434+00 MVP-MN-279/279.02 ATWS 1506/1507/726/725	Weather:	Dry

FIELD INSPECTION PHOTO LOG

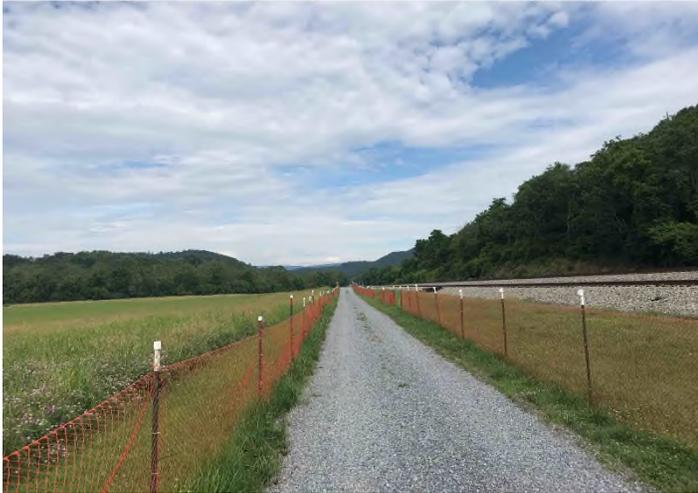
Figure 1: MVP-MN-279 – Controls in place and functioning properly.

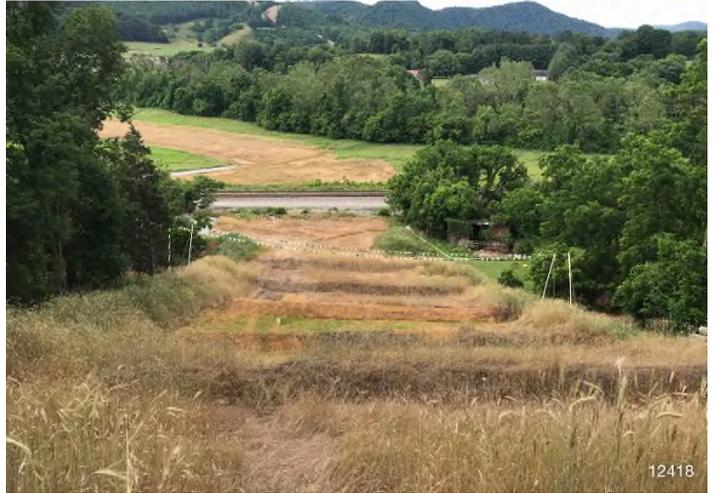
Figure 2: STA 12418+00 – Controls in place and functioning properly. Area stabilized.

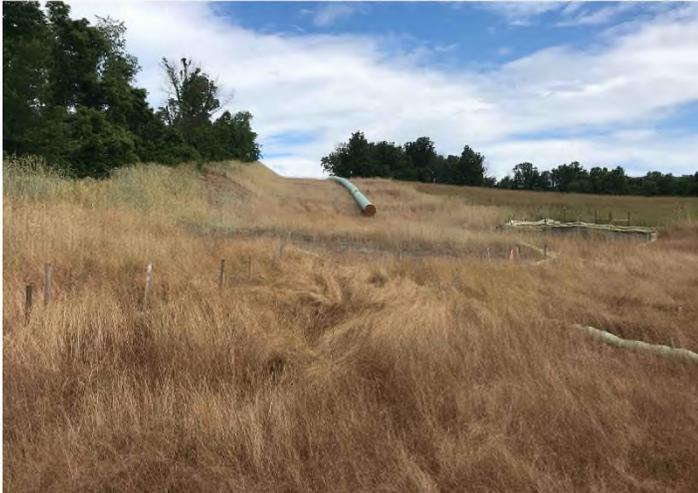
Figure 3: STA 12410+00 – Controls in place and functioning properly. Area stabilized.

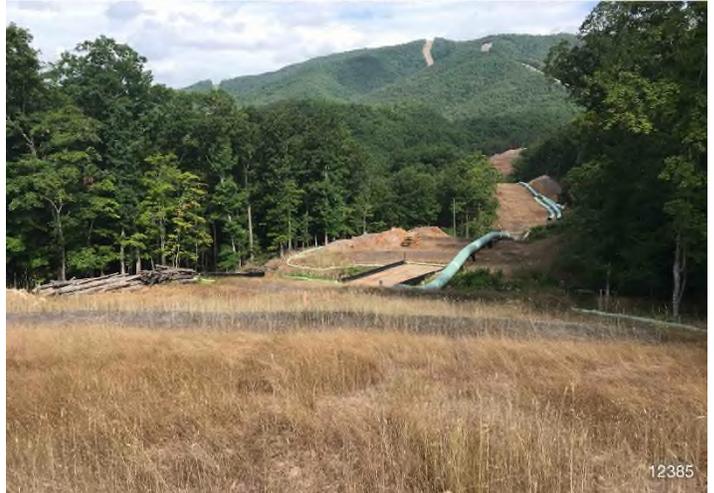
Figure 4: STA 12385+00 – Controls in place and functioning properly. Area stabilized.
