FIELD INSPECTION REPORT

Project Name:	Mountain Valley Pipeline	Inspector:	Marshall Willis
Inspection Date:	Thursday, June 25, 2020	Project Contact:	Brian Clauto, Cory Chalmers
Spread H: Franklin County	STA 12994+00 – 13063+00 MVP-FR-290 ATWS 954/1038/1039	Weather:	Dry

FIELD INSPECTION PHOTO LOG

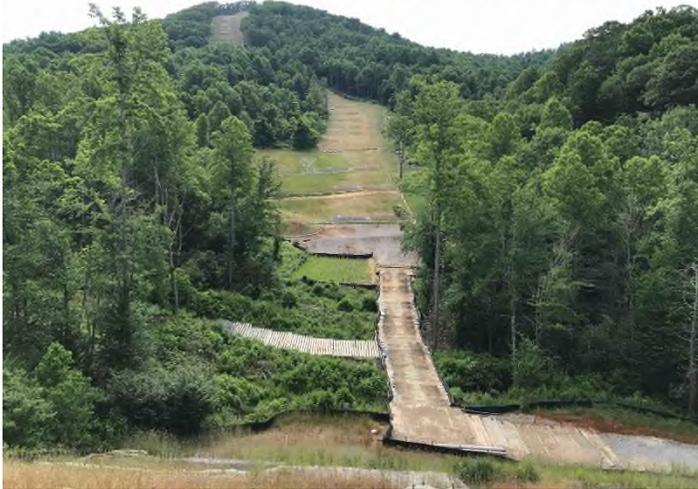
Figure 1: STA 13060+00 – Controls in place and functioning properly.

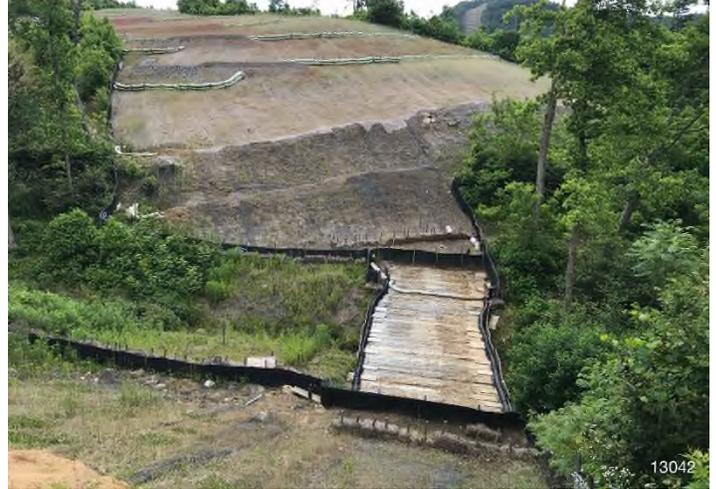
Figure 2: STA 13042+00 – Controls in place and functioning properly. Area stabilized with erosion fabric and vegetation.

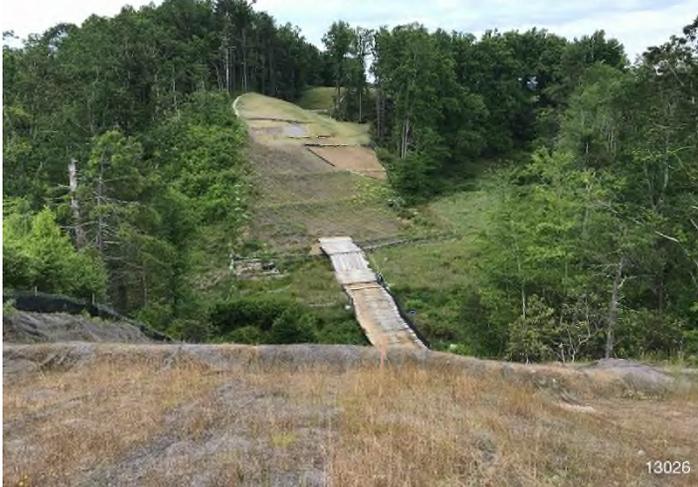
Figure 3: STA 13026+00 – Controls in place and functioning properly. Area stabilized with vegetation and erosion control fabric.

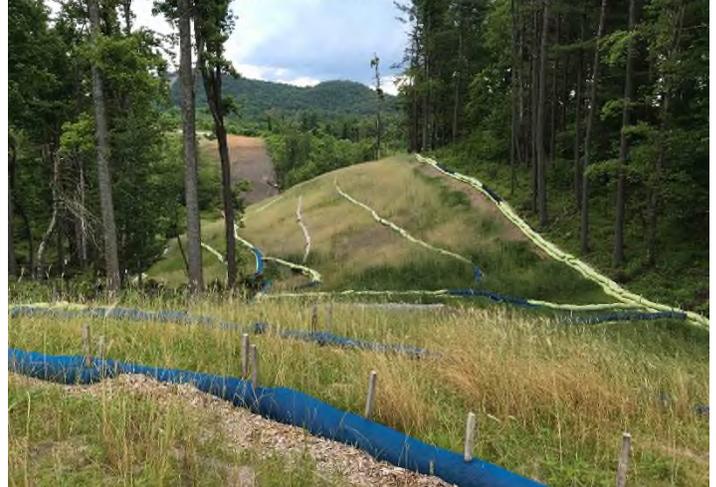
Figure 4: STA 13020+00 – Controls in place and functioning properly. Area stabilized.
