FIELD INSPECTION

Project Name:	Mountain Valley Pipeline	Inspector:	Marshall Willis
Inspection Date:	Thursday, June 27, 2019	Project Contact:	Brian Clauto
Spread H: Montgomery County Franklin County	STA 12298+05 – 12370+00 STA 13060+00 – 13084+00 MVP-FR-290 MVP-MN-276.03	Weather (Wet/Dry/Rain):	Dry

FIELD INSPECTION PHOTO LOG

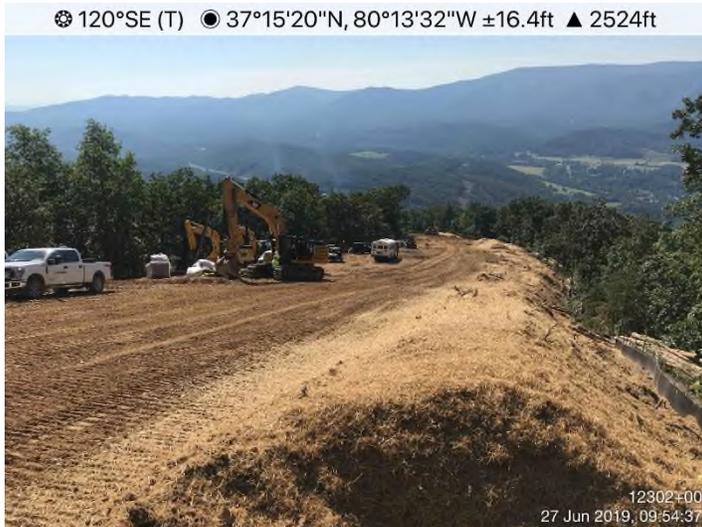
Fig. 1: STA 12302+00 – Controls in place.

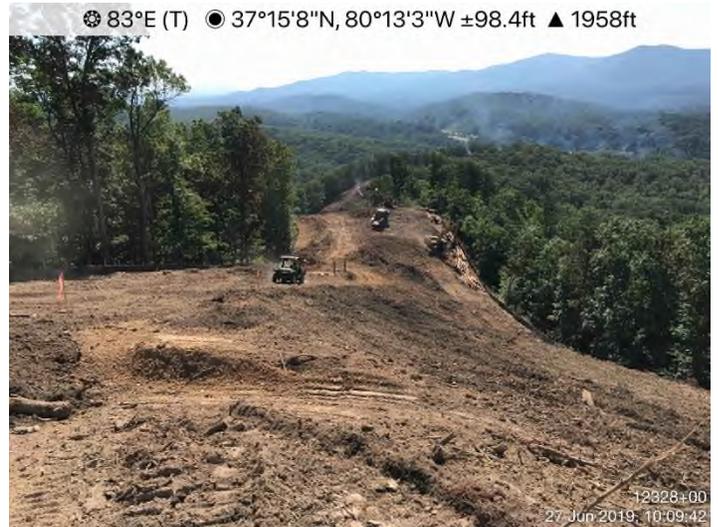
Fig. 2: STA 12328+00 – Controls in place.

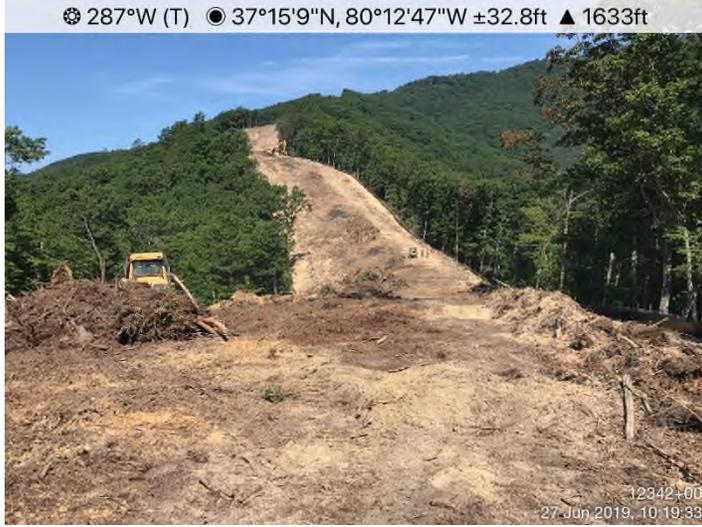
Fig. 3: STA 12342+00 – Controls in place.

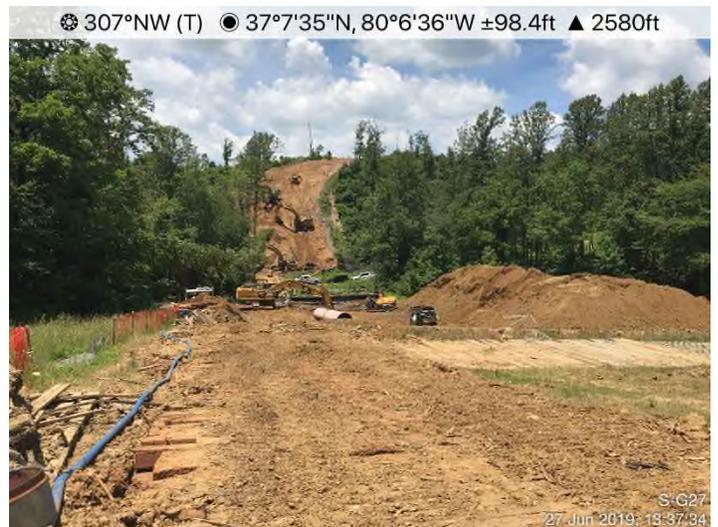
Fig. 4: STA 13084+00 – Controls in place.
