FIELD INSPECTION REPORT

Project Name:	Mountain Valley Pipeline	Inspector:	Marshall Willis
Inspection Date:	Tuesday, June 30, 2020	Project Contact:	Brian Clauto, Cory Chalmers
Spread H: Franklin County	STA 13061+44 – 13115+50 MVP-FR-290/291 ATWS 1248/1248A/344/1249/1410	Weather:	Dry

FIELD INSPECTION PHOTO LOG

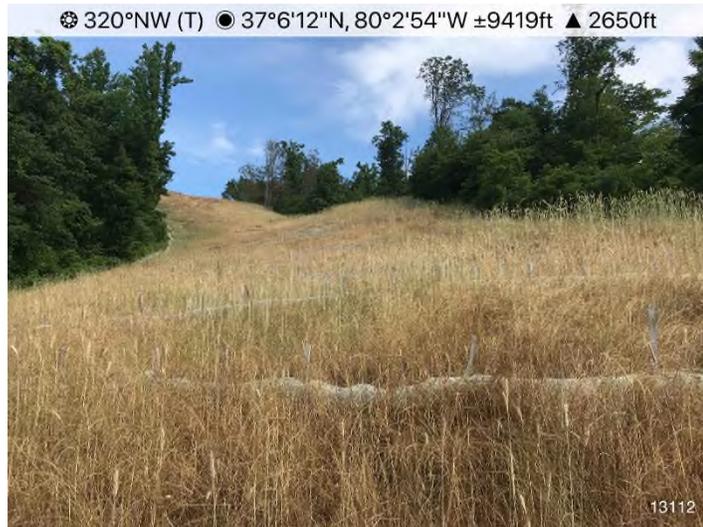
Figure 1: STA 13112+00 – Controls in place and functioning properly. Area stabilized.

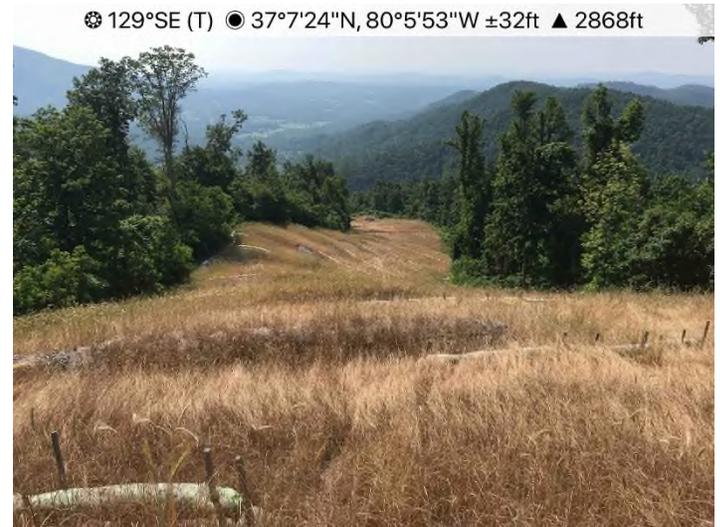
Figure 2: STA 13105+00 – Controls in place and functioning properly. Area stabilized.

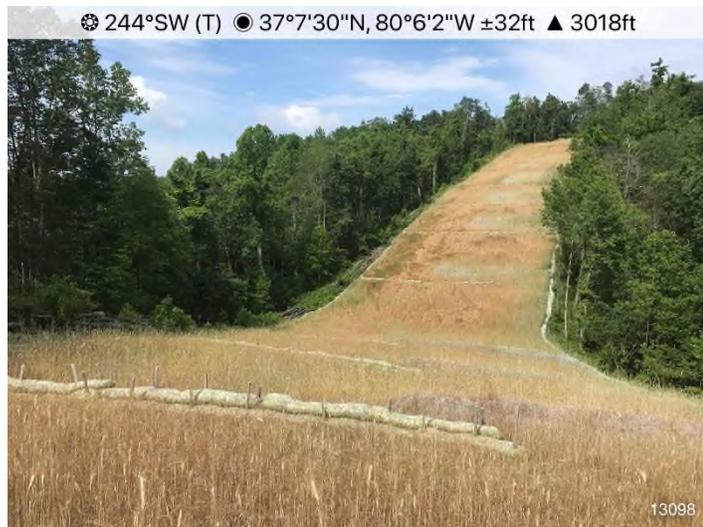
Figure 3: STA 13098+00 – Controls in place and functioning properly. Area stabilized.

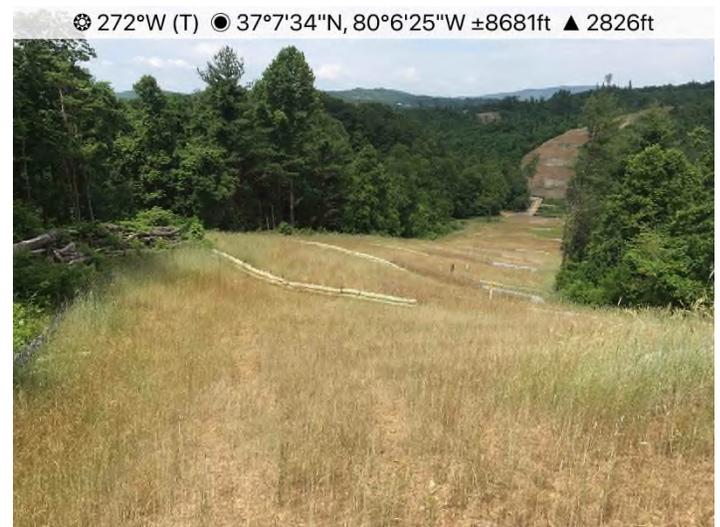
Figure 4: STA 13074+00 – Controls in place and functioning properly. Area stabilized.
