FIELD INSPECTION

Project Name:	Mountain Valley Pipeline	Inspector:	Marshall Willis
Inspection Date:	Tuesday, June 4, 2019	Project Contact:	Brian Clauto
Spread H: Montgomery County Roanoke County	MLV-AR-027 STA 12374+50 – 12430+72 STA 12687+14 – 12694+04 MVP-RO-279.02	Weather (Wet/Dry/Rain):	Dry

FIELD INSPECTION PHOTO LOG

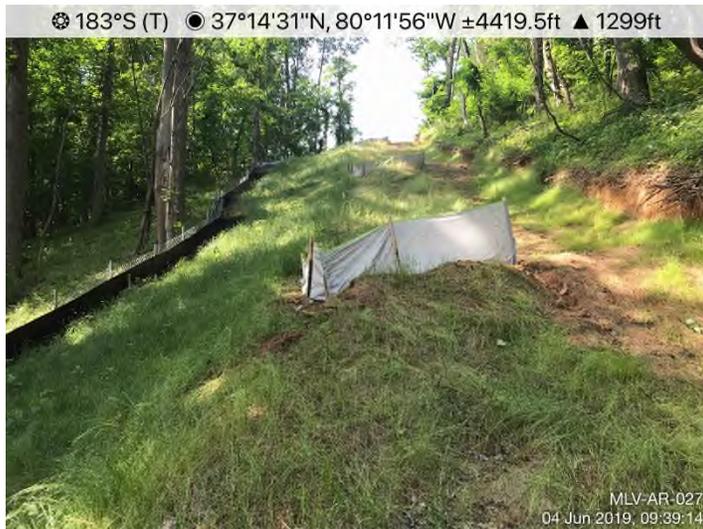
Fig. 1: MLV-AR-027 – Controls in place.

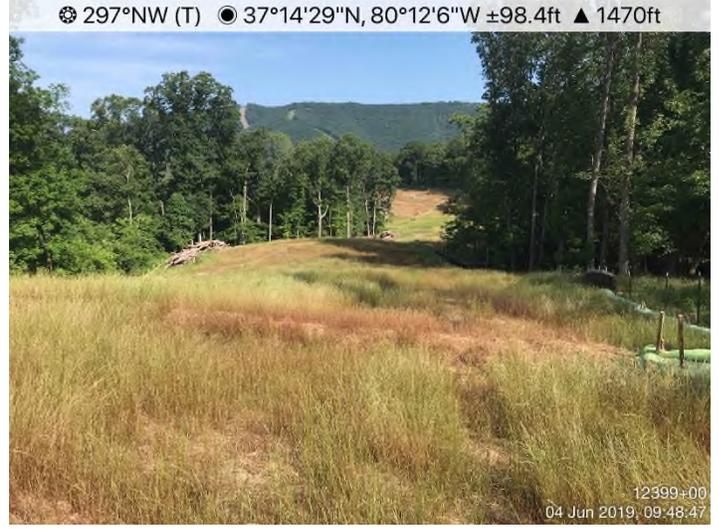
Fig. 2: STA 12399+00 – Controls in place. Area Stabilized.

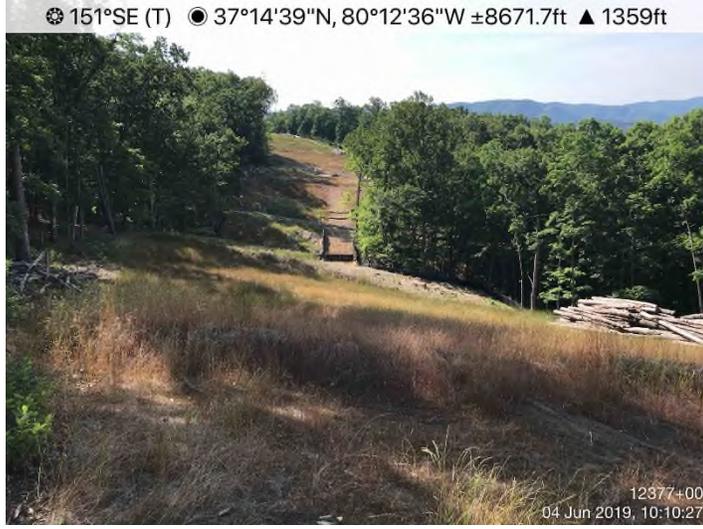
Fig. 3: STA 12377+00 – Controls in place. Area Atabilized.

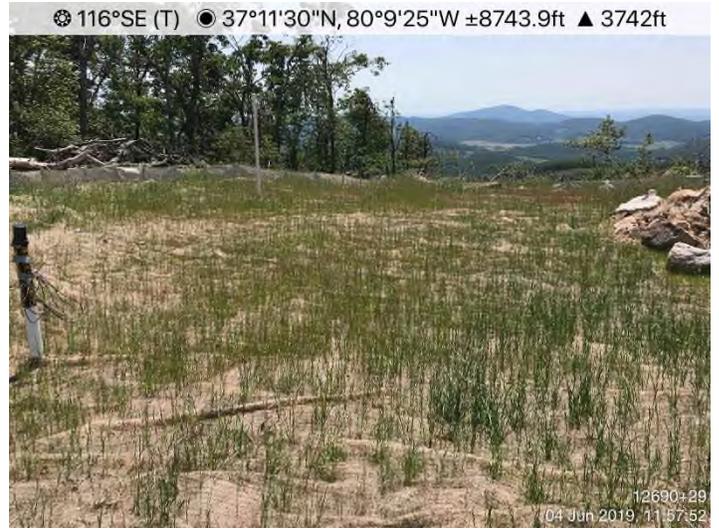
Fig. 4: STA 12690+29 – Controls in place. Area stabilized with fabric.
