FIELD INSPECTION

Project Name:	Mountain Valley Pipeline	Inspector:	Marshall Willis
Inspection Date:	Wednesday, July 10, 2019	Project Contact:	Brian Clauto
Spread H: Franklin County	STA 13258+74 – 13262+66 MVP-FR-293.01 ATWS 1055	Weather (Wet/Dry/Rain):	Dry

FIELD INSPECTION PHOTO LOG

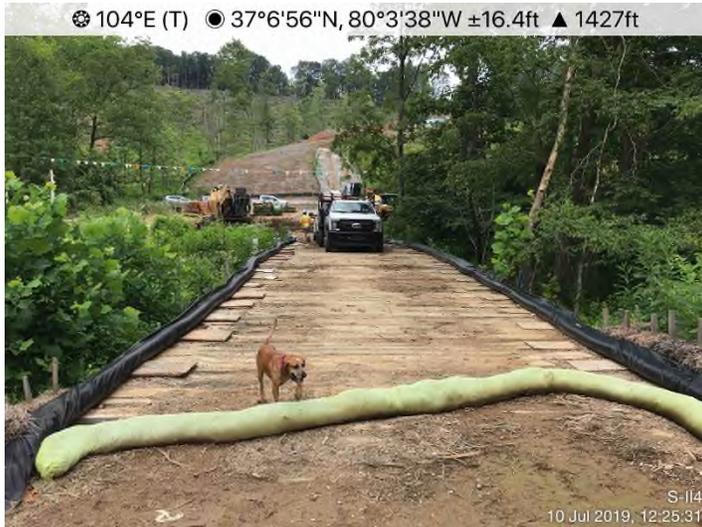
Fig. 1: Stream S-II4 – Clean bridge with sideboards in place and in good condition.

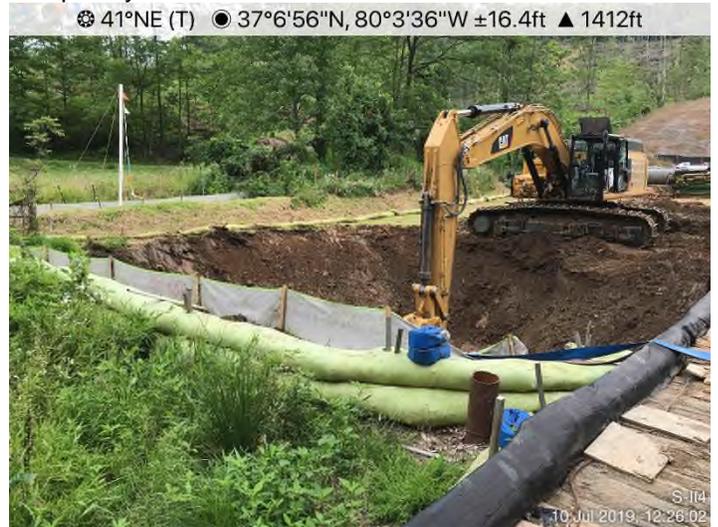
Fig. 2: Stream S-II4 – GAS bore pit in progress. CFS and P1 in place and functioning properly. Perimeter berms adequately stabilized.

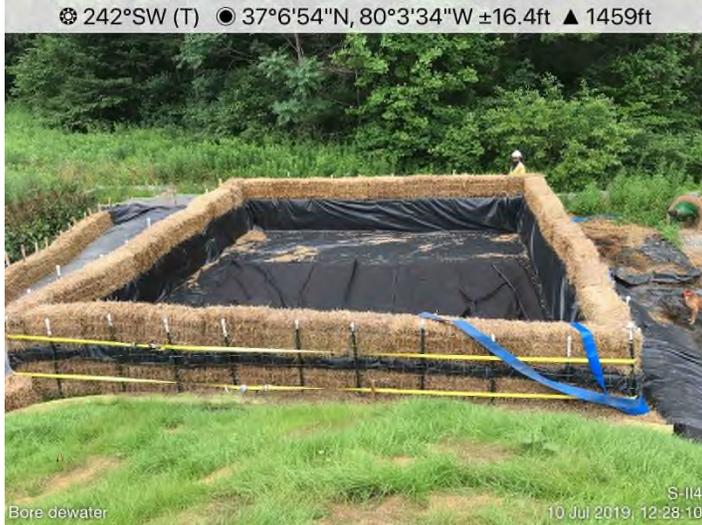
Fig. 3: ATWS 1055 – Dewatering structure for GAS of conventional bore pit. Sediment bags are clean, filter structure intact and dewatering to stabilized area.

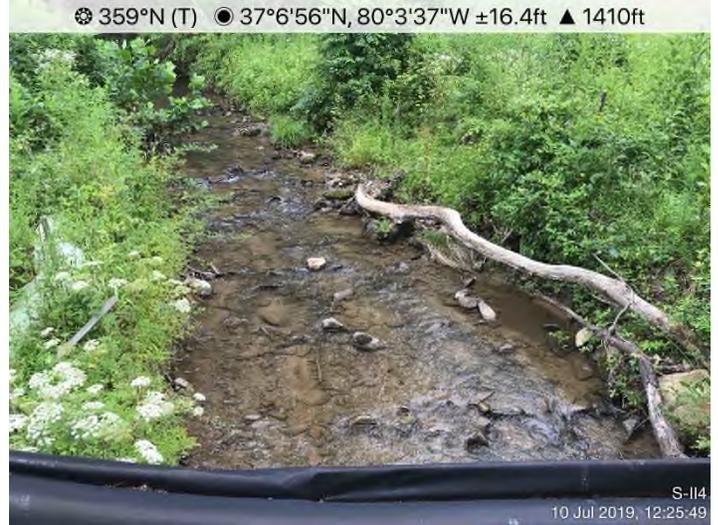
Fig. 4: Stream S-II4 – Upstream view of stream S-II4 from construction bridge. Bridge sideboards in place and in good condition.
