FIELD INSPECTION

| Project Name: | Mountain Valley Pipeline | Inspector: | Matthew Grant |
| Inspection Date: | Thursday, July 11, 2019 | Project Contact: | Brian Clauto |
| Spread: Montgomery Co. MN 276.03 MP232-235 12300-12421 | Spread H | Weather (Wet/Dry/Rain): | Dry |

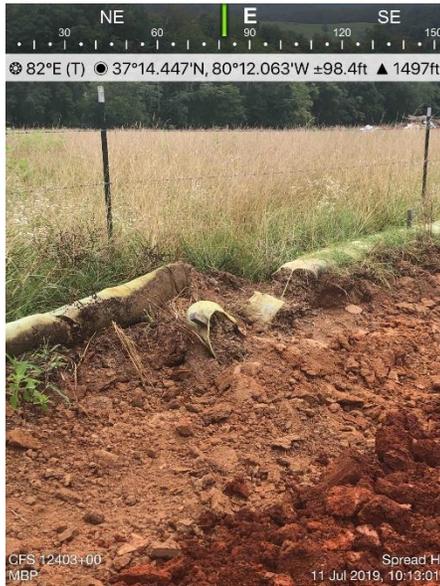
- Inspected designated stream included: S-OO16
- ECD's were in place and no impacts were observed at S-OO16 stream.
- 2 areas of CFS on MN 276.03 are torn and require repair.
- St12403 CFS torn and requires repair
- St12406 CFS torn and requires repair

Fig. 1 CFS torn at St 12403

Recommended Corrective Action: Maintain controls per the approved plan and annual standard and specs.

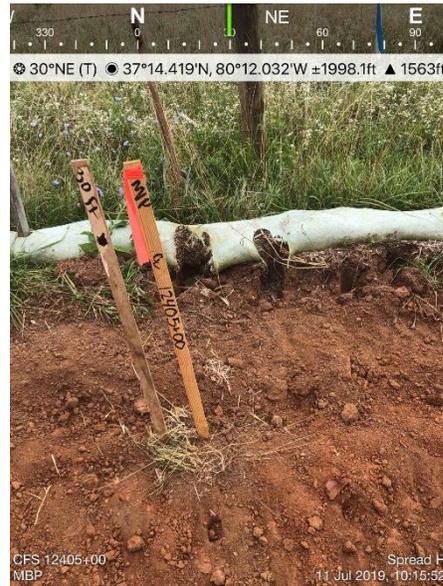
Fig. 2 CFS torn at St12405

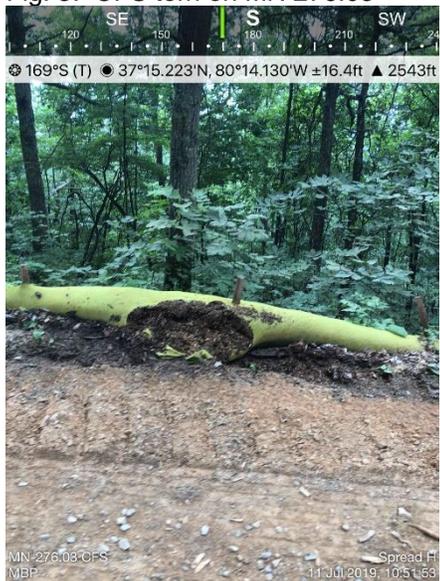
Fig. 3. CFS torn on MN 276.03

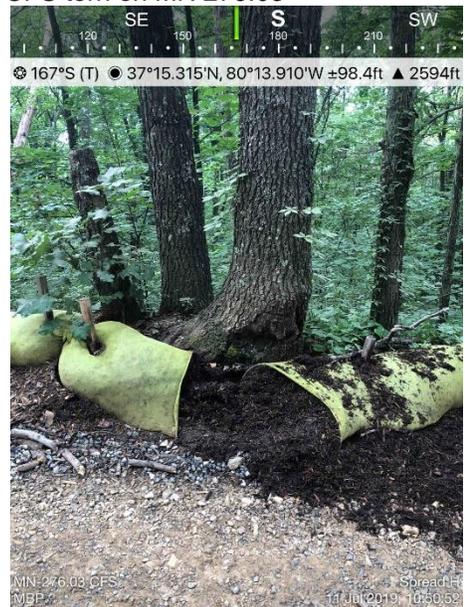
Fig. 4. CFS torn on MN 276.03
