FIELD INSPECTION

Project Name:	Mountain Valley Pipeline	Inspector:	Marshall Willis
Inspection Date:	Monday, July 15, 2019	Project Contact:	Brian Clauto
Spread H: Franklin County	STA 13258+74 – 13262+66 STA 13060+00 – 13070+00 MVP-FR-293.01/290 ATWS 344/1055	Weather (Wet/Dry/Rain):	Dry

Project Name: Mountain Valley Pipeline

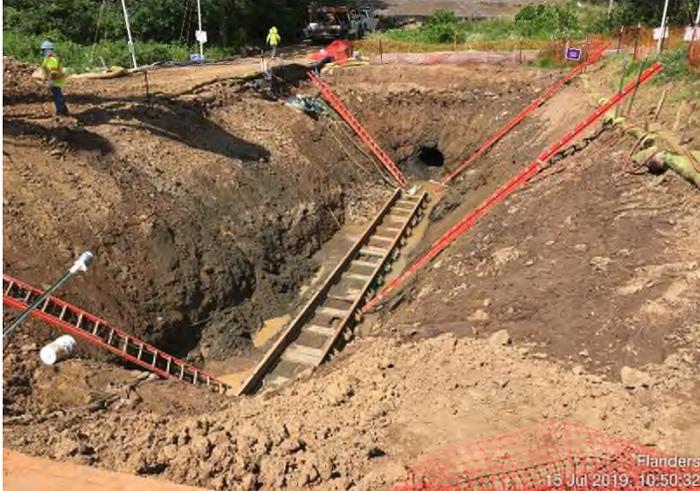
Fig. 1: **Stream S-II4** – GAS borepit for S-II4. Pumps have secondary containment. Trench dewatering to sediment bag inside dewatering structure.

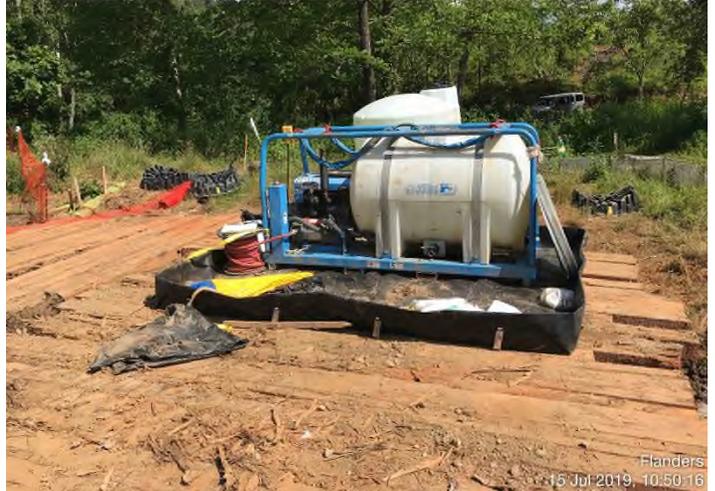
Fig. 2: **STA 13262+25** – Secondary containment structures intact and functioning as designed.

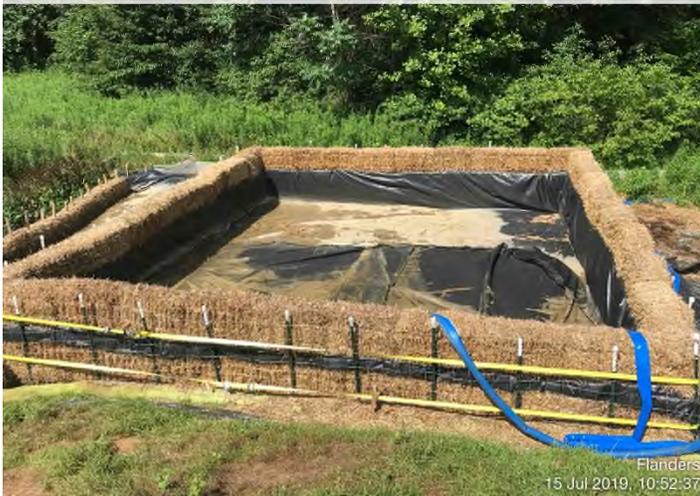
Fig. 3: **ATWS 1055** – Dewatering structure for GAS of conventional bore pit. Sediment bags are clean, filter structure intact and dewatering to stabilized area.

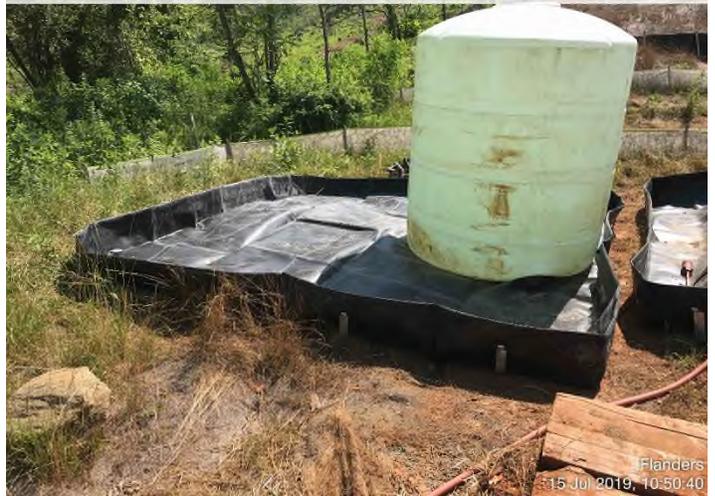
Fig. 4: **STA 13262+25** – Secondary containment structures intact and functioning as designed.

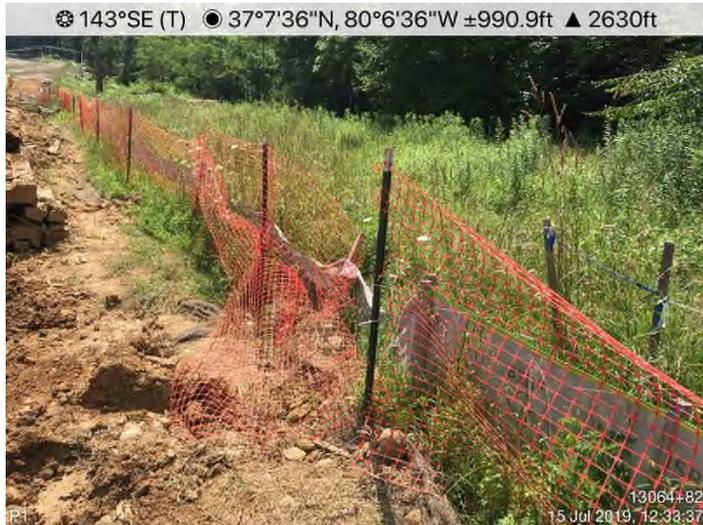
Fig. 9: **STA 13064+82** – P1 in repair needed.

- STA 13063+10: (S-G27) Re-establish and stabilize 50' buffer zone.
- ATWS 344: Repair CFS end-treatment.
- ATWS 344: Repair CFS end-treatment and sump.
- STA 13064+82: Repair P1.
- STA 13063+64: Repair P1.

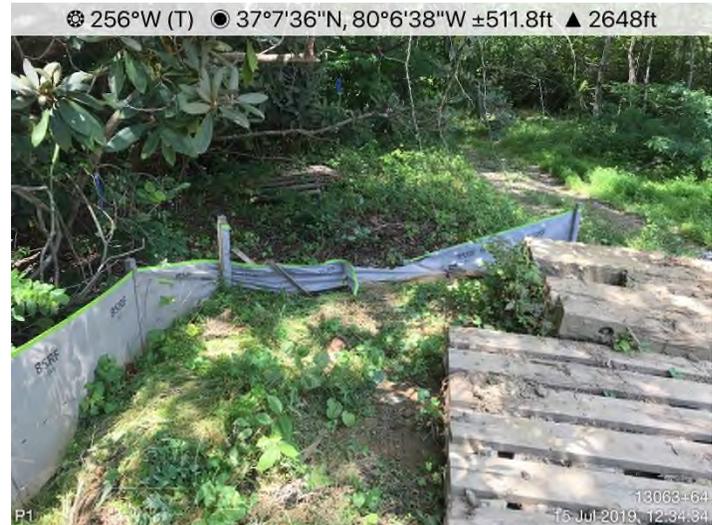
Fig. 10: **STA 13063+64** – P1 in repair needed.
