FIELD INSPECTION

Project Name:	Mountain Valley Pipeline	Inspector:	Matthew Grant
Inspection Date:	Wednesday, July 17, 2019	Project Contact:	Brian Clauto
Spread: Montgomery Co. MN270 MP228 St12070-12087 Franklin Co. FR290 MP247 St13063 FR293.01 MP251.1	Spread H	Weather (Wet/Dry/Rain):	Dry

FIELD INSPECTION PHOTO LOG

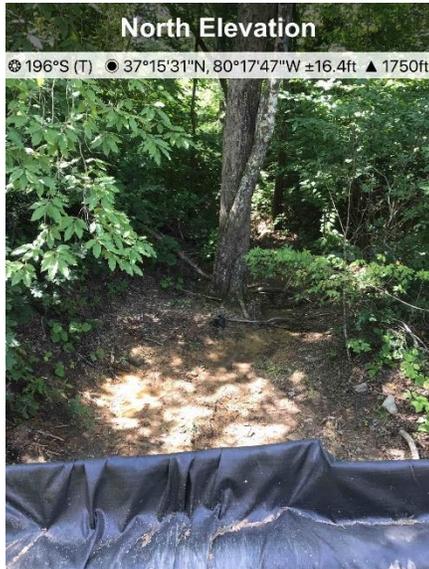
- Inspected designated streams included: MM-14, MM-15 S-RR13, S-G26, S-G27, W-RR4, S-II4
- Designated streams MM-14 and MM-15 have been impacted.
- St12086 sediment is off the ROW
- FR 290 P1 requires maintenance
- FR290 ECD requires repair

- Fig. 1 Designated stream MM-15 shows signs of sediment in stream

Recommended Corrective Action: Maintain controls per the approved plan and annual standard and specs, remove sediment per DEQ approval.

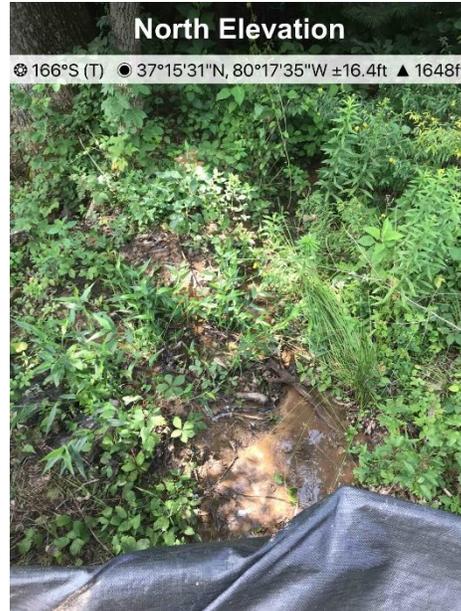
- Fig. 2 Designated stream MM-14 shows signs of sediment in stream

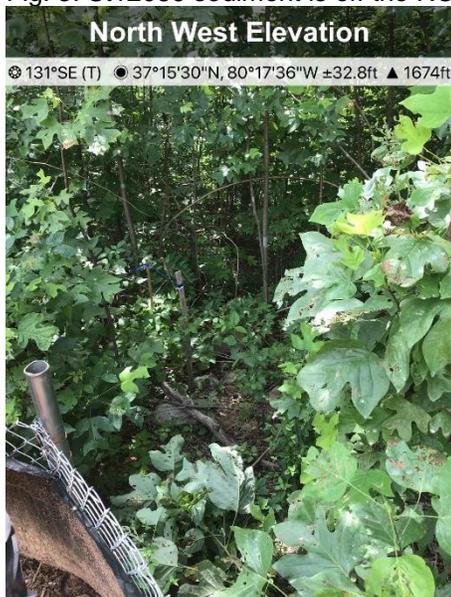
- Fig. 3. St12086 sediment is off the ROW

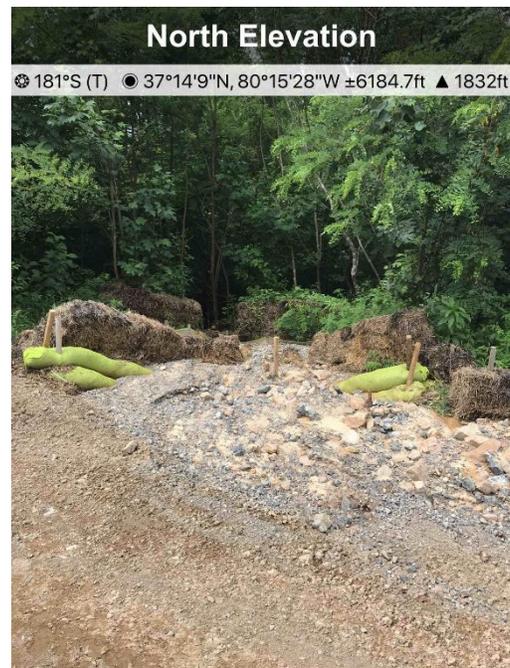
- Fig. 4. FR290 ECD requires repair

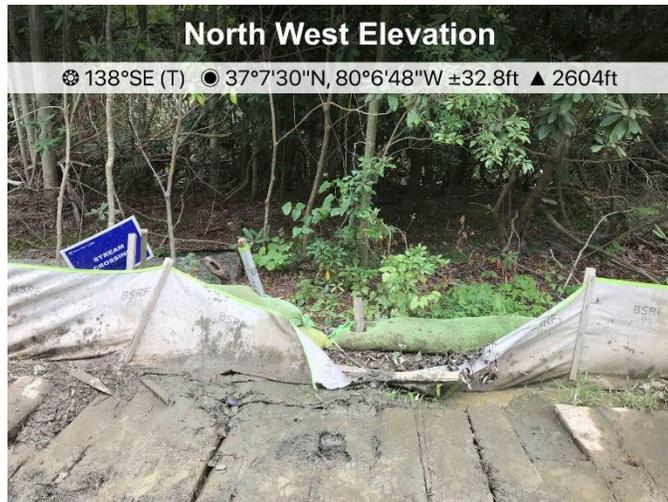
- Fig. 5 FR 290 P1 requires maintenance
