FIELD INSPECTION

Project Name:	Mountain Valley Pipeline	Inspector:	Marshall Willis
Inspection Date:	Wednesday, July 24, 2019	Project Contact:	Brian Clauto
Spread H: Roanoke County	STA 12950+00 – 12973+43 MVP-RO-288	Weather (Wet/Dry/Rain):	Dry

FIELD INSPECTION PHOTO LOG

Project Name: Mountain Valley Pipeline

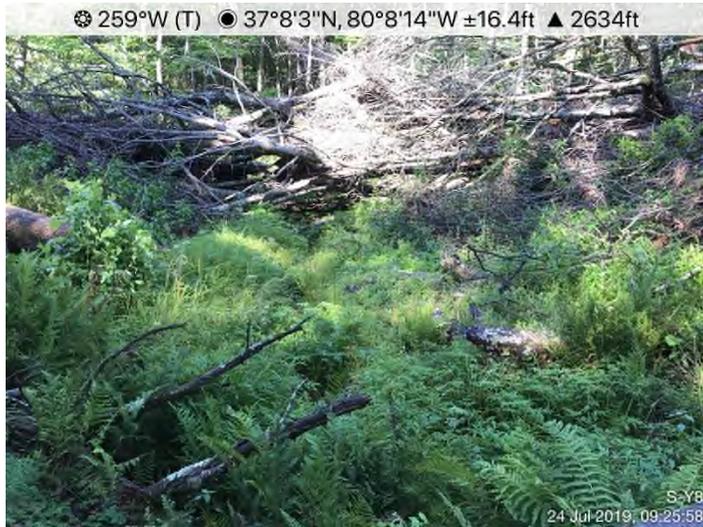
Fig. 1: **Stream S-Y8** – No ground disturbance. Trees flush cut and bridged over stream.

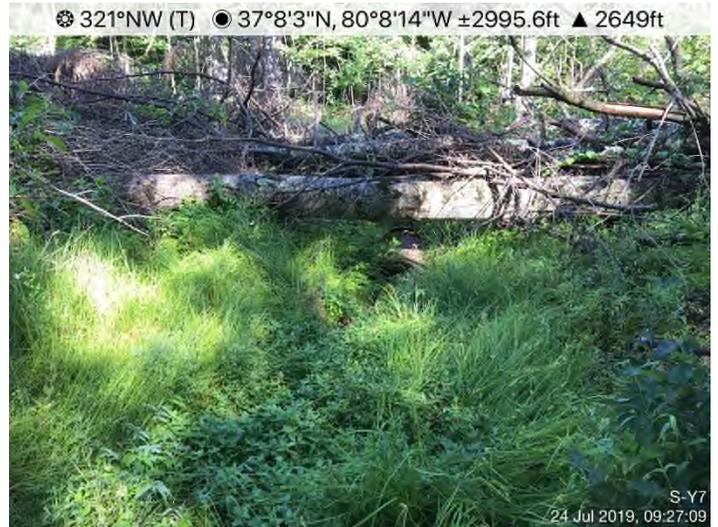
Fig. 2: **Stream S-Y7** – No ground disturbance. Trees flush cut and bridged over stream.

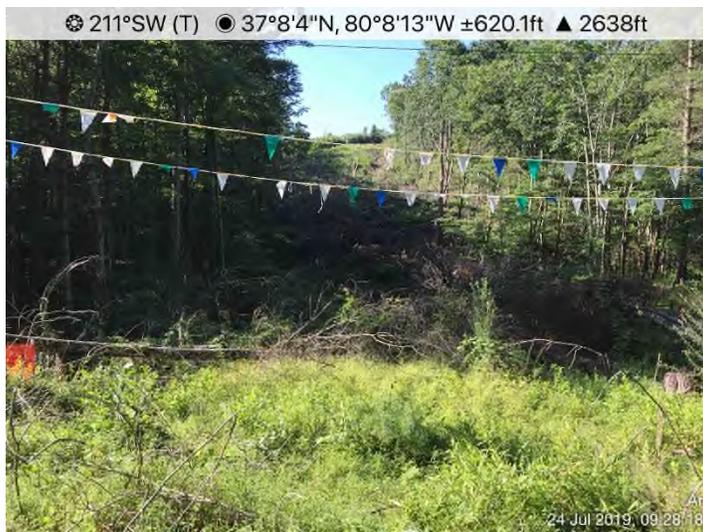
Fig. 3: **STA 12957+30** – No ground disturbance at MVP-RO-287 looking SW.

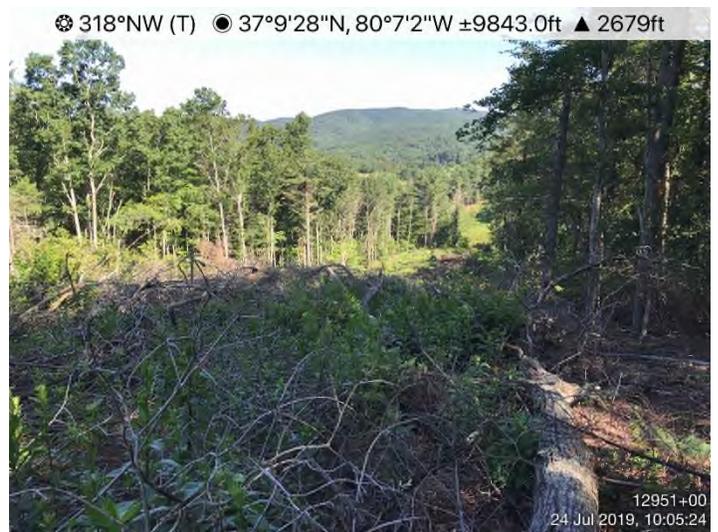
Fig. 4: **STA 12951+00** – No ground disturbance. Looking NW.
