FIELD INSPECTION

Project Name:	Mountain Valley Pipeline	Inspector:	Marshall Willis
Inspection Date:	Tuesday, July 30, 2019	Project Contact:	Brian Clauto
Spread H: Montgomery County	STA 12298+39 – 12421+68 MVP-MN-276.03 ATWS 724	Weather (Wet/Dry/Rain):	Dry

FIELD INSPECTION PHOTO LOG

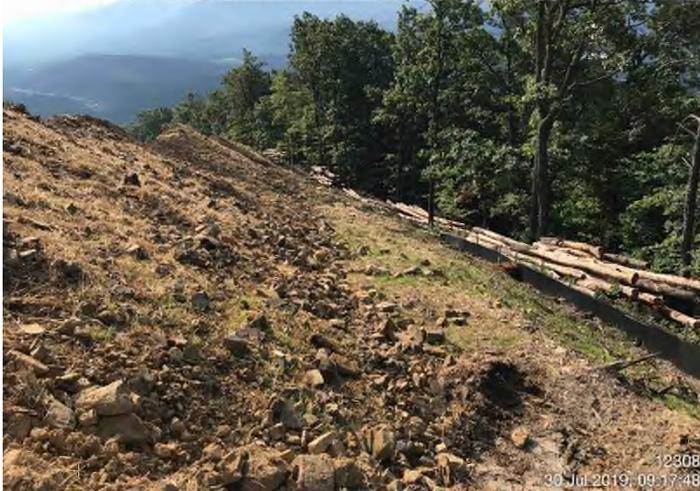
Fig. 1: **STA 12308+00** – Perimeter controls in place and functioning. Topsoil piles stabilized with straw and millet.

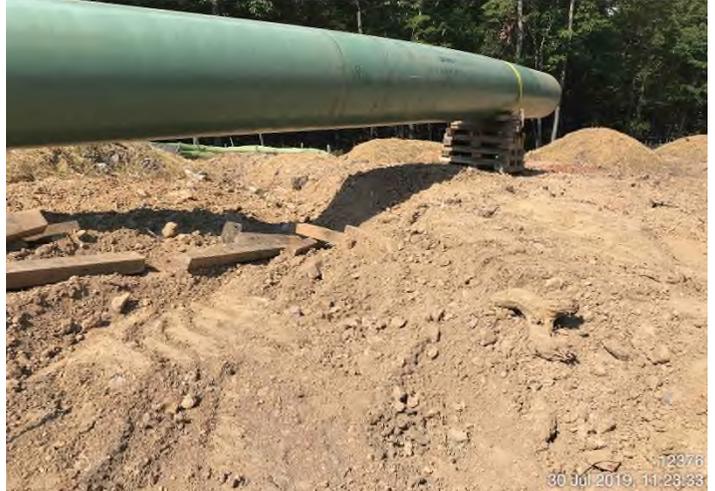
STA 12376+00: Repair obstructed waterbar flow path.

Fig. 2: **STA 12376+00** – Waterbar flow path obstructed. Maintain clear flowpath.

Recommended Corrective Action: Maintain and install all controls per the approved plan and specs.

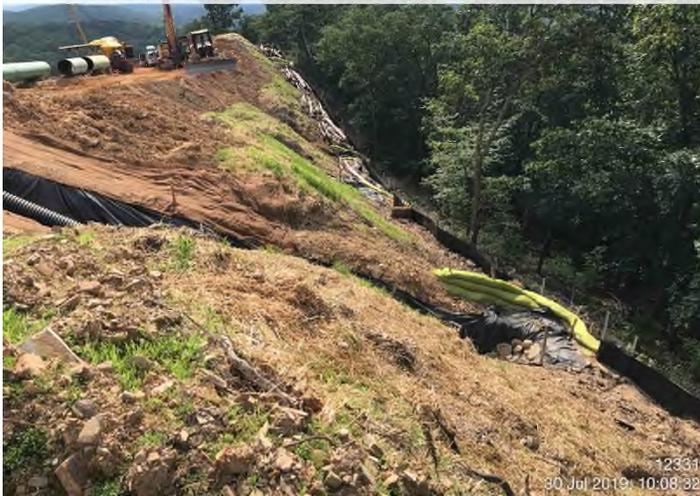
Fig. 3: **STA 12331+00** – Perimeter controls and slope drains in place and functioning. Topsoil piles stabilized with straw and millet.

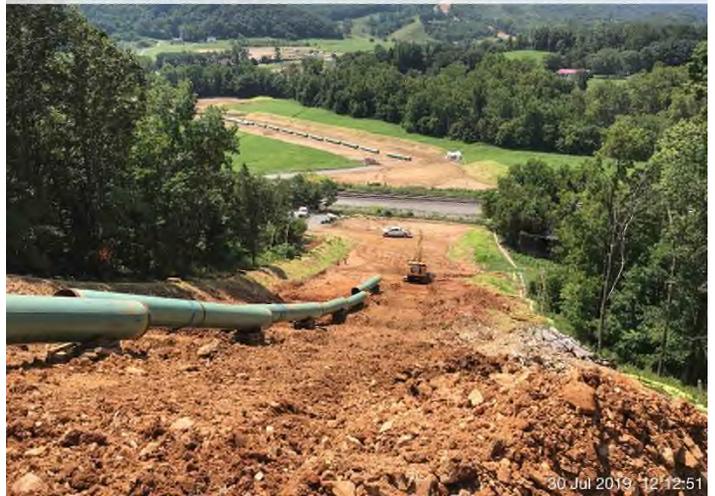
Fig. 4: **STA 12415+00** – Perimeter controls in place and functioning. Topsoil piles stabilized with straw and millet.
