FIELD INSPECTION REPORT

Project Name:	Mountain Valley Pipeline	Inspector:	Matthew Grant
Inspection Date:	Tuesday, July 7, 2020	Project Contact:	Brian Clauto
Spread H: Montgomery	AR 276.03, 273 ATWS 1374, 1168, 1167 MP 232.5, 232.8, 232.4, 231.5, 230 Ironto laydown yard	Weather:	Dry

FIELD INSPECTION PHOTO LOG

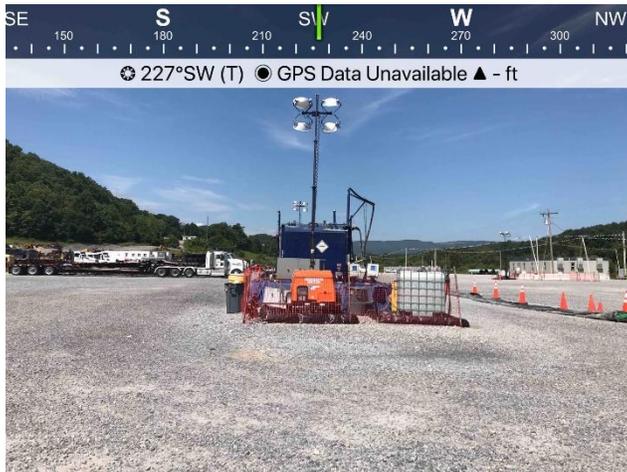
Figure 1: Fueling station / protection is in place at the Ironto laydown yard.

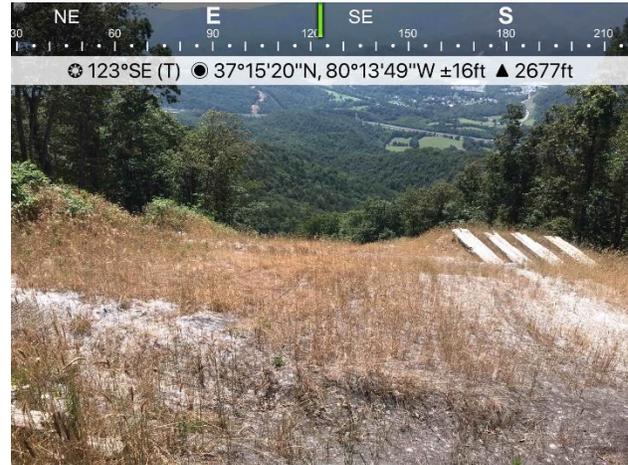
Figure 2: Near MP 232.5 temporary stabilization is in place.

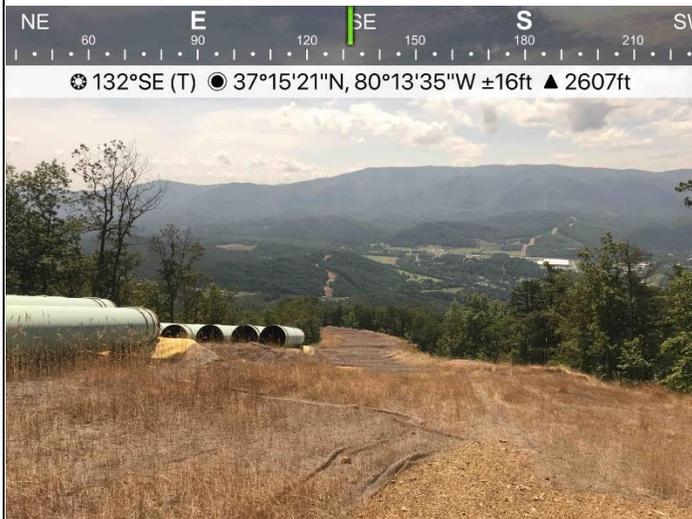
Figure 3: Near MP 232.8, pipe has been stockpiled, waterbars remain matted and temporary stabilization is in place.

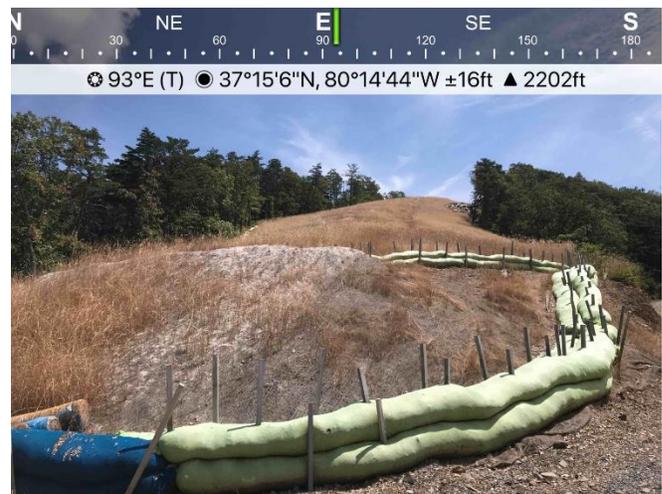
Figure 4: Near MP 231.5 ECD's and stabilization is in place and functioning.
