FIELD INSPECTION REPORT

| Project Name: | Mountain Valley Pipeline | Inspector: | Marshall Willis |
| Spread H: Montgomery County | STA 12033+34 – 12072+00 MVP-MN-270/268 ATWS 1162/1163/1161 | Weather: | Dry |

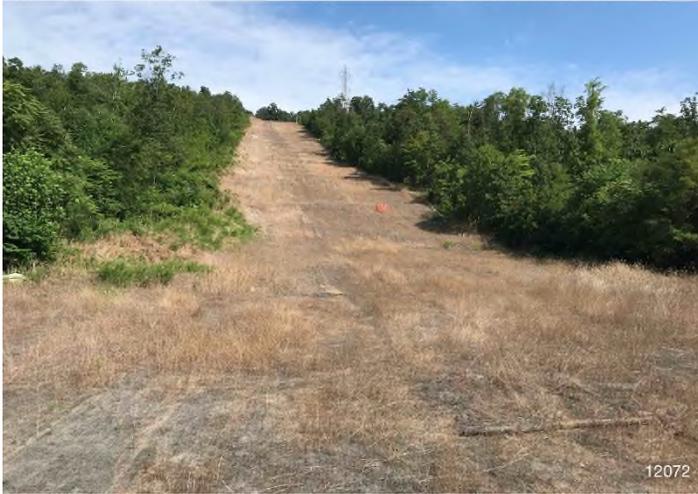
Figure 1: STA 12072+00 – Controls in place and functioning properly.

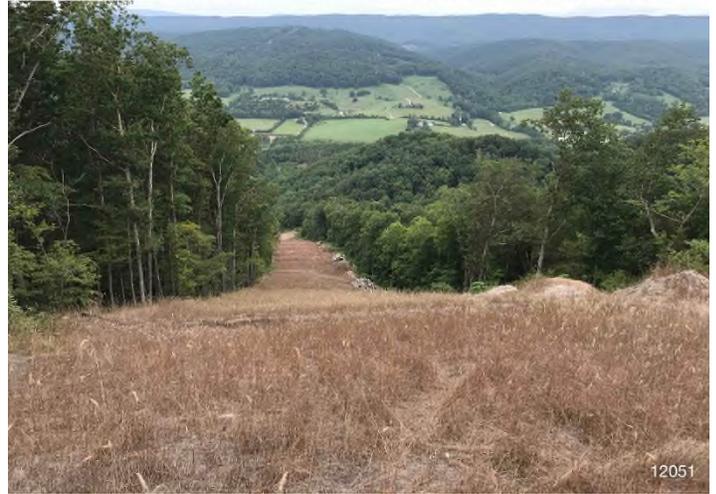
Figure 2: STA 12051+00 – Controls in place and functioning properly.

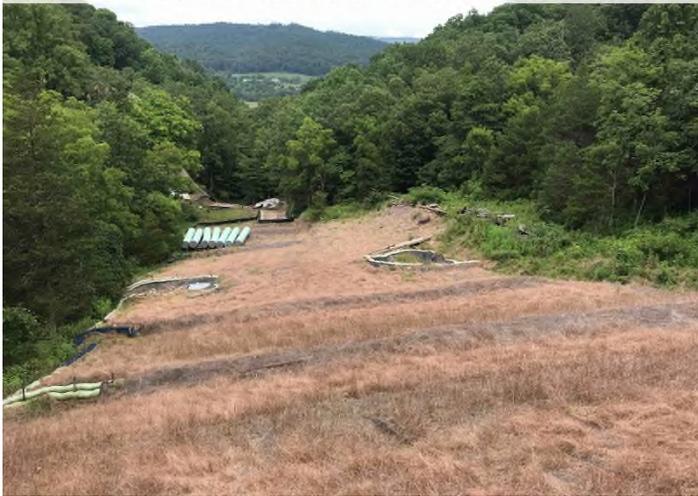
Figure 3: STA 12040+00 – Controls in place and functioning properly. Area stabilized.

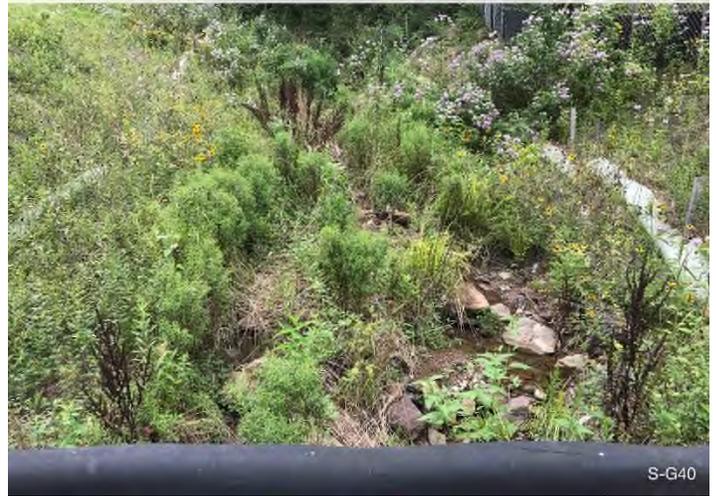
Figure 4: Stream S-G40 – Controls in place and functioning properly around S-G40 crossing.
