FIELD INSPECTION

Project Name:	Mountain Valley Pipeline	Inspector:	Matthew Grant
Inspection Date:	Tuesday, August 13, 2019	Project Contact:	Cory Chalmers
Spread: Montgomery County MP236 St12470-12482+67	Spread H	Weather (Wet/Dry/Rain):	Dry

FIELD INSPECTION PHOTO LOG

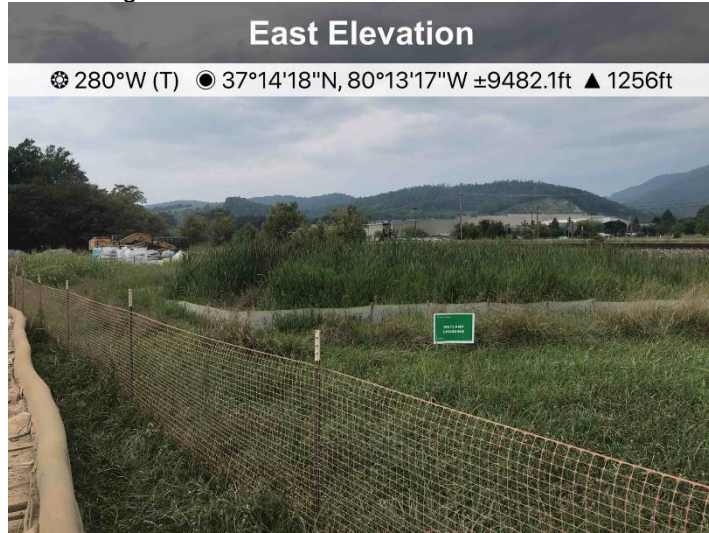
- Fig. 1 Designated wetland WKL58, ECD's are in place and functioning.

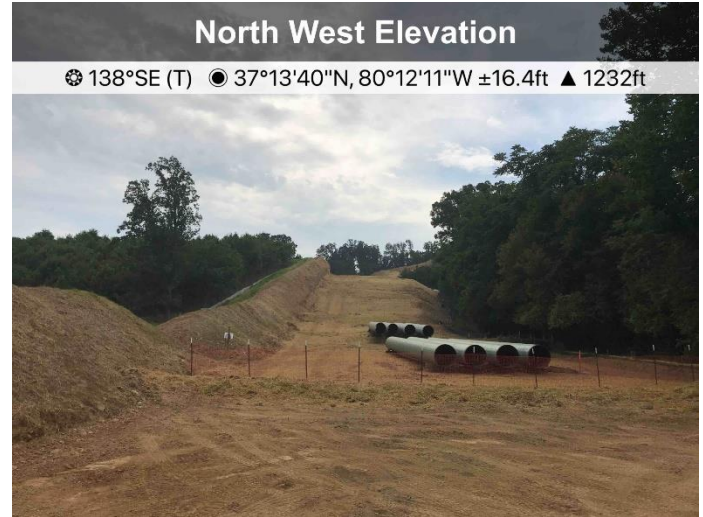
- Fig. 2 Near St12470+00 stabilization has been applied.

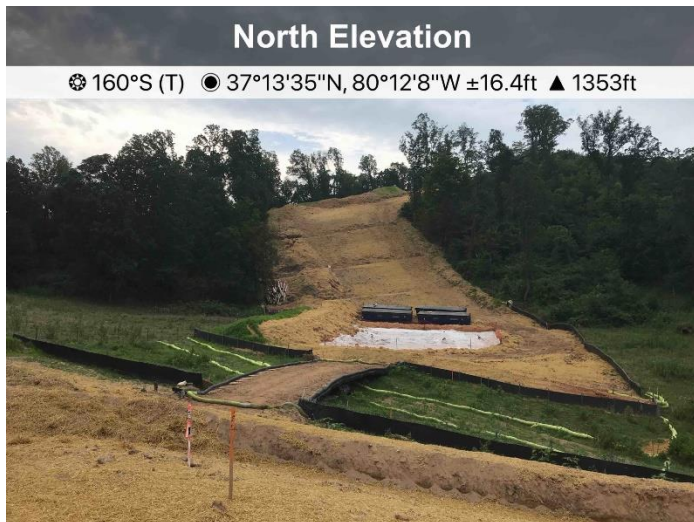
- Fig. 3. Near St12181+00 ECD's are in place and stabilization has been applied.

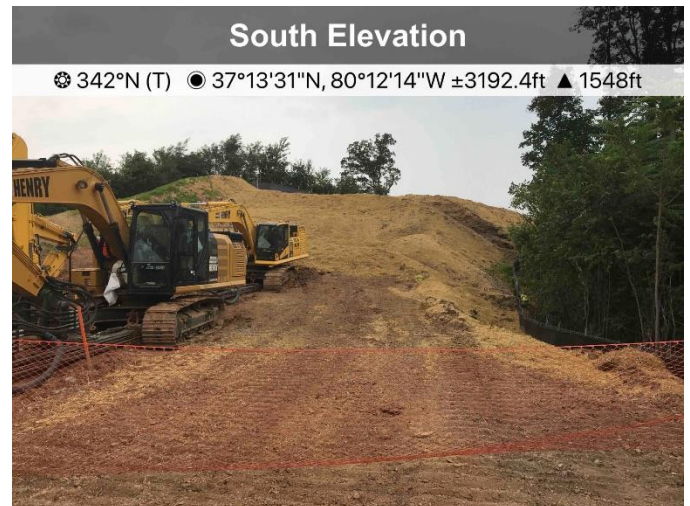
- Fig. 4. Near St12482+67 stabilization has been applied.
