FIELD INSPECTION

Project Name:	Mountain Valley Pipeline	Inspector:	Matthew Grant
Inspection Date:	Tuesday, August 14, 2018	Project Contact:	Brian Clauto
Spread: Locations in Spread H inspected MP 246.5- 246.9	Spread H	Weather (Wet/Dry/Rain):	Dry

FIELD INSPECTION PHOTO LOG

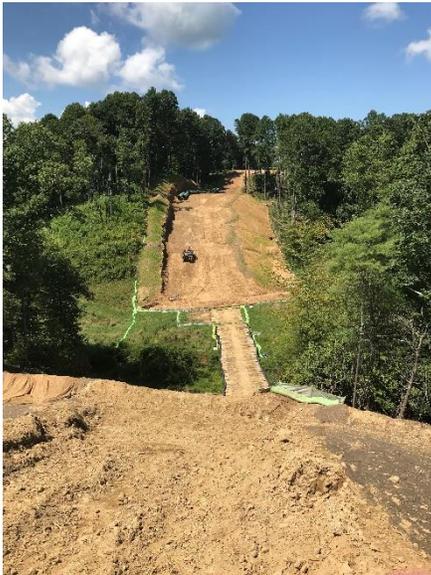
Fig. 1
Near station 13026+00, water bar and stabilization matting installed

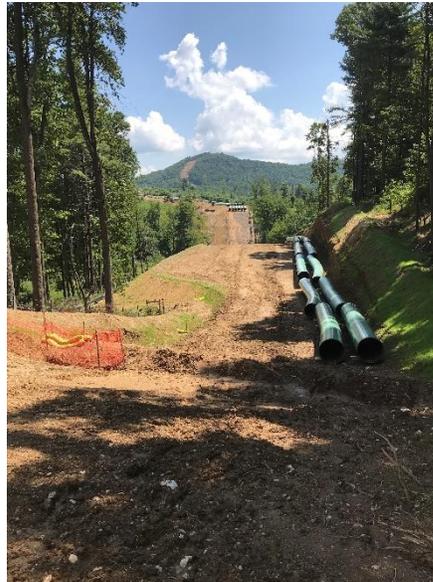
Fig. 2
Near station 13017+55 water bar and slope stabilization applied
