FIELD INSPECTION

Project Name:	Mountain Valley Pipeline	Inspector:	Matthew Grant
Inspection Date:	Wednesday, August 14, 2019	Project Contact:	Brian Clauto
Spread: Montgomery Co. MP228-230 St12070-12190 AR275 ATWS 1375	Spread H	Weather (Wet/Dry/Rain):	Dry

FIELD INSPECTION PHOTO LOG

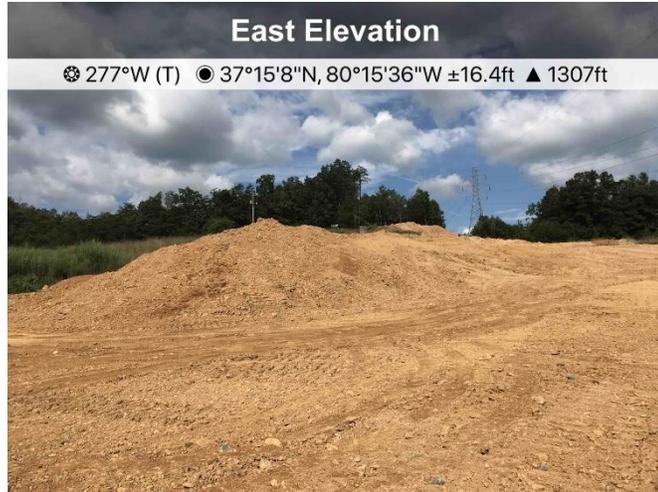
- Inspected designated streams included: SC-21, ECD's were in place at designated stream crossing and functioning.
- St12188+00 stockpile lacks stabilization.
- St12190+00 sump lacks adequate storage

Fig. 1 St12188+00 stockpile lacks stabilization

Recommend Corrective Action: Maintain and install all controls per the approved plan and specs

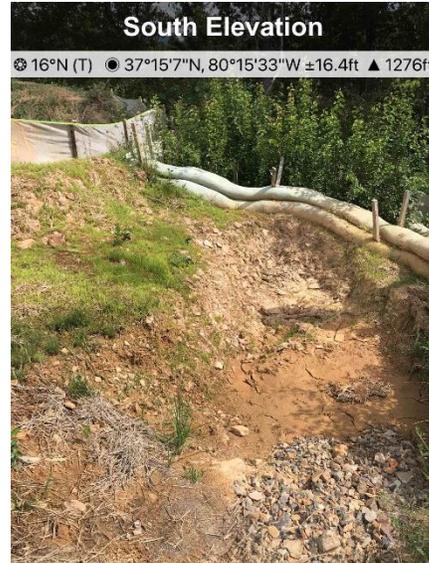
Fig. 2 St12190+00 sump lacks adequate storage

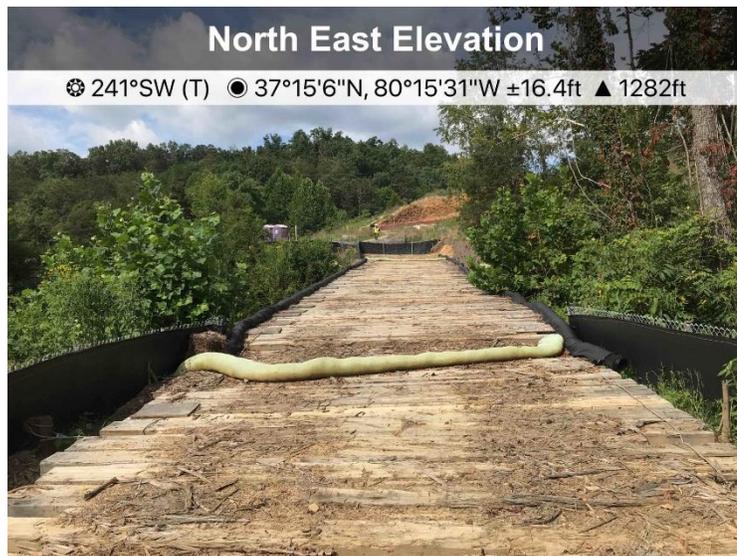
Fig. 3 Designated stream SC-21, ECD's are in place and functioning.

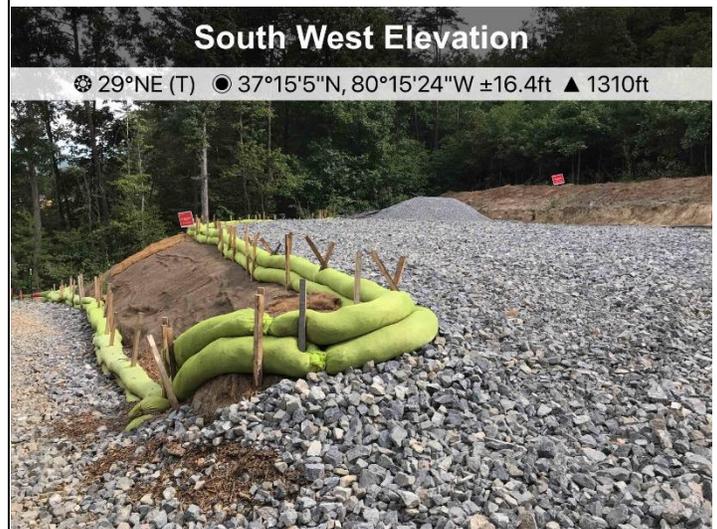
Fig. 4 ATWS1375 is stabilized and ECD's are in place and functioning
