FIELD INSPECTION

Project Name:	Mountain Valley Pipeline	Inspector:	Marshall Willis
Inspection Date:	Wednesday, August 14, 2019	Project Contact:	Brian Clauto, Cory Chalmers
Spread H: Montgomery County	STA 12482+67– 12544+06	Weather (Wet/Dry/Rain):	Dry

FIELD INSPECTION PHOTO LOG

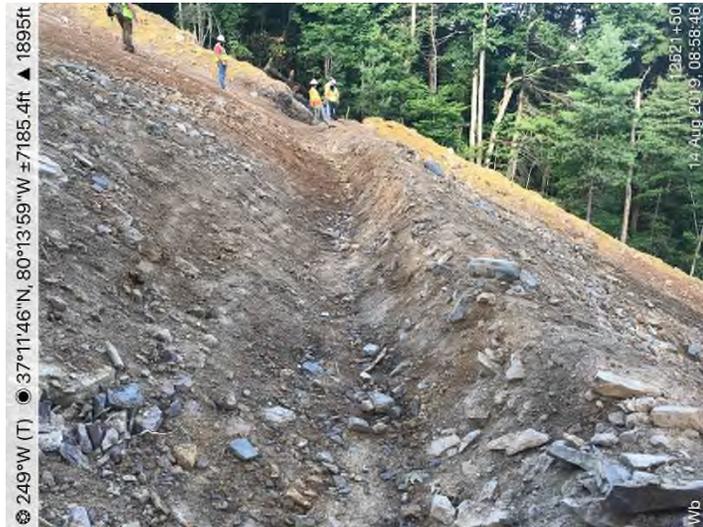
Fig. 1: **STA 12521+50** – Waterbar does not have positive drainage to end-treatment.

Recommended Corrective Action: Maintain and install all controls per the approved plan and PSS&S.

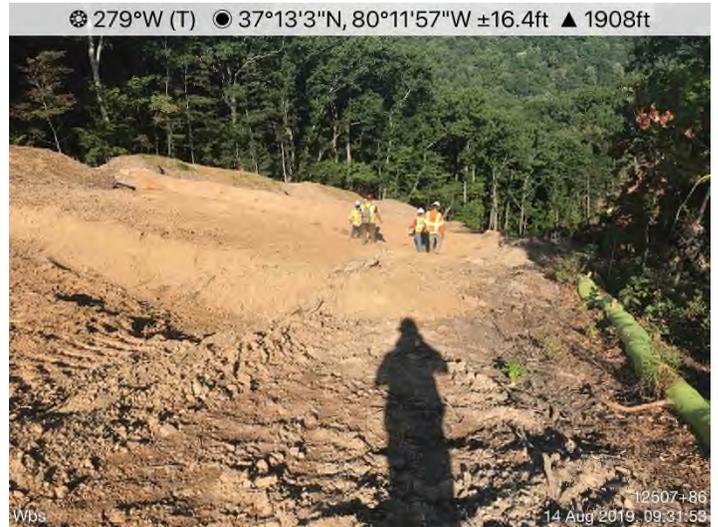
Fig. 2: **STA 12507+86** – Waterbars do not extend full length of ROW.

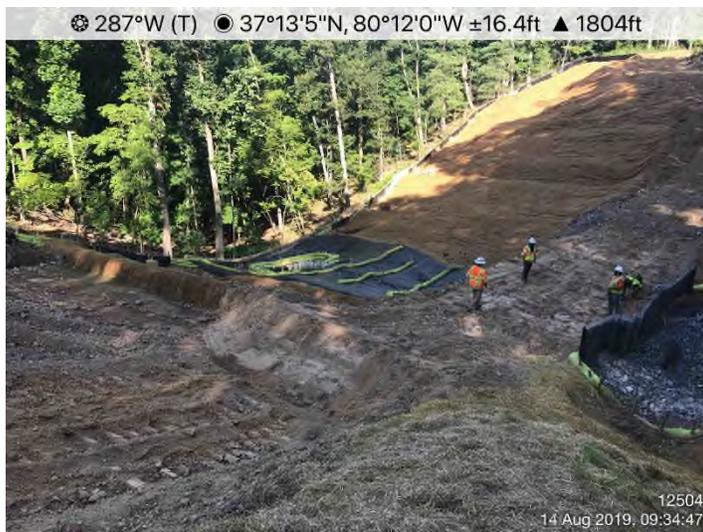
Fig. 3: **STA 12504+00** – Bridge sideboards needed along CWD crossing.

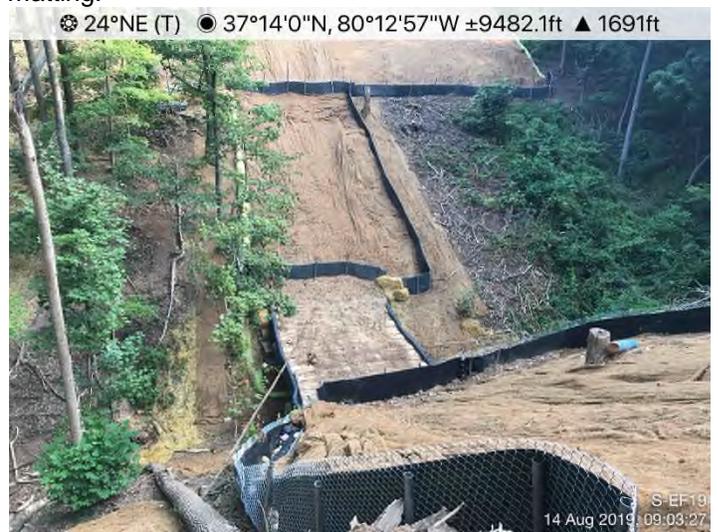
Fig. 4: **Stream S-EF19** – Controls in place along stream S-EF19. SSF entrenched properly and stabilized with erosion matting.
