FIELD INSPECTION

Project Name:	Mountain Valley Pipeline	Inspector:	Marshall Willis
Inspection Date:	Thursday, August 15, 2019	Project Contact:	Brian Clauto, Cory Chalmers
Spread H: Montgomery County	STA 12482+67– 12544+06	Weather (Wet/Dry/Rain):	Dry

FIELD INSPECTION PHOTO LOG

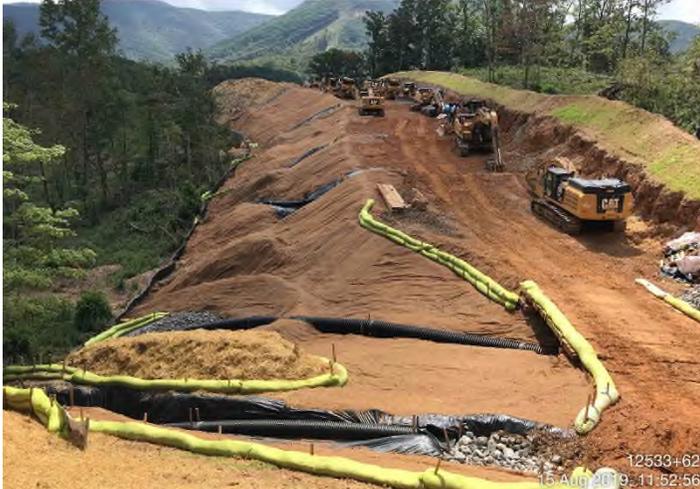
Fig. 1: **STA 12533+62** – Controls in place. Slope drains used to convey discharge down fill slopes. Stockpiles stabilized with straw and seed. Fill slopes stabilized with erosion blanket.

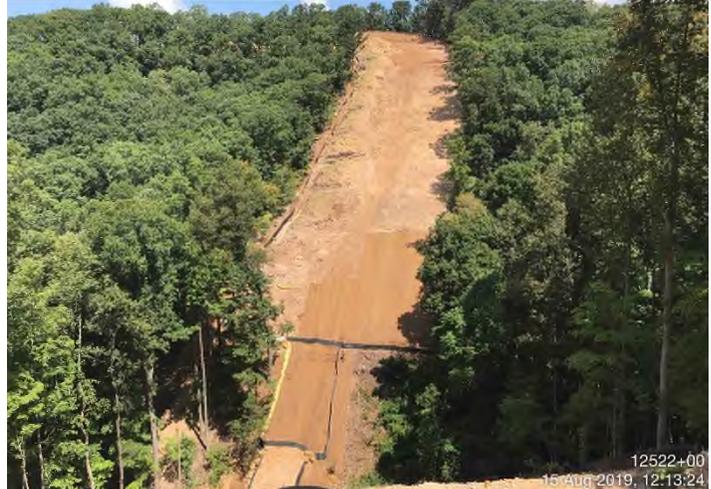
Fig. 2: **STA 12522+800** – Controls in place. Waterbars extend full length of ROW and connected to end-treatment CFS and sumps. Stockpiles stabilized with straw and millet.

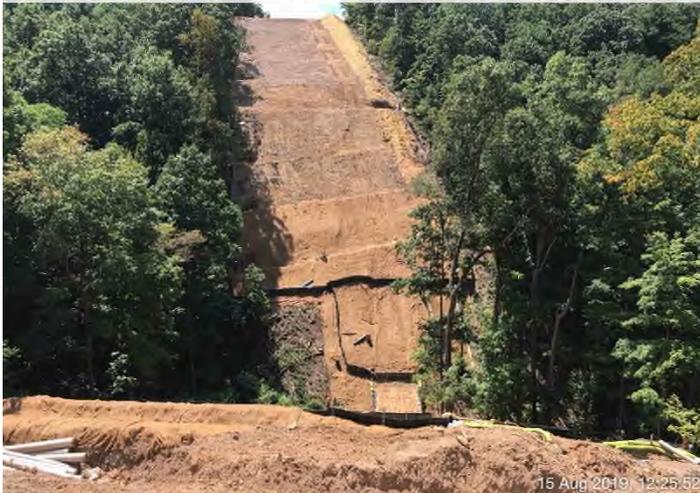
Fig. 3: **STA 12515+30** – Controls in place. Berms stabilized with straw and millet. Waterbars installed full length of ROW and connected to sumps and end-treatments.

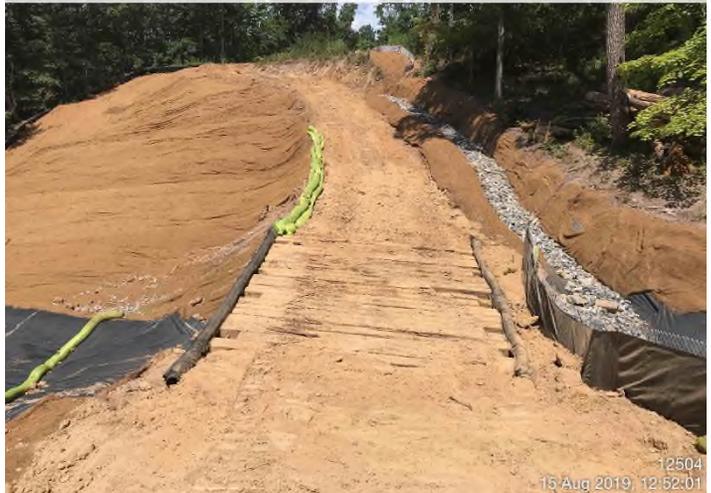
Fig. 4: **STA 12504+00** – Controls in place. Sideboards for CWD crossing installed. Area stabilized with erosion matting and millet.
