FIELD INSPECTION

Project Name:	Mountain Valley Pipeline	Inspector:	Matthew Grant
Inspection Date:	Tuesday, August 20, 2019	Project Contact:	Brian Clauto
Spread: Franklin Co. MP247 St13063+23-13061+44 AR290	Spread H	Weather (Wet/Dry/Rain):	Dry

FIELD INSPECTION PHOTO LOG

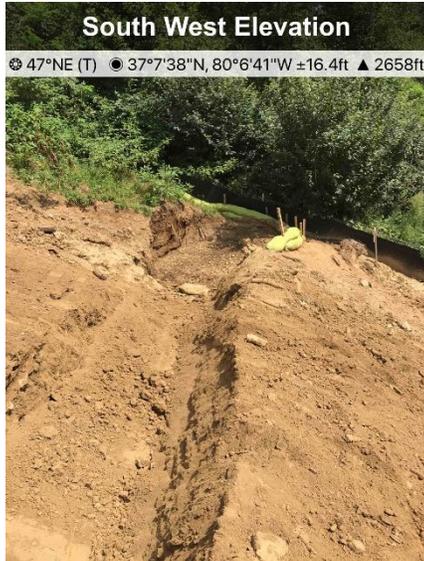
▪ Fig. 1 St13061+44 sump lacks adequate storage

Recommend Corrective Action: Maintain and install all controls per the approved plan and specs

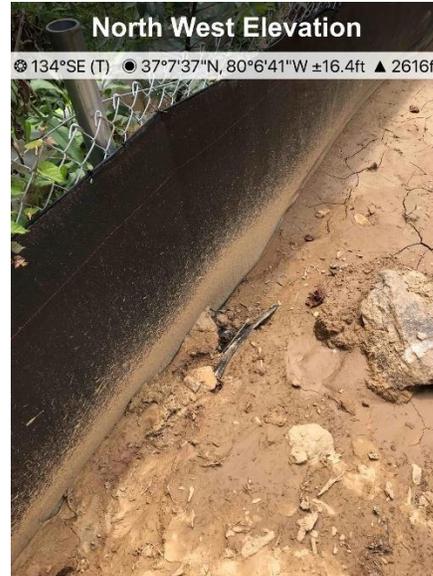
▪ Fig. 2 St13061+44 SSF has been undermined

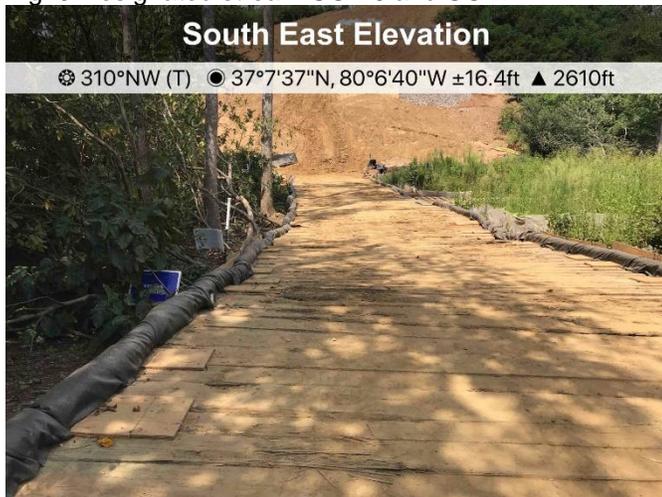
▪ Fig. 3 Designated stream SG-26 and SG-27

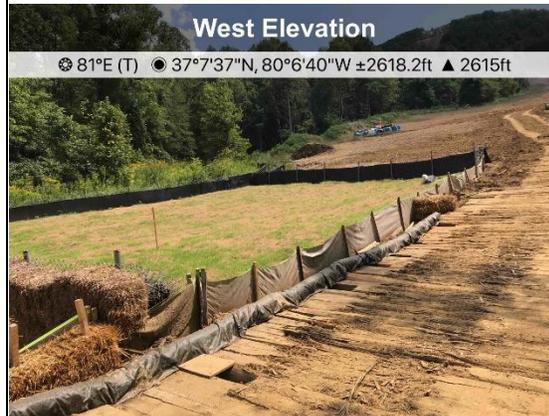
▪ Fig. 4 Bore pit has been backfilled and stabilized near St13063+25
