FIELD INSPECTION

Project Name:	Mountain Valley Pipeline	Inspector:	Matthew Grant
Inspection Date:	Wednesday, August 21, 2019	Project Contact:	Brian Clauto
Spread: Montgomery Co. MP231 AR 276.03 St12235-12197+73	Spread H	Weather (Wet/Dry/Rain):	Dry

FIELD INSPECTION PHOTO LOG

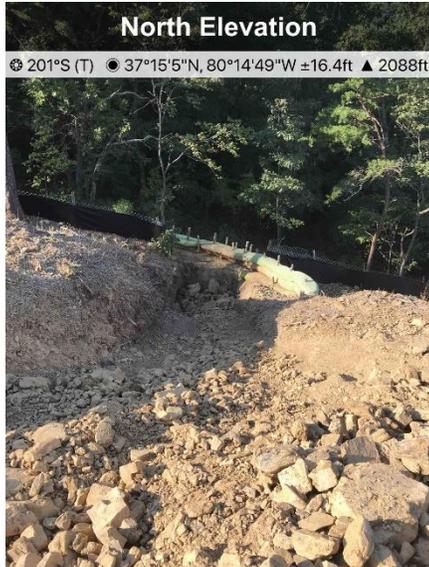
Fig. 1 St12232+20 sump lacks adequate storage

Recommend Corrective Action: Maintain and install all controls per the approved plan and specs

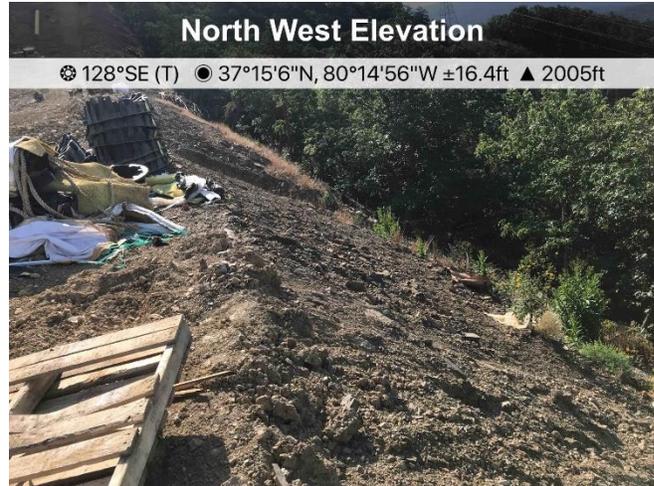
Fig. 2 St12232+00 uncontained trash

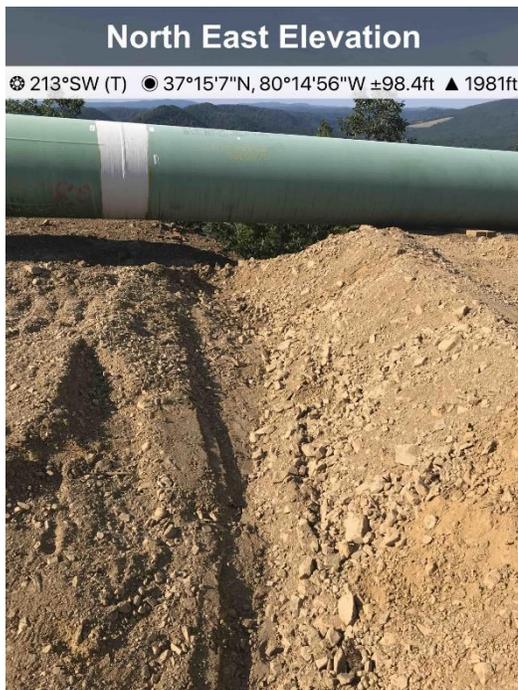
Fig. 3. St12225+00 waterbar flow path requires maintenance.

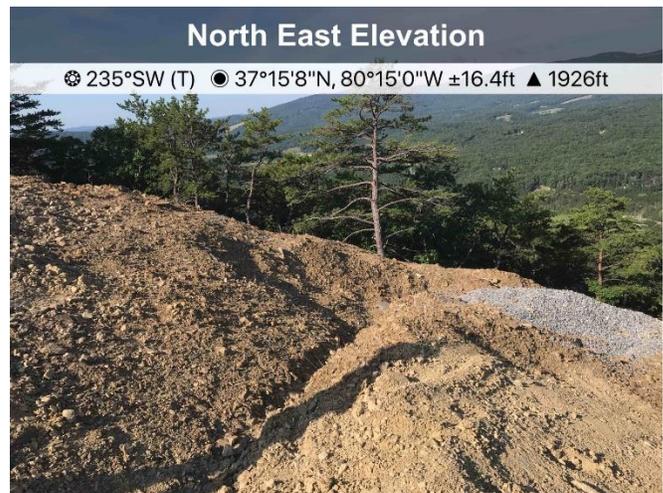
Fig. 4 St12222+10 waterbar lacks end treatment

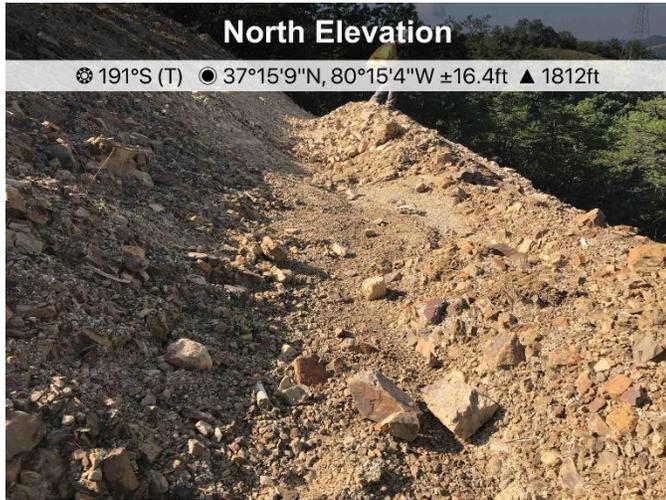
- Fig. 5 St12218+40 waterbar not built to spec

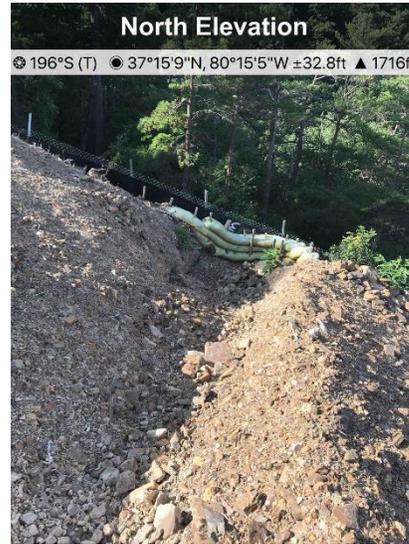
- Fig. 6 St12217+50 waterbar requires maintenance of end treatment and sump

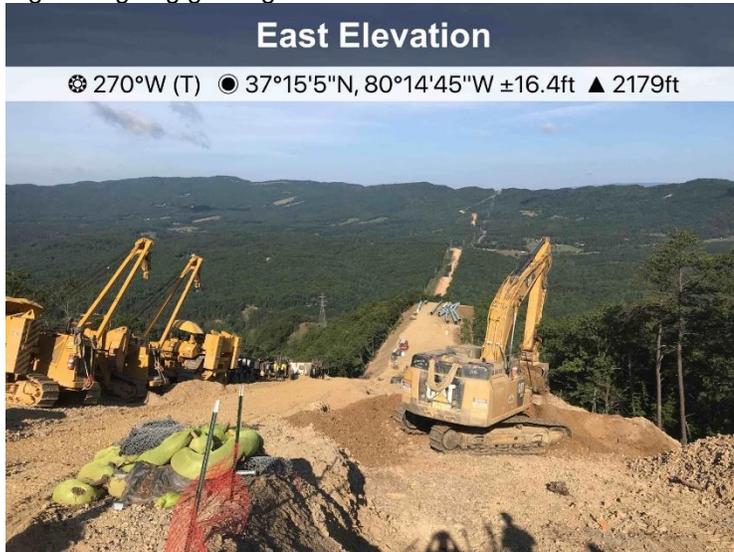
- Fig. 7 Ongoing grading activities near St12235+00

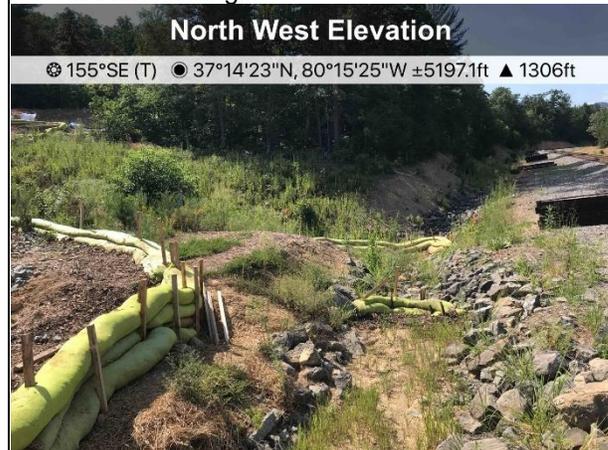
- Fig. 8 Designated stream S-0011, ECD's are in place and functioning.
