FIELD INSPECTION REPORT

Project Name:	Mountain Valley Pipeline	Inspector:	Marshall Willis
Inspection Date:	Wednesday, August 5, 2020	Project Contact:	Brian Clauto, Cory Chalmers
Spread H: Montgomery County	STA 12445+86 – 12485+00 ATWS 645/1566 MVP-MLV-AR-28	Weather:	Dry

FIELD INSPECTION PHOTO LOG

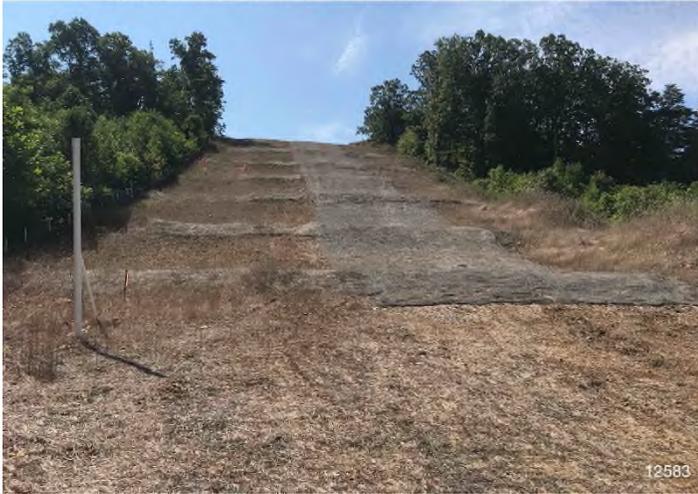
Figure 1: STA 12483+00 – Controls in place and functioning properly. Area stabilized with straw and erosion matting.

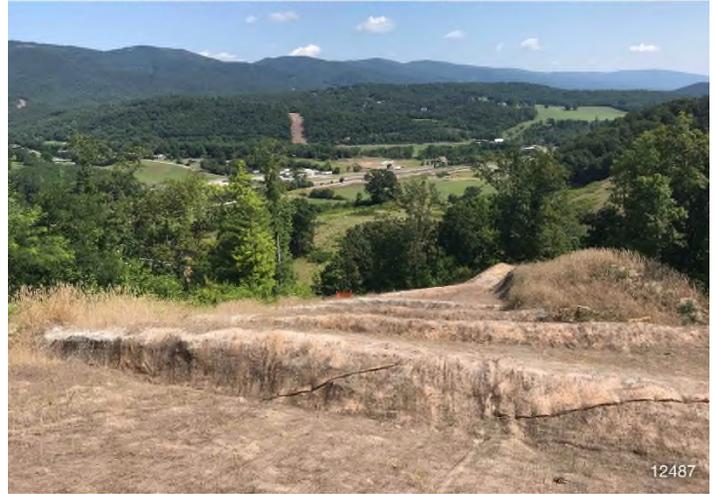
Figure 2: STA 12487+00 – Controls in place and functioning properly. Area stabilized with straw and erosion matting.

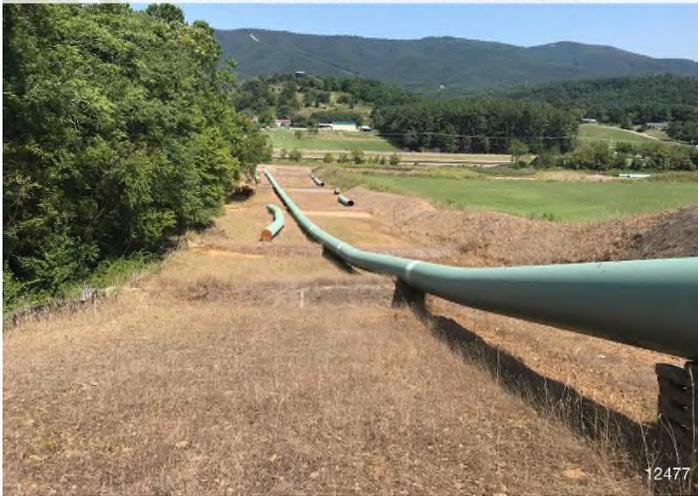
Figure 3: STA 12477+00 – Controls in place and functioning properly. Area stabilized with straw and erosion matting.

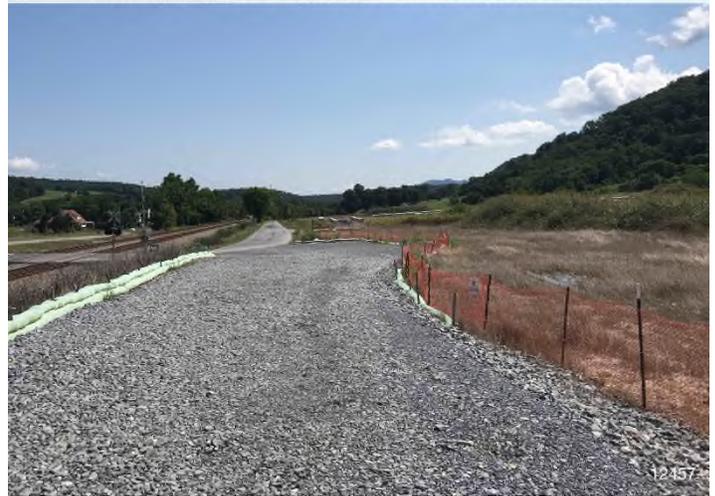
Figure 4: STA 12457+00 – Controls in place and functioning properly.
