FIELD INSPECTION

Project Name:	Mountain Valley Pipeline	Inspector:	Marshall Willis
Inspection Date:	Wednesday, August 7, 2019	Project Contact:	Brian Clauto, Cory Chalmers
Spread H: Roanoke County Montgomery County	STA 12445+19 – 12544+06 STA 12071+80 – 12102+69	Weather (Wet/Dry/Rain):	Dry

FIELD INSPECTION PHOTO LOG

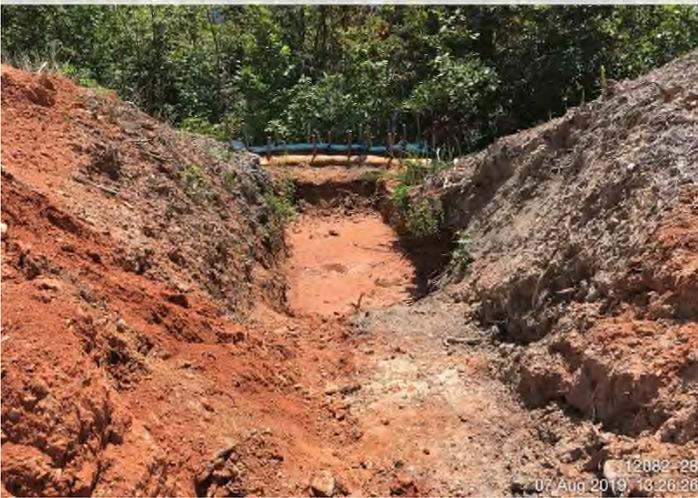
STA 12082+28: Maintain sump.
 STA 12083+00: Maintain sump.
 STA 12093+28: Maintain sump.

<p>Fig. 1: STA 12082+28 – Sump maintenance needed.</p> <div style="border: 1px solid gray; padding: 2px; margin-bottom: 5px;"> 162°S (T) 37°15'31"N, 80°17'42"W ±16.4ft ▲ 1790ft </div>

Recommended Corrective Action: Install and maintain all controls per the approved plans and PSS&S.

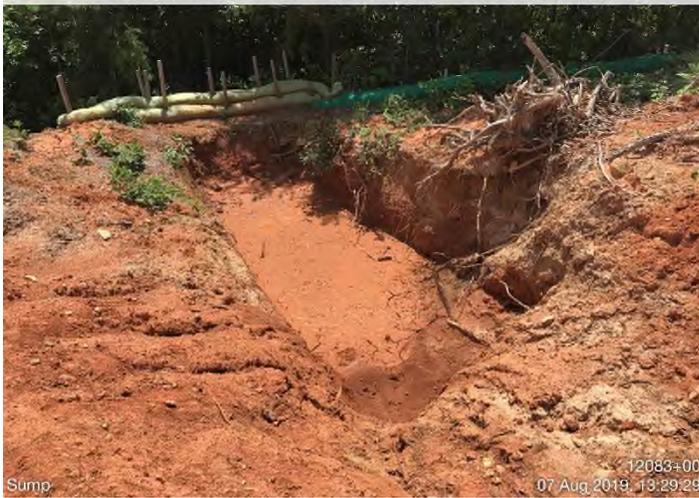
<div style="text-align: right; font-size: small; margin-top: 5px;"> 12082+28 07 Aug 2019 13:26:26 </div>	<p>Fig. 2: STA 12083+00 – Sump maintenance needed.</p> <div style="border: 1px solid gray; padding: 2px; margin-bottom: 5px;"> 181°S (T) 37°15'31"N, 80°17'39"W ±16.4ft ▲ 1773ft </div>

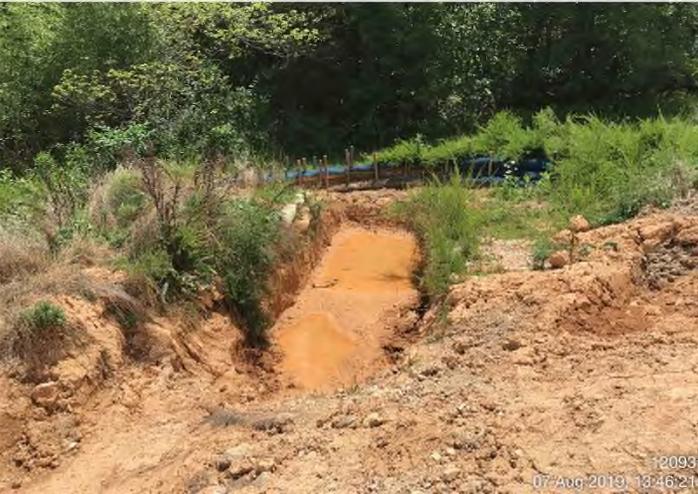
<div style="text-align: right; font-size: small; margin-top: 5px;"> 12083+00 07 Aug 2019 13:29:29 Sump </div>
<p>Fig. 3: STA 12093+00 – Sump maintenance needed.</p> <div style="border: 1px solid gray; padding: 2px; margin-bottom: 5px;"> 175°S (T) 37°15'29"N, 80°17'28"W ±16.4ft ▲ 1594ft </div>

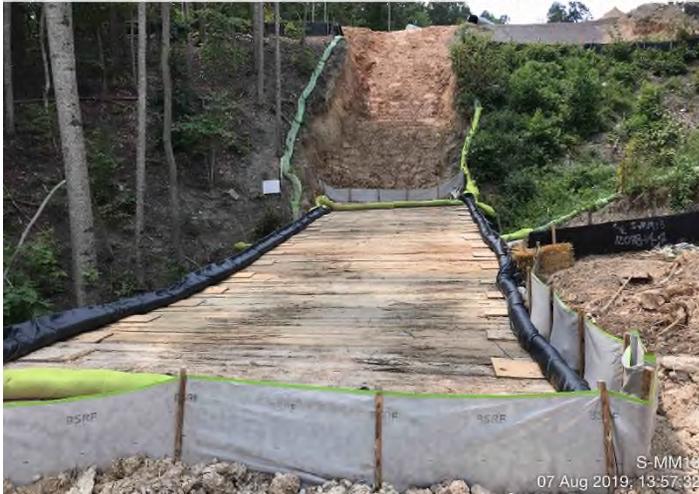
<div style="text-align: right; font-size: small; margin-top: 5px;"> 12093+00 07 Aug 2019 13:46:21 </div>	<p>Fig. 4: Stream S-MM13 – Perimeter controls in place. Bridge clean and sideboards in place and functioning.</p> <div style="border: 1px solid gray; padding: 2px; margin-bottom: 5px;"> 247°SW (T) 37°15'29"N, 80°17'20"W ±16.4ft ▲ 1536ft </div>
