## FIELD INSPECTION

<b>Project Name:</b>	Mountain Valley Pipeline	<b>Inspector:</b>	Marshall Willis
<b>Inspection Date:</b>	Tuesday, September 10, 2019	<b>Project Contact:</b>	Brian Clauto, Cory Chalmers
<b>Spread H: Montgomery County</b>	STA 12298+39 – 12387+85 MVP-MN-276.03	<b>Weather (Wet/Dry/Rain):</b>	Dry

# FIELD INSPECTION PHOTO LOG

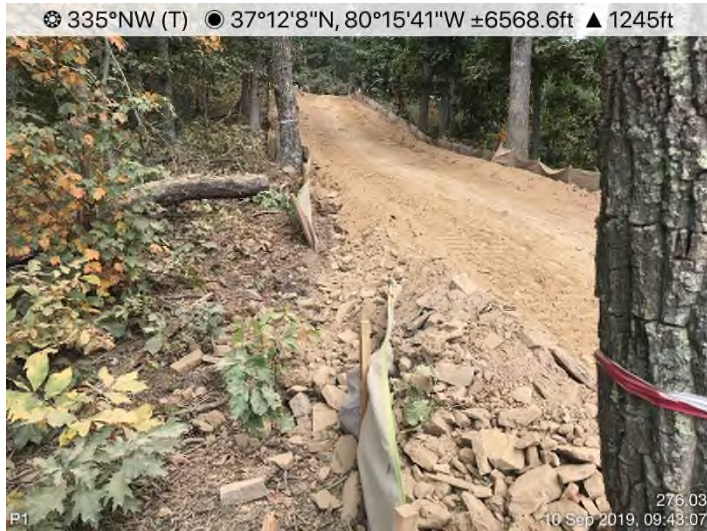
STA 12298+00 (MVP-MN-276.03): Maintain/repair P1 along AR.  
 STA 12299+00: Maintain sump.  
 STA 12321+00 through STA 12356+00: Install waterbars per PSS&S.  
 STA 12360+90: Stabilize fill slopes.  
 STA 12361+00: Maintain SSF.

**Fig. 1: STA 12298+00** – Maintain P1 along MVP-MN-276.03.

**Recommended Corrective Action:** Install and maintain all controls per the approved plans and PSS&S.

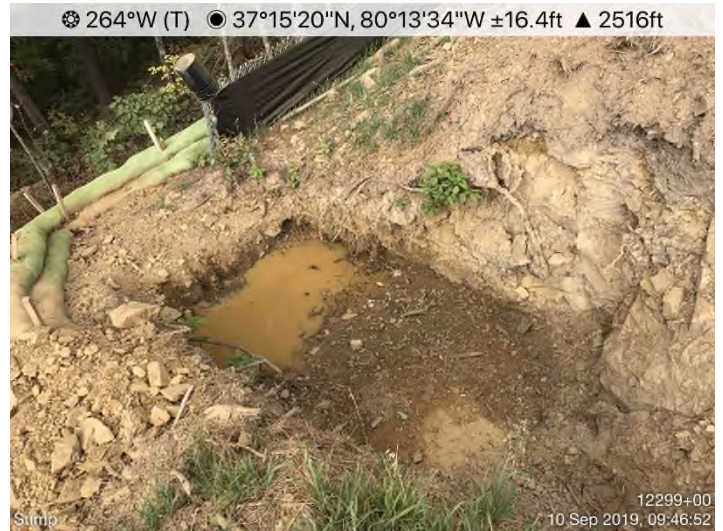
**Fig. 2: STA 12299+00** – Sump maintenance needed.

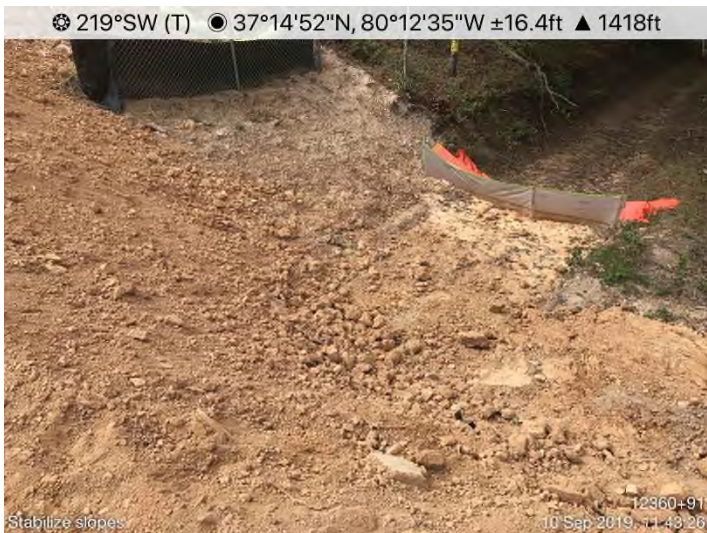
**Fig. 3: STA 12360+91** – Stabilize fill slopes.

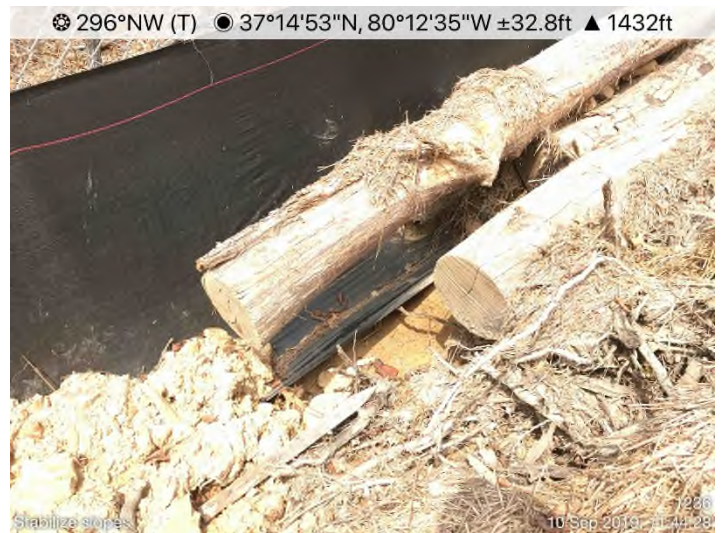
**Fig. 4: STA 12361+10** – SSF undermined.

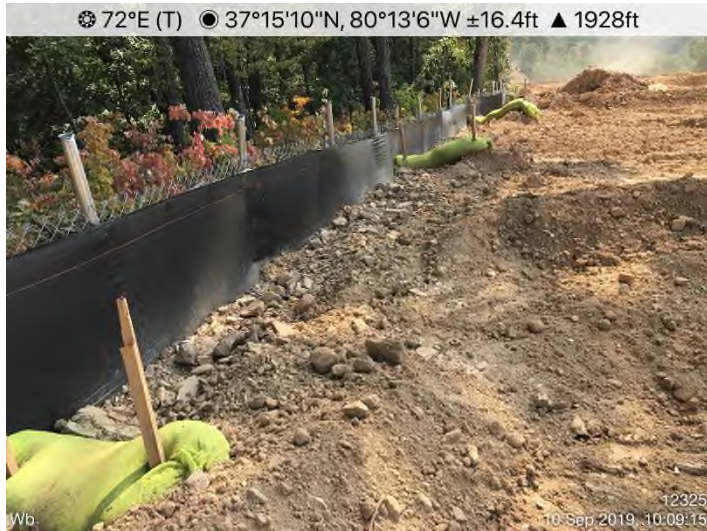
Fig. 5: **STA 12321+00 to 12356+00** – Waterbars do not extend full length of ROW.

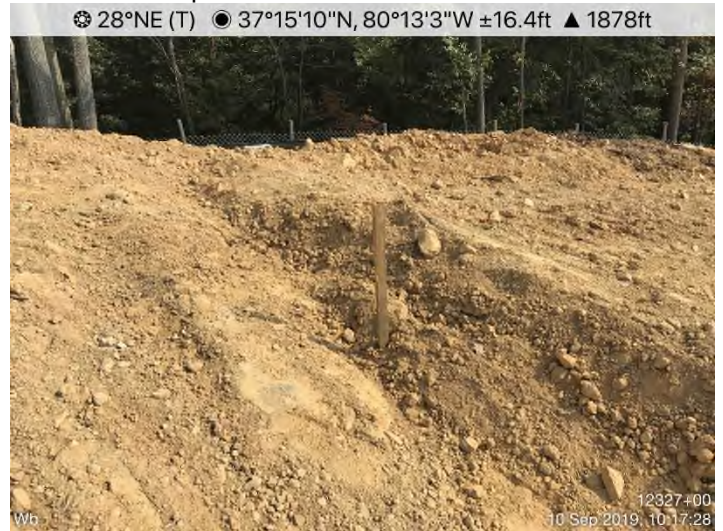
Fig. 6: **STA 12321+00 to 12356+00** – Waterbars do not extend full length of ROW. Waterbars do not meet dimensional requirements of PSS&S.

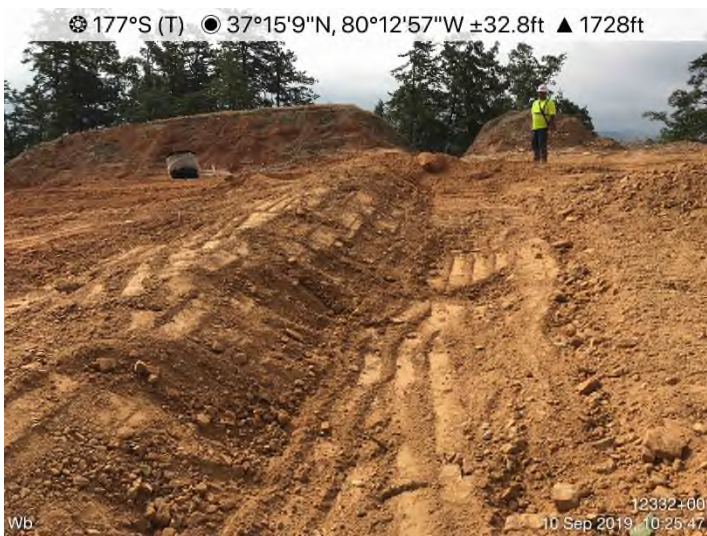
Fig. 7: **STA 12321+00 to 12356+00** – Waterbars do not have positive drainage to end treatments.

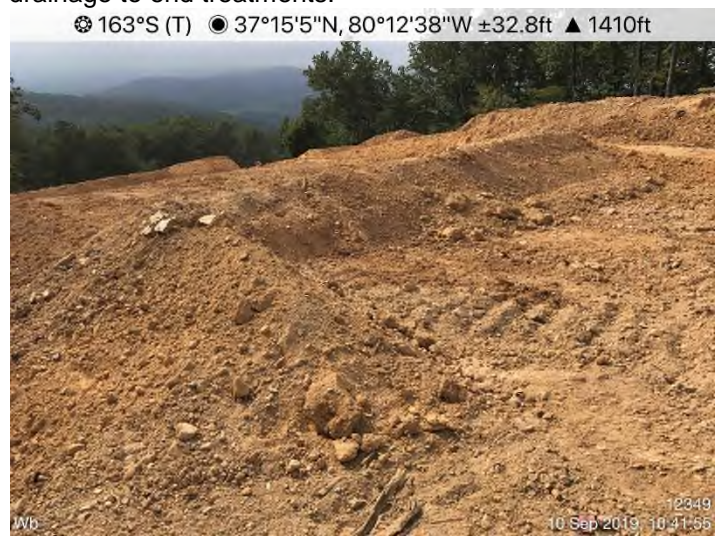
Fig. 8: **STA 12321+00 to 12356+00** – Waterbars do not extend full length of ROW. Waterbars do not have positive drainage to end treatments.
