FIELD INSPECTION

Project Name:	Mountain Valley Pipeline	Inspector:	Matthew Grant
Inspection Date:	Wednesday, September 4, 2019	Project Contact:	Brian Clauto
Spread: Roanoke Co. MP240 12690+29-12712 ATWS1224 & 1225 ARO 280 AR 279.01 Montgomery Co. ATWS 1159 MP227.7-229.2 ST12031+56-12103+00	Spread H	Weather (Wet/Dry/Rain):	Dry

FIELD INSPECTION PHOTO LOG

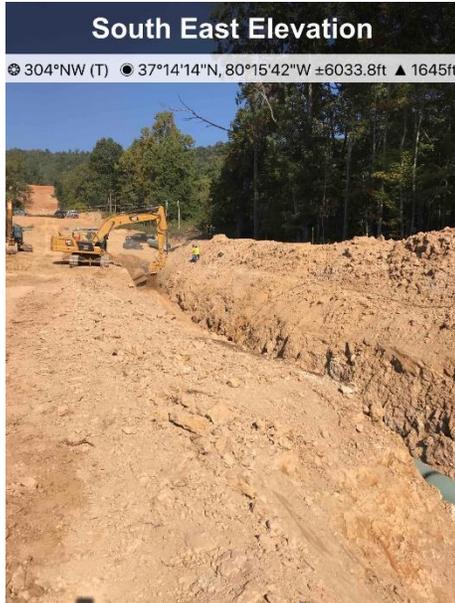
▪ Fig. 1 Near MP 229 backfilling of trench

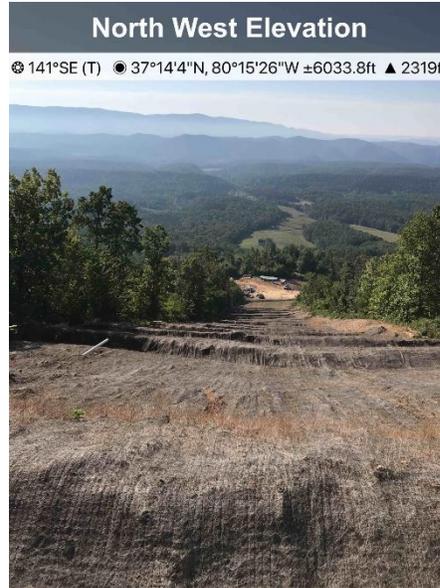
▪ Fig. 2 Near MP 228.3 area remains matted.

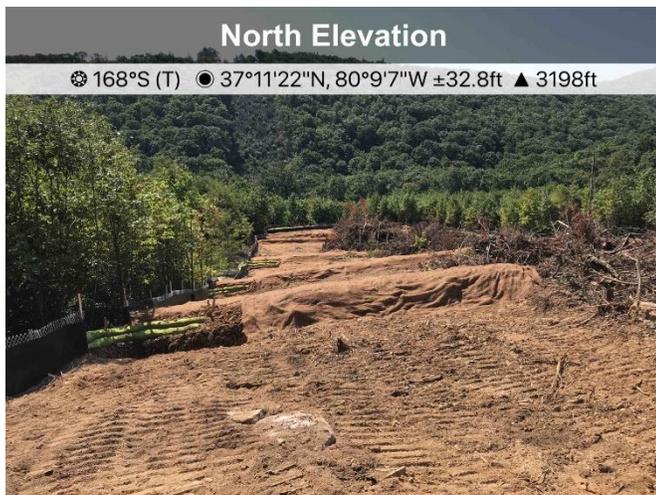
▪ Fig. 3 Near MP 240.3 waterbars have been matted

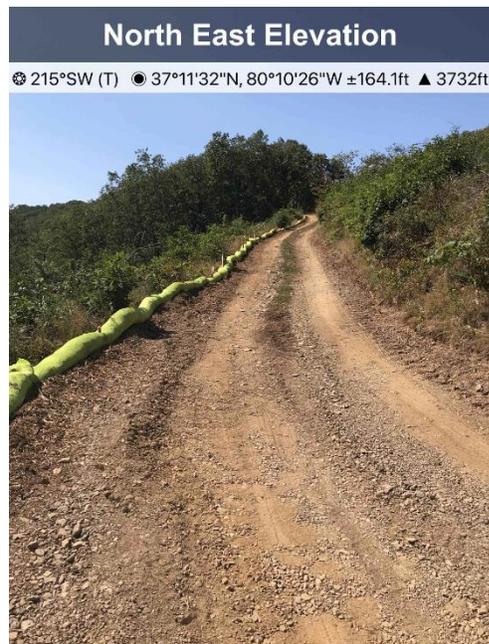
▪ Fig. 4 ECD's in place at AR279.01
