FIELD INSPECTION

Project Name:	Mountain Valley Pipeline	Inspector:	Marshall Willis
Inspection Date:	Thursday, January 2, 2020	Project Contact:	Brian Clauto, Cory Chalmers
Spread I: Franklin County	STA 13644+82 – 13748+30 ATWS 1067/1362/566	Weather (Wet/Dry/Rain):	Dry

FIELD INSPECTION PHOTO LOG

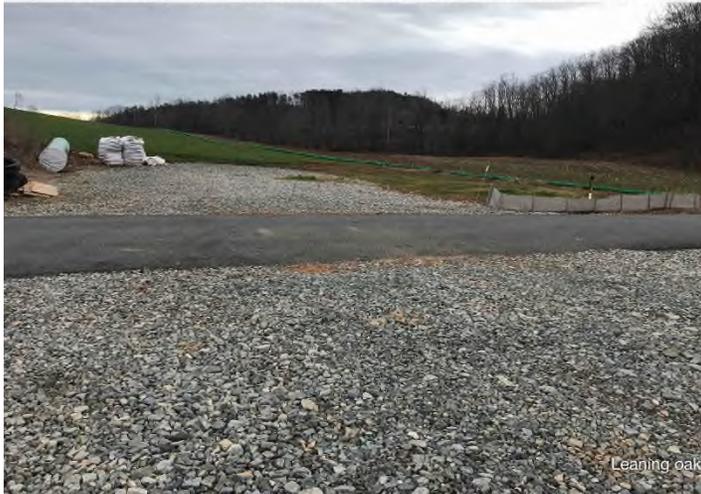
Fig. 1: **STA 13644+82** – Leaning Oak Road Crossing. Controls in place and functioning properly.

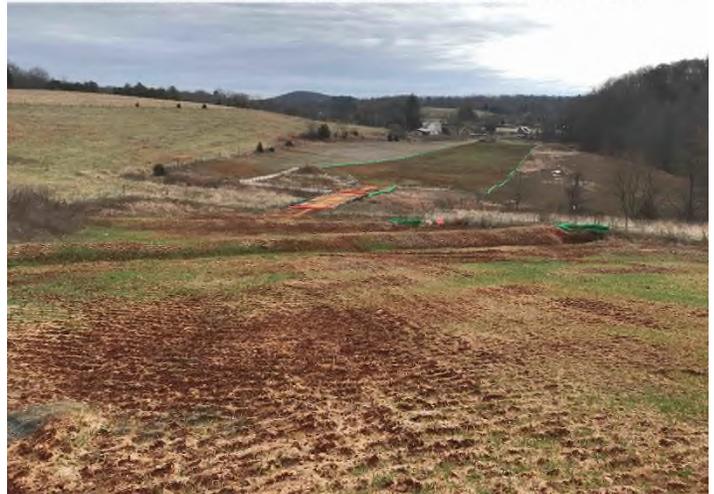
Fig. 2: **STA 13662+00** – Controls in place and functioning properly. Area stabilized with Flexterra.

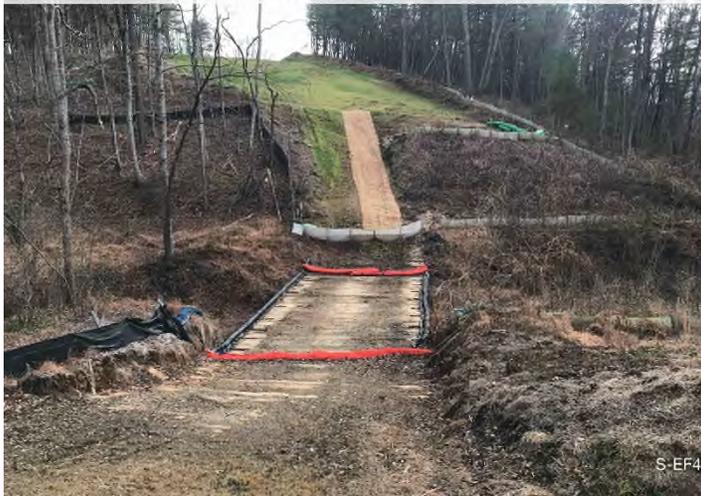
Fig. 3: **STA 13727+50** – Controls in place around Stream S-EF4 crossing. Area stabilized.

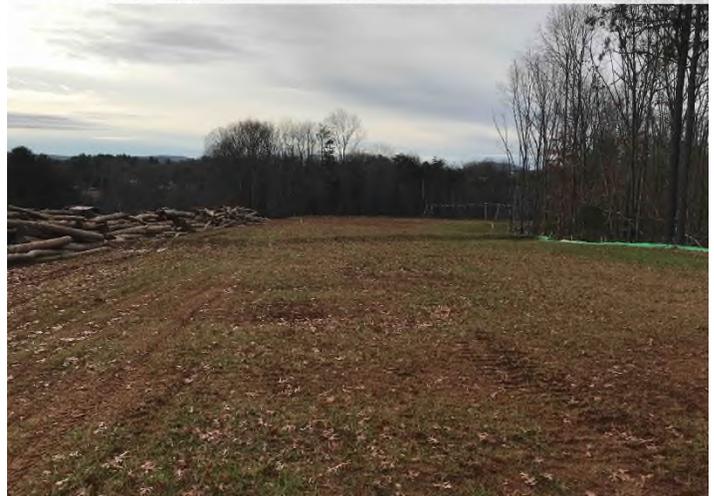
Fig. 4: **STA 13738+00** – Controls in place and functioning properly. Area stabilized with Flexterra.
