FIELD INSPECTION REPORT

Project Name:	Mountain Valley Pipeline	Inspector:	Marshall Willis
Inspection Date:	Friday, January 24, 2020	Project Contact:	Brian Clauto, Cory Chalmers
Spread I: Franklin County	STA 13415+51 – 13438+31 STA 13539+00 – 13543+00 STA 13562+63 – 13575+21 MVP-FR-293.02	Weather:	Rainy

FIELD INSPECTION PHOTO LOG

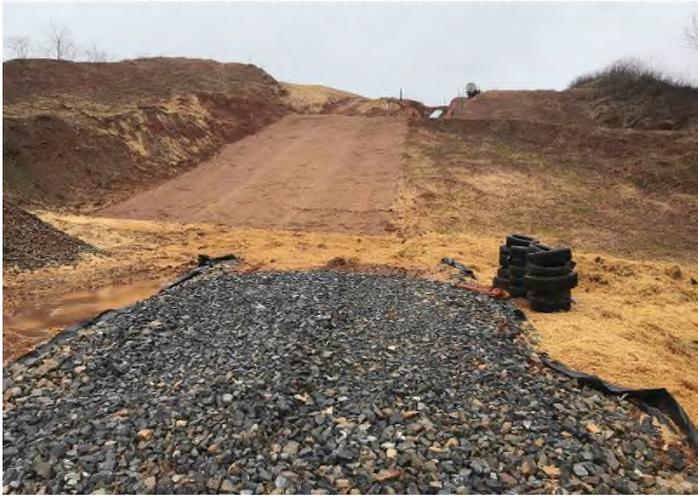
Figure 1: STA 13416+00 – Controls in place and functioning properly. Area stabilized with straw and erosion matting.

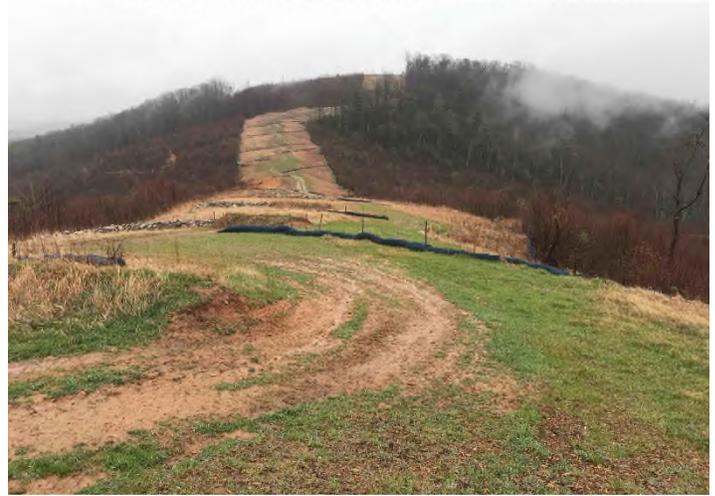
Figure 2: STA 13438+00 – Controls in place and functioning properly.

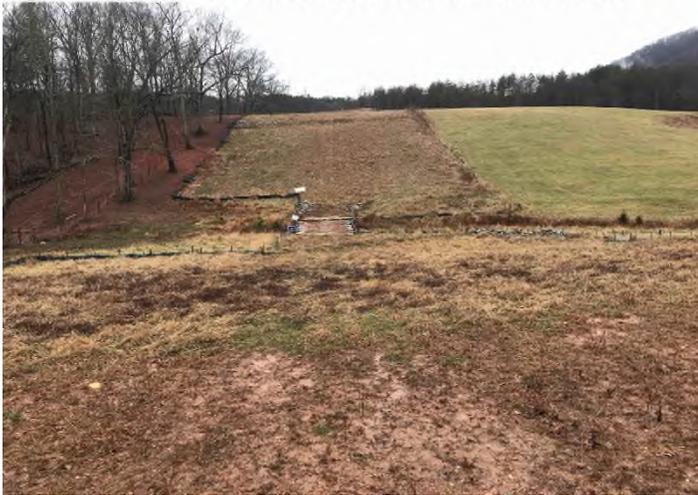
Figure 3: STA 13541+00 – Controls in place and functioning properly.

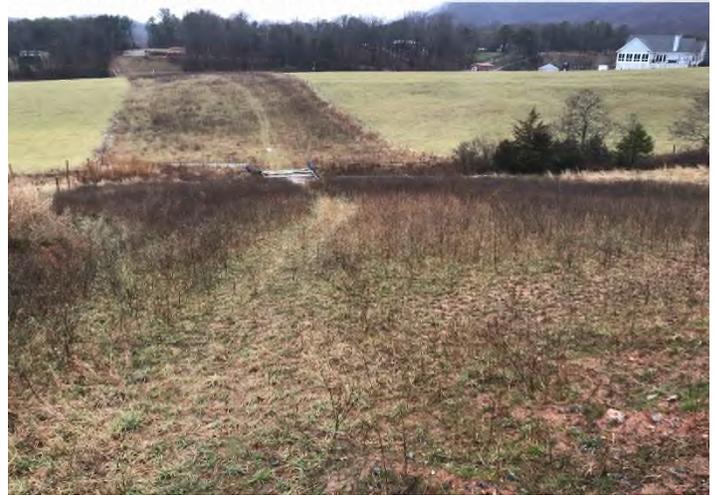
Figure 4: STA 13574+00 – Controls in place and functioning properly.
