## FIELD INSPECTION

Project Name:	Mountain Valley Pipeline	Inspector:	Marshall Willis
Inspection Date:	Friday, January 3, 2020	Project Contact:	Brian Clauto, Cory Chalmers
Spread I: Franklin County	STA 13850+00 – 13958+31 ATWS 697/698A/1299A MVP-FR-303.01/305	Weather (Wet/Dry/Rain):	Rainy

# FIELD INSPECTION PHOTO LOG

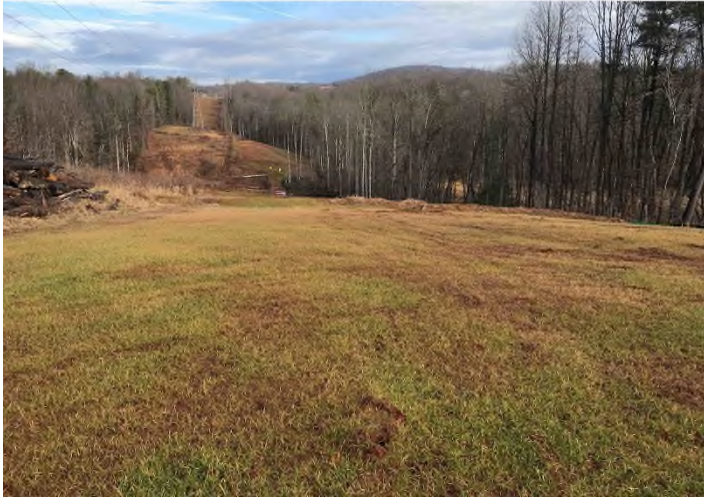
**Fig. 1: STA 13853+00** – Controls in place and functioning properly. Area stabilized.

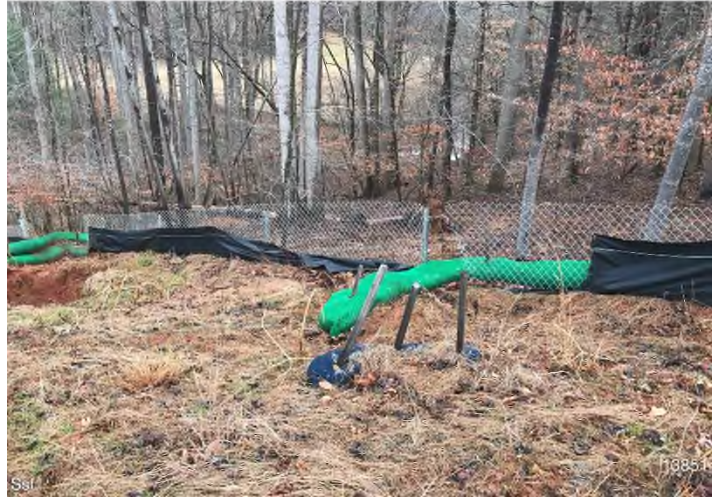
- STA 13851+00: SSF maintenance needed.

**Fig. 2: STA 13851+00** – SSF maintenance needed.

**Recommended Corrective Action:** Maintain and install all controls per the approved plans and PSS&S.

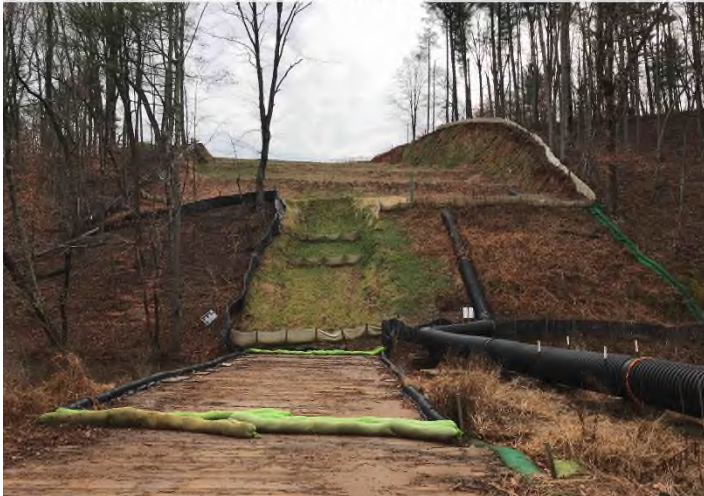
**Fig. 3: Wetland W-CD5** – Controls in place around wetland crossing. Area stabilized.

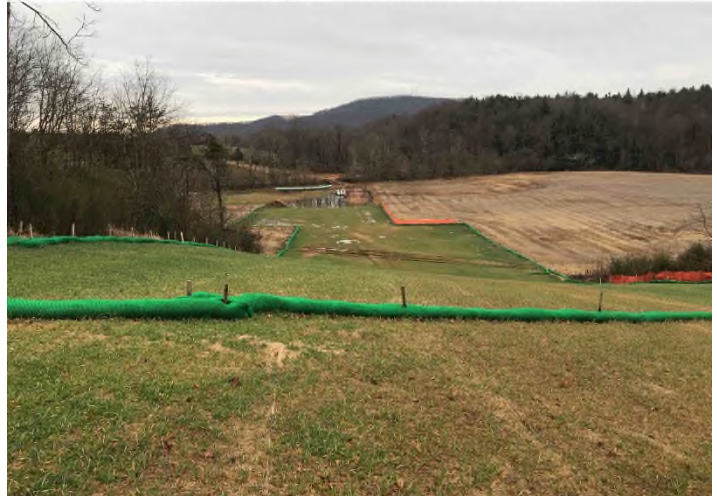
**Fig. 4: STA 13906+50** – Controls in place and functioning properly. Area stabilized.
