FIELD INSPECTION

Project Name:	Mountain Valley Pipeline	Inspector:	Matthew Grant
Inspection Date:	Wednesday, January 9, 2019	Project Contact:	Brian Clauto
Spread: Franklin County MP 266 MP273, MP275, MP276	Spread I	Weather (Wet/Dry/Rain):	Wet

FIELD INSPECTION PHOTO LOG

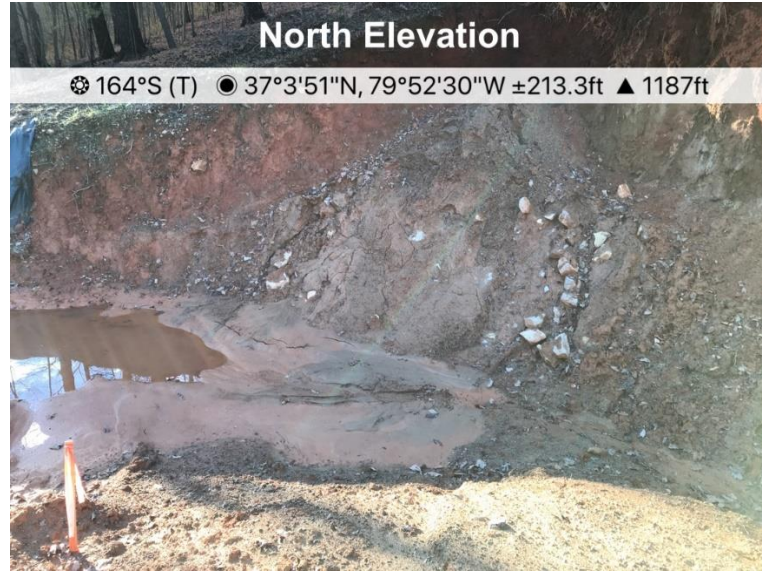
- Fig. 2 Sump near St# 14065+80 requires maintenance

Recommended Corrective Action: Remove off site sediment per DEQ approval and maintain all controls per the approved plan and specs.

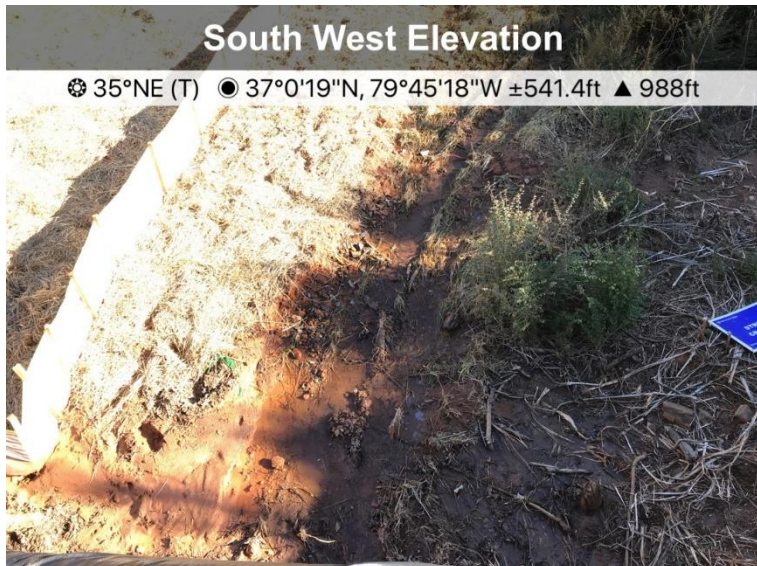
- Fig. 3 Sediment was observed at designated stream SG-17 at St#14546+00 MP 275

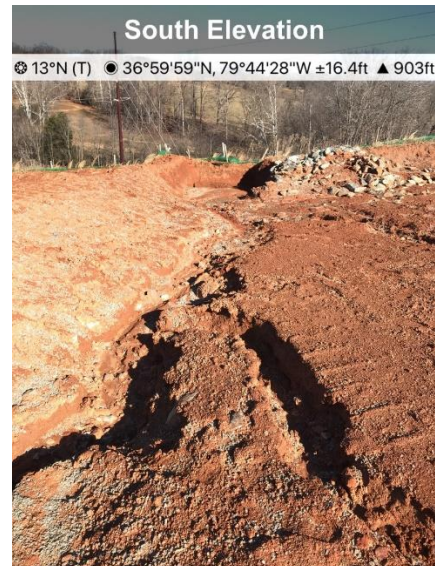
- Fig. 4 Waterbar & sump at St14587+00 has erosion in flow path and sump requires clean out.

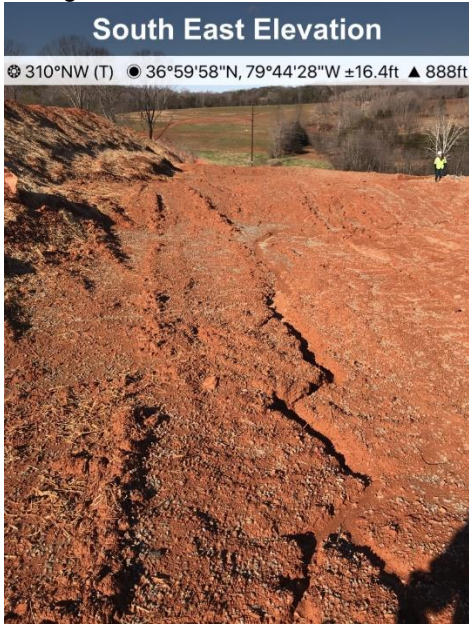
- Fig. 5 Between St#14583-14589 lacks adequate stabilization
