FIELD INSPECTION

Project Name:	Mountain Valley Pipeline	Inspector:	Marshall Willis
Inspection Date:	Tuesday, October 1, 2019	Project Contact:	Brian Clauto, Cory Chalmers
Spread I: Franklin County	STA 13431+88 – 13478+00 STA 13541+66 – 13552+00 STA 13644+82 – 13661+00	Weather (Wet/Dry/Rain):	Dry

FIELD INSPECTION PHOTO LOG

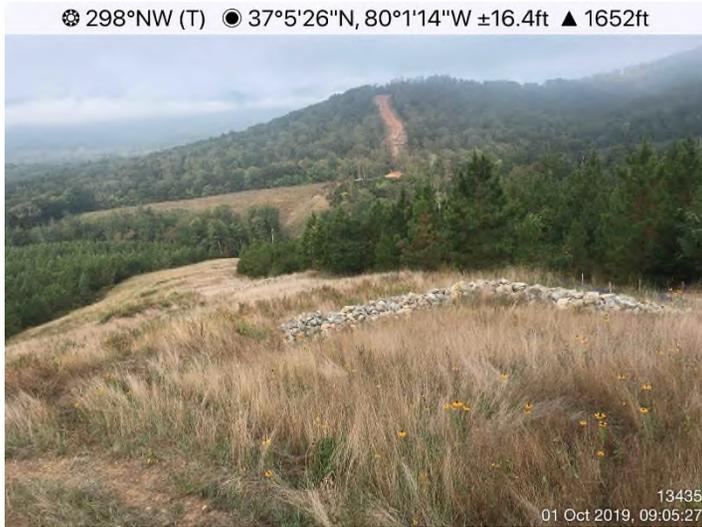
Fig. 1: **STA 13435+00** – Controls in place and functioning properly. Area stabilized.

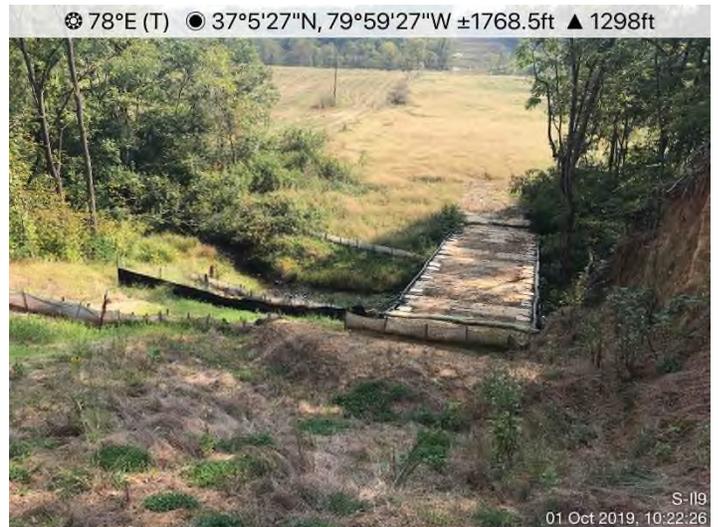
Fig. 2: **Stream S-II9** – Controls in place around S-II9. Area stabilized.

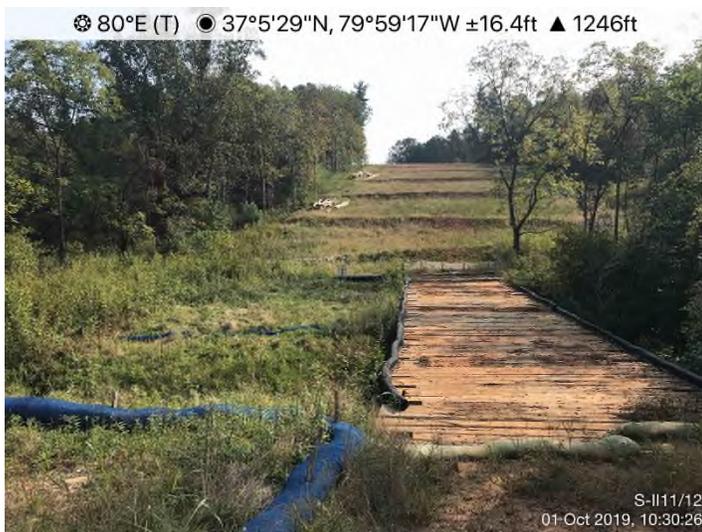
Fig. 3: **Stream S-II11 and S-II2** – Controls in place and functioning properly.

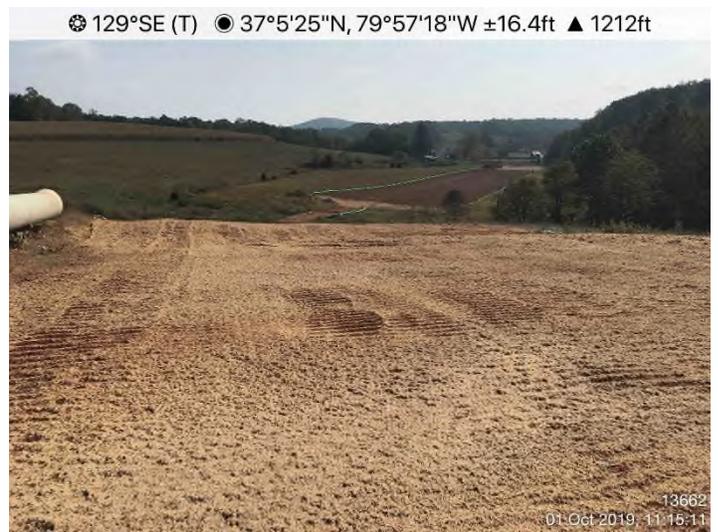
Fig. 4: **STA 13662+00** – Controls in place. Are stabilized.
