FIELD INSPECTION

Project Name:	Mountain Valley Pipeline	Inspector:	Marshall Willis
Inspection Date:	Wednesday, October 2, 2019	Project Contact:	Brian Clauto, Cory Chalmers
Spread I: Franklin County	MVP-FR-303.01/305 STA 13852+46 – 13875+73 STA 13892+45 – 13916+12 STA 13939+50 – 13930+00	Weather (Wet/Dry/Rain):	Dry

FIELD INSPECTION PHOTO LOG

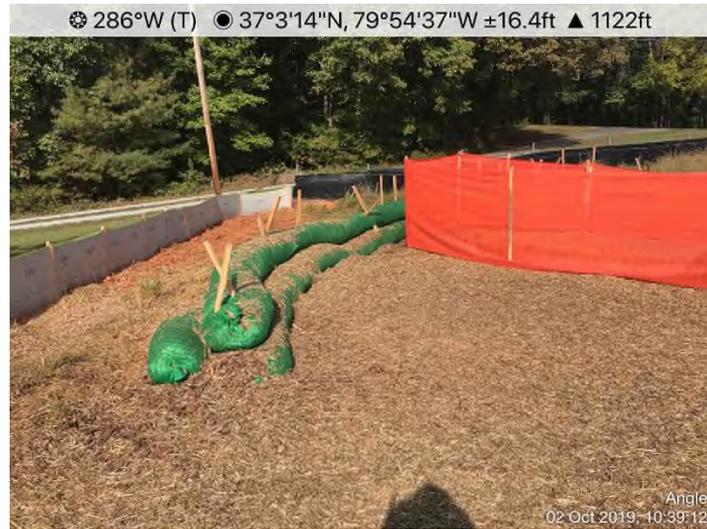
Fig. 1: **STA 13894+12** – Controls in place in place. Area stabilized with straw and seed.

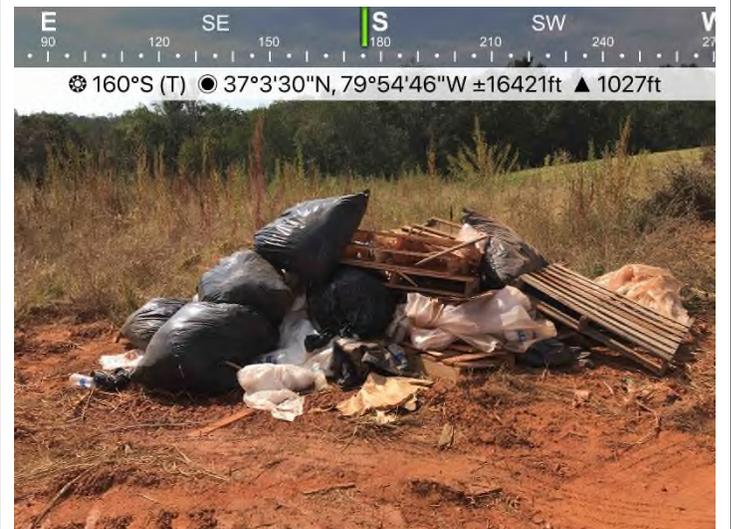
Fig. 2: **MVP-FR-303.01** – Clean up and properly dispose of trash debris.

MVP-FR-303.01: Remove/properly dispose of trash.
MVP-FR-303.01: Properly contain opened fertilizer per SWPPP. Clean up spill.

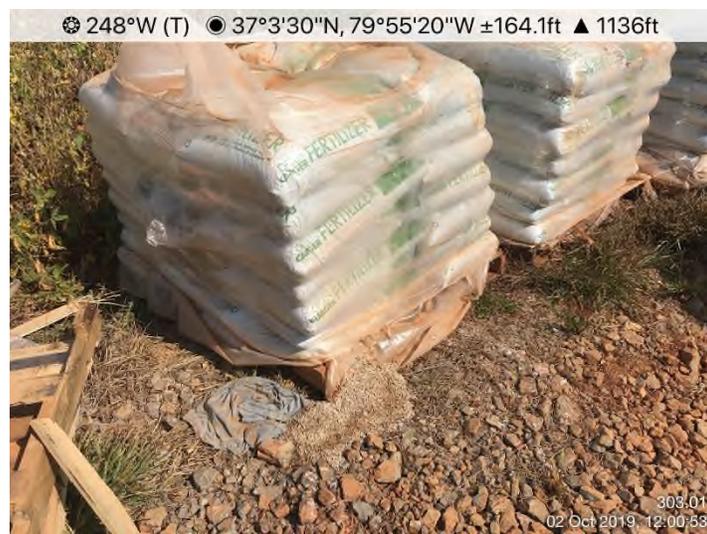
Fig. 3: **MVP-FR-303.01** – Clean up and properly contain opened fertilizer per SWPPP.

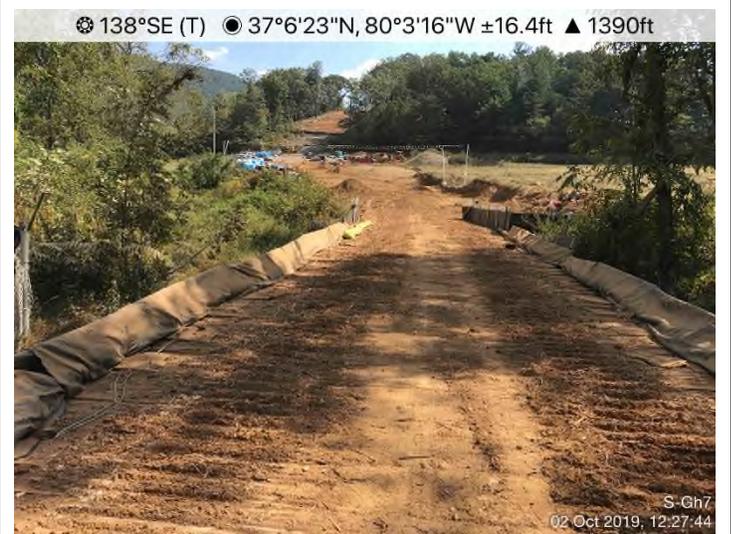
Fig. 4: **Stream S-GH7** – Controls in place. Sideboards and geo-underlayment in place and functioning properly.
