FIELD INSPECTION

Project Name:	Mountain Valley Pipeline	Inspector:	Marshall Willis
Inspection Date:	Wednesday, October 23, 2019	Project Contact:	Brian Clauto, Cory Chalmers
Spread I: Franklin County	STA 13996+58 – 14009+81 STA 13892+55 – 13917+50 STA 13676+85 – 13704+00 STA 13830+00 – 13820+00 MVP-FR-300/302/306.02	Weather (Wet/Dry/Rain):	Wet

FIELD INSPECTION PHOTO LOG

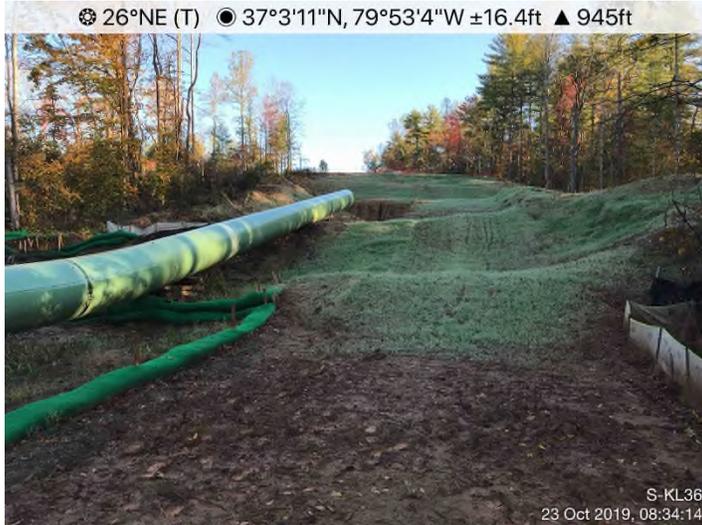
Fig. 1: **STA 14000+00** – Controls in place. Area stabilized with hydro-mulch.

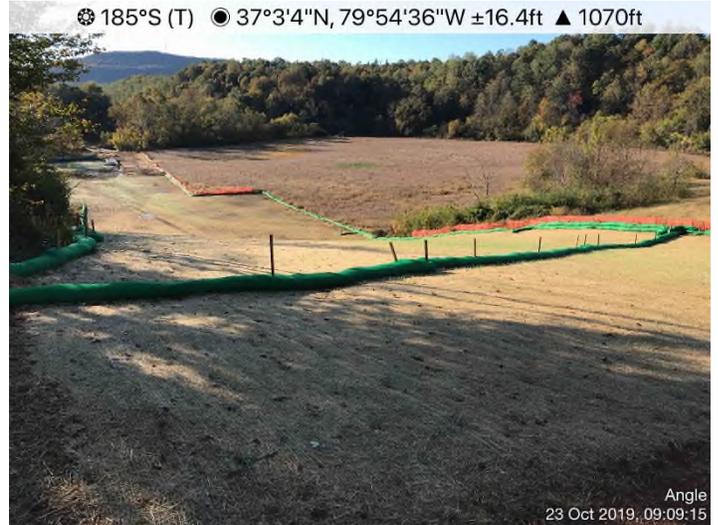
Fig. 2: **STA 13906+55** – Controls in place. Area stabilized with straw and erosion blanket.

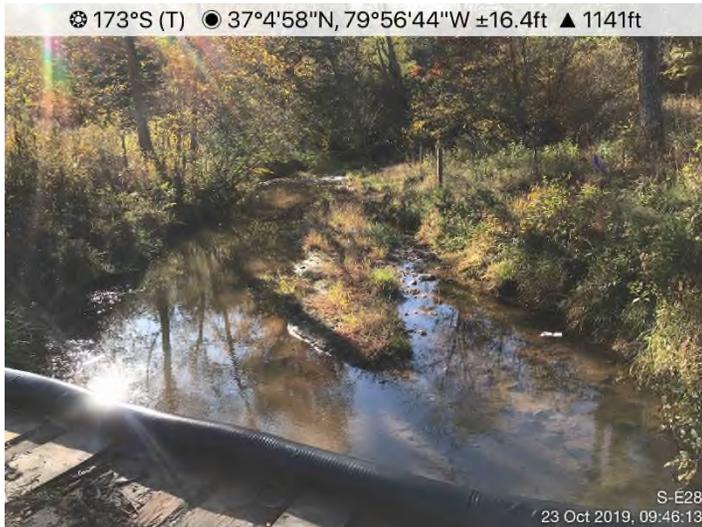
Fig. 3: **Stream S-E28** – Controls in place along Teels Creek.

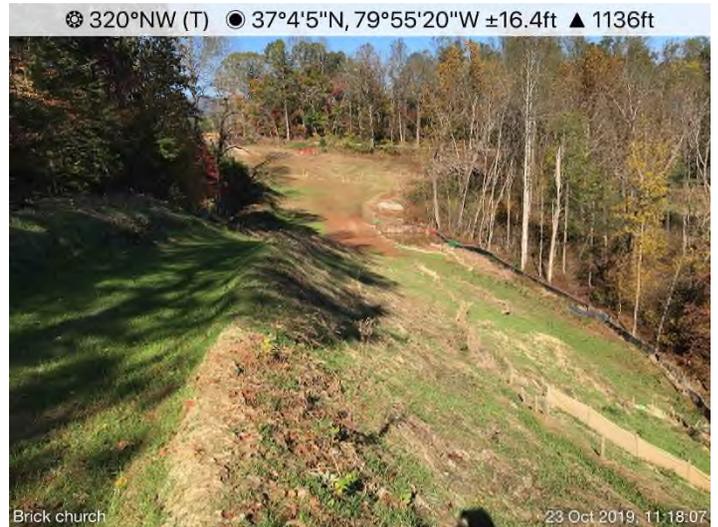
Fig. 4: **STA 13820+00** – Controls in place. Area stabilized.
