FIELD INSPECTION

Project Name:	Mountain Valley Pipeline	Inspector:	Marshall Willis
Inspection Date:	Tuesday, October 29, 2019	Project Contact:	Brian Clauto, Cory Chalmers
Spread I: Pittsylvania County	STA 15113+00 – 15221+11	Weather (Wet/Dry/Rain):	Wet

FIELD INSPECTION PHOTO LOG

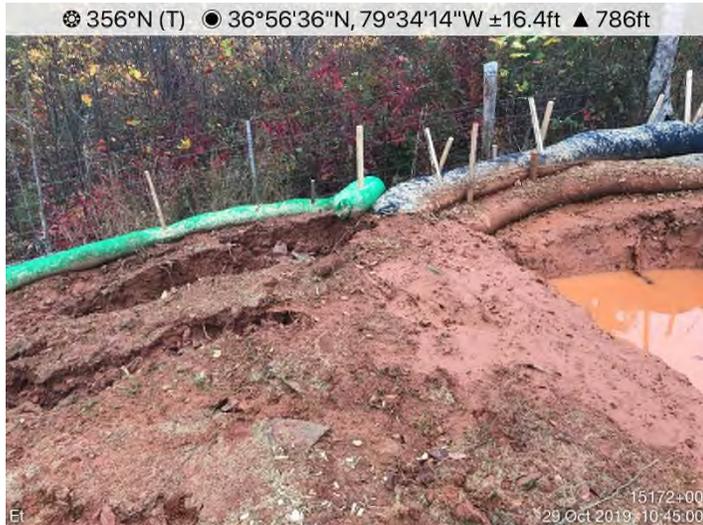
Fig. 1: **STA 15172+00** – End-treatment bypassed. CFS outlet higher than waterbar. Maintenance needed.

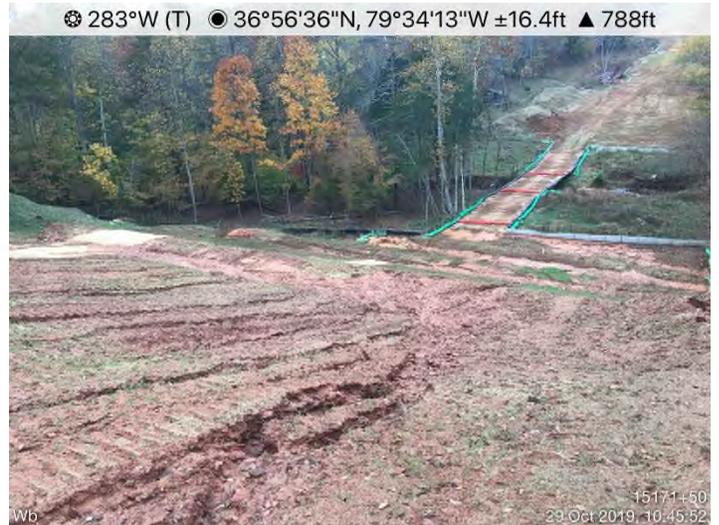
Fig. 2: **STA 15171+50 to 15169+58** – Waterbar maintenance needed.

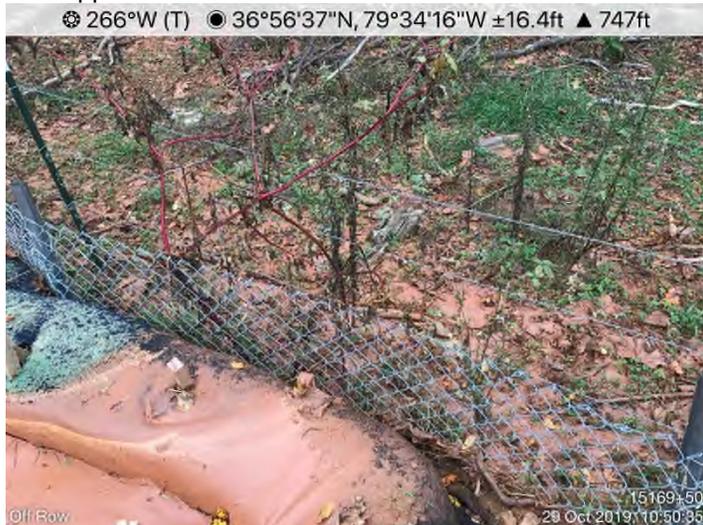
Fig. 3: **STA 15169+58** – Sediment off ROW. Controls overtopped.

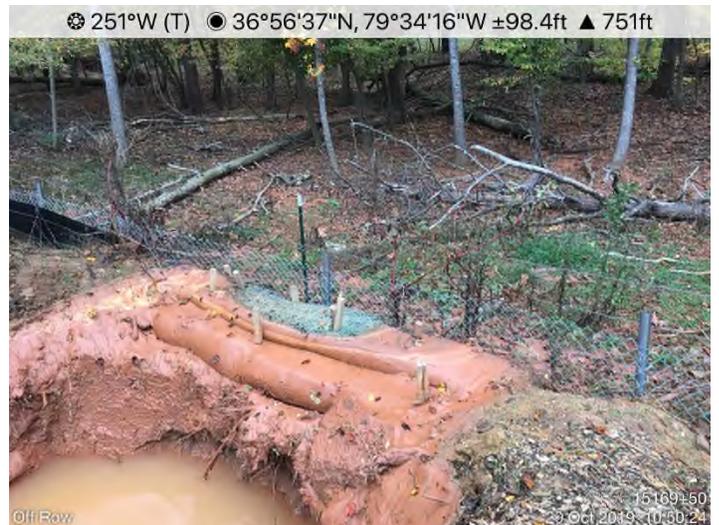
Fig. 4: **STA 15169+58** – CFS overtopped. Maintenance needed.

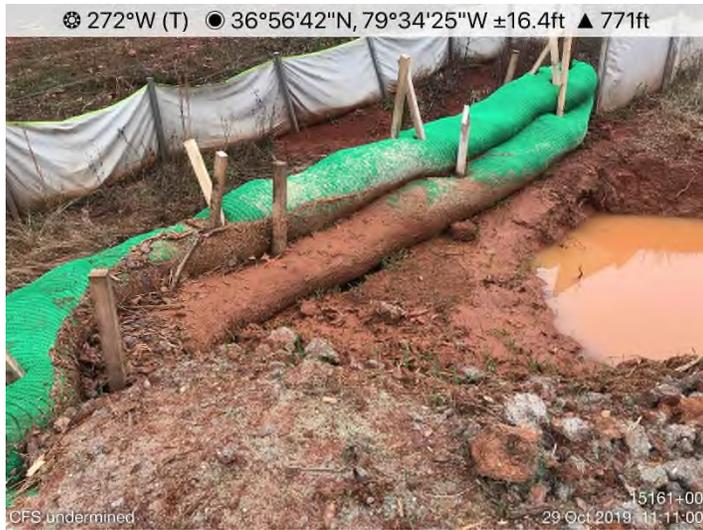
Fig. 9: STA 15161+00 – CFS undermined.

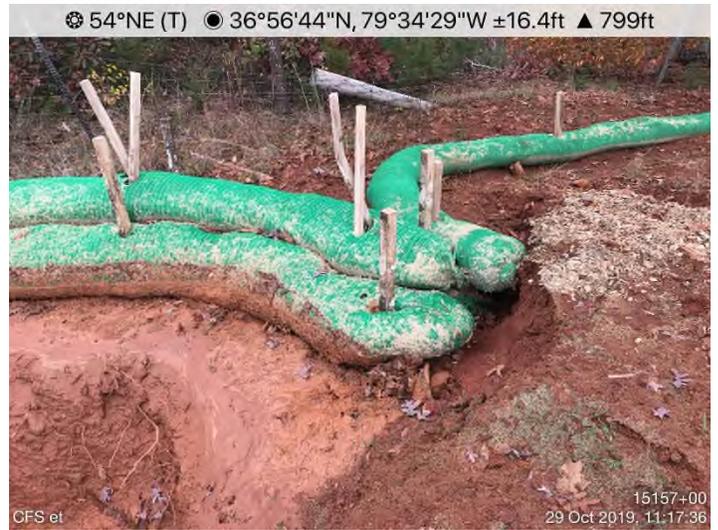
Fig. 10: STA 15157+00 – CFS end-treatment bypassed. Maintenance needed.

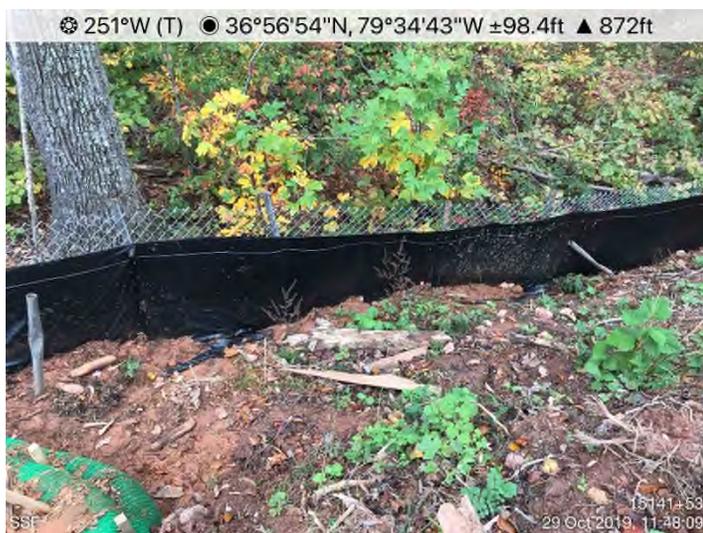
Fig. 11: STA 15142+00 – SSF undermined.

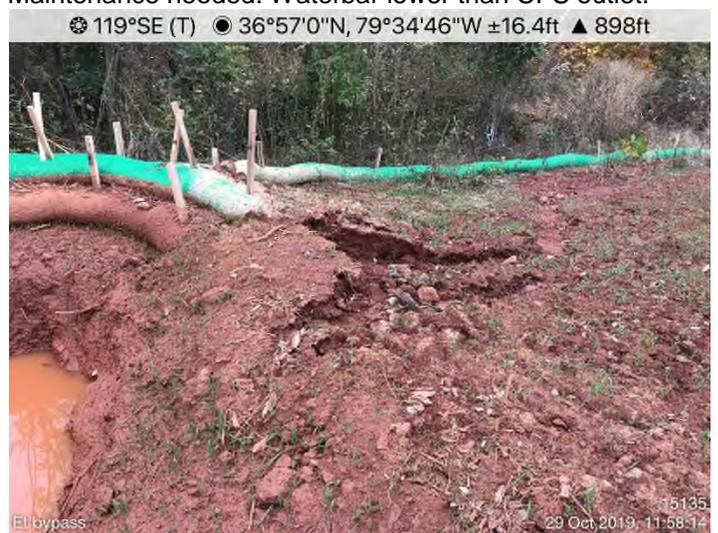
Fig. 12: STA 15135+00 – CFS end-treatment bypassed. Maintenance needed. Waterbar lower than CFS outlet.

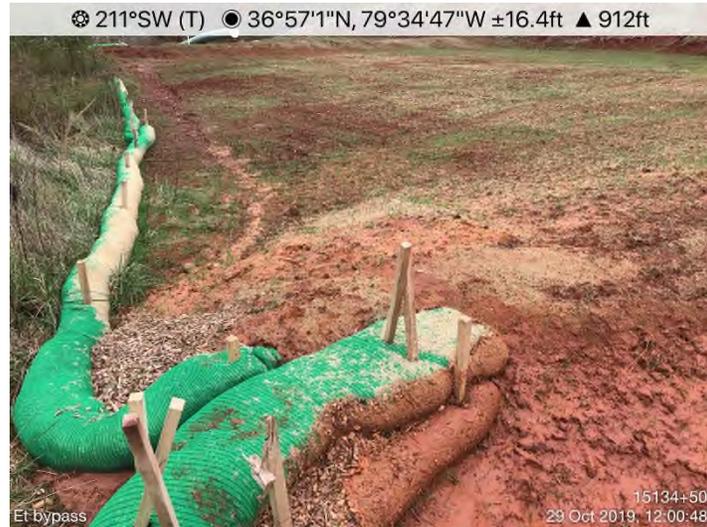
Fig. 13: **STA 15134+50** – CFS end-treatment bypassed. Maintenance needed. Waterbar lower than CFS outlet.

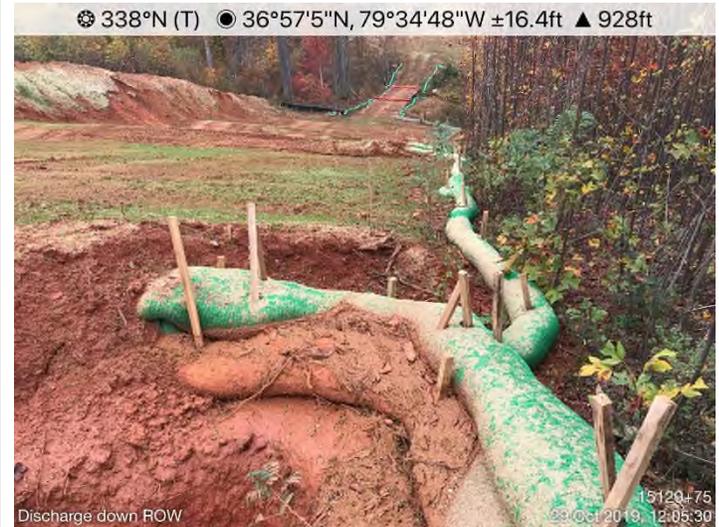
Fig. 14: **STA 15128+71** – Waterbar does not discharge off ROW. Maintenance needed.

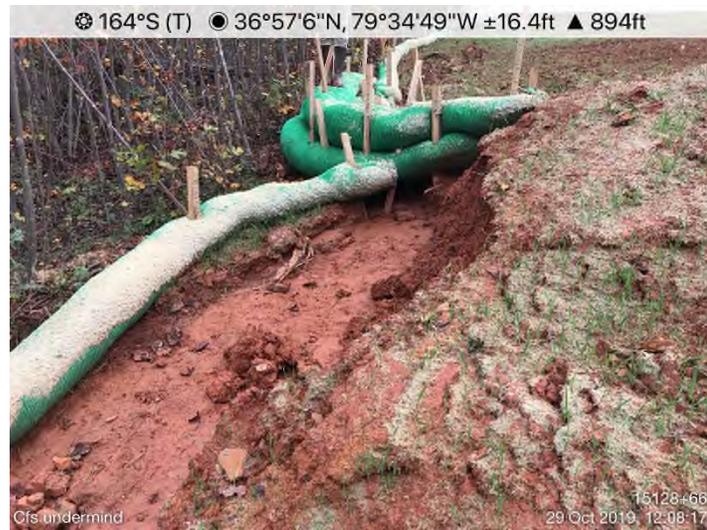
Fig. 15: **STA 15128+65** – CFS undermined. Maintenance needed.

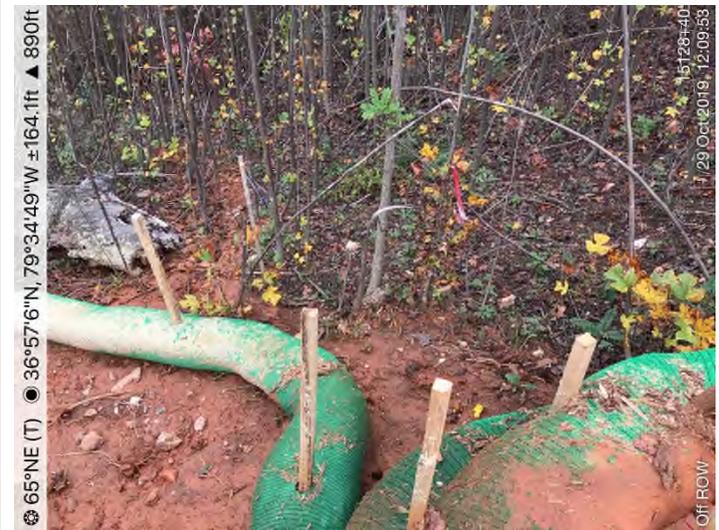
Fig. 16: **STA 15128+40** – Sediment off ROW due to upslope control failure and incorrect installation of waterbar end treatments.

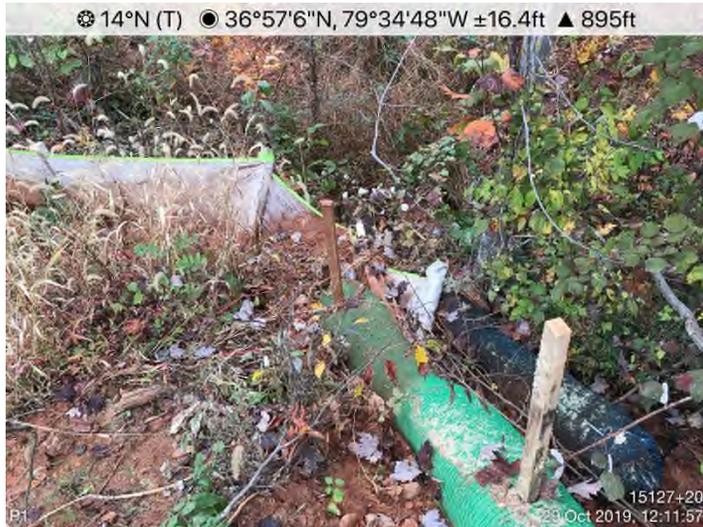
STA 15127+20: P1 maintenance needed.
 STA 15126+40: Sediment off ROW impacting Wetland W-A5 due to failed controls and overtopping of upslope waterbars.
 STA 15126+00: CFS maintenance needed.
 STA 15126+00: End-treatment bypassed. Waterbar lower than end-treatment.
 STA 15125+00: End-treatment bypassed. Waterbar lower than end-treatment.
 STA 15117+00: Waterbar lower than end-treatment.. WB discharge unable to get off ROW.

Fig. 17: **STA 15127+20** – P1 maintenance needed.

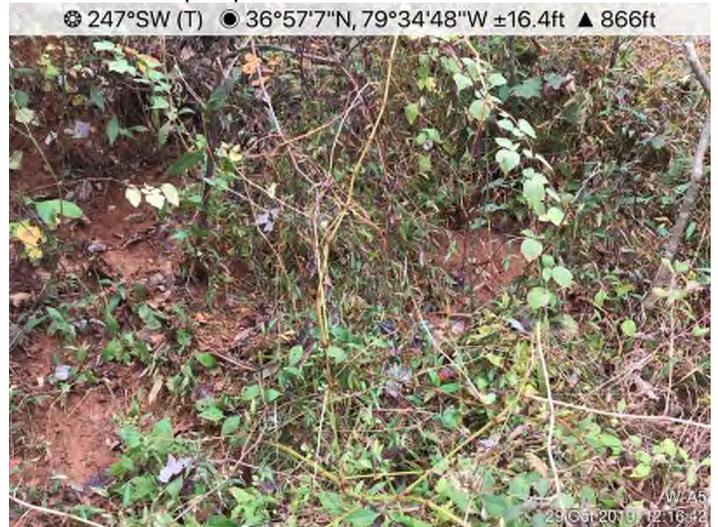
Fig. 18: **Wetland W-A5** – Sediment off ROW impacting wetland W-A5 due to control failure and incorrect installation of upslope controls.

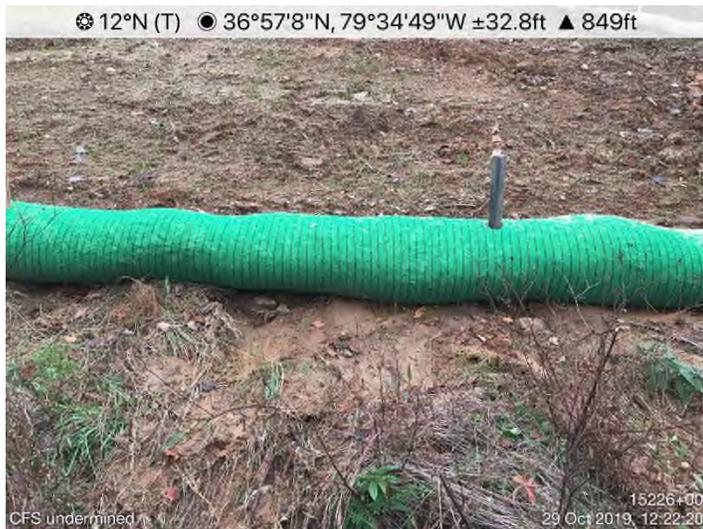
Fig. 19: **STA 15126+00** – CFS undermined.

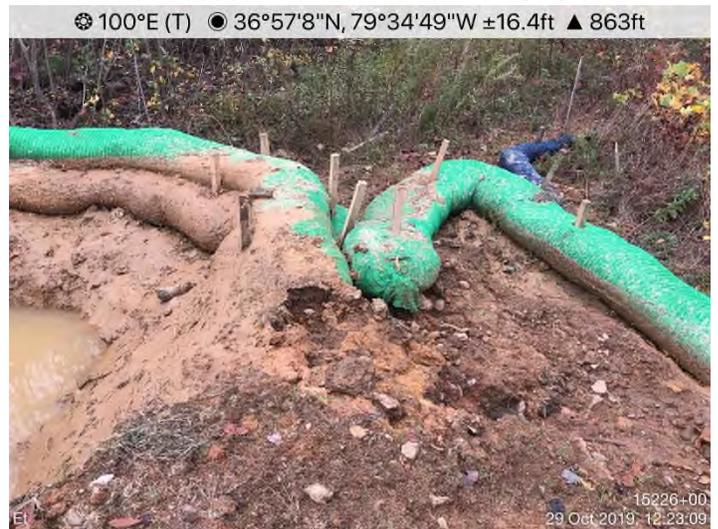
Fig. 20: **STA 15126+00** – CFS end-treatment bypassed. Maintenance needed. Waterbar lower than CFS outlet.

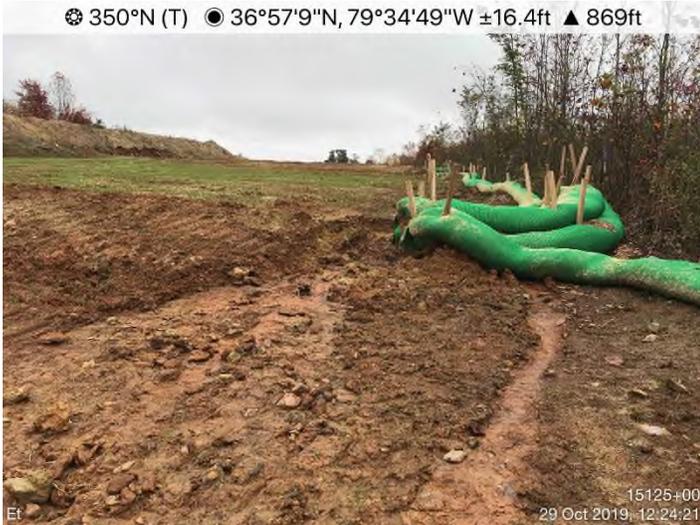
Fig. 21: **STA 15125+00** – CFS end-treatment bypassed. Maintenance needed. Waterbar lower than CFS outlet.

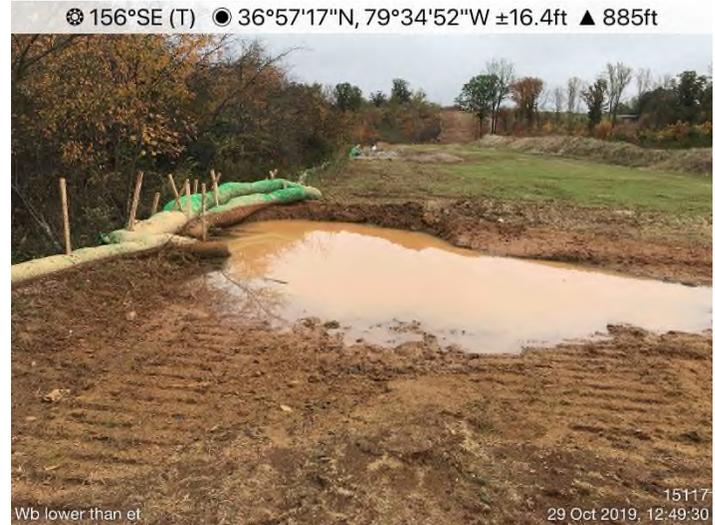
Fig. 22: **STA 15117+00** – CFS end-treatment bypassed. Maintenance needed. Waterbar lower than CFS outlet.
