## FIELD INSPECTION

<b>Project Name:</b>	Mountain Valley Pipeline	<b>Inspector:</b>	Marshall Willis
<b>Inspection Date:</b>	Tuesday, October 29, 2019	<b>Project Contact:</b>	Brian Clauto, Cory Chalmers
<b>Spread I: Pittsylvania County</b>	STA 15113+00 – 15221+11	<b>Weather (Wet/Dry/Rain):</b>	Wet

# FIELD INSPECTION PHOTO LOG

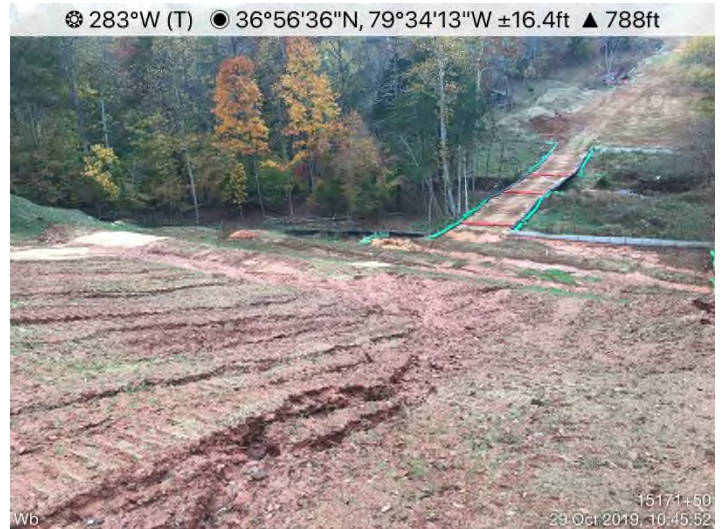
Fig. 2: **STA 15171+50 to 15169+58** – Waterbar maintenance needed.

**Recommended Corrective Action:** Maintain and install all controls per the approved plans and PSS&S.

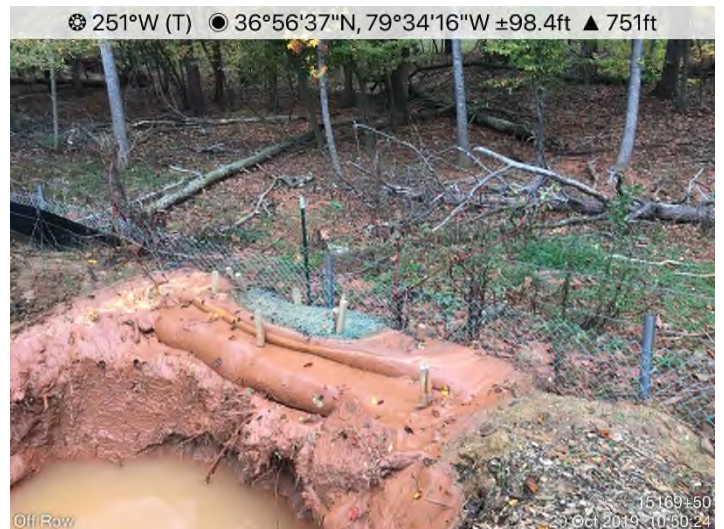
Fig. 4: **STA 15169+58** – CFS overtopped. Maintenance needed.

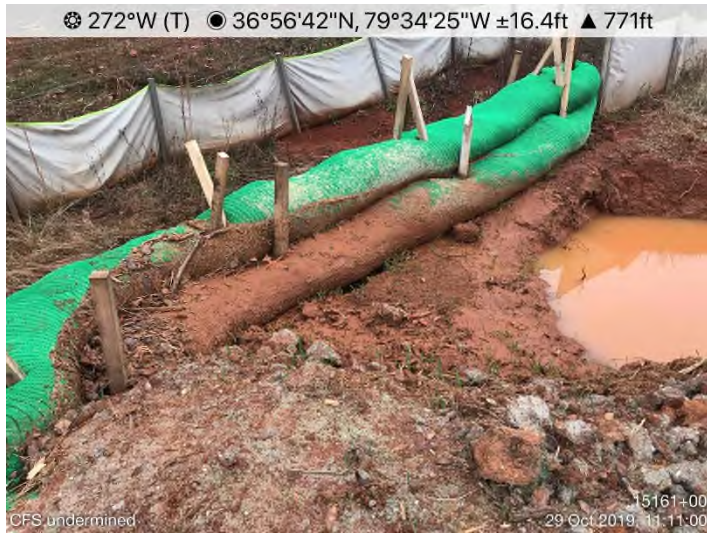
Fig. 9: **STA 15161+00** – CFS undermined.

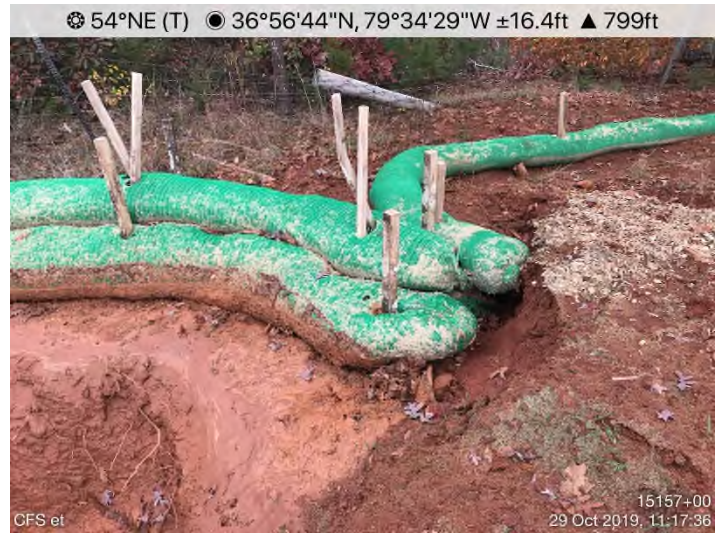
Fig. 10: **STA 15157+00** – CFS end-treatment bypassed. Maintenance needed.

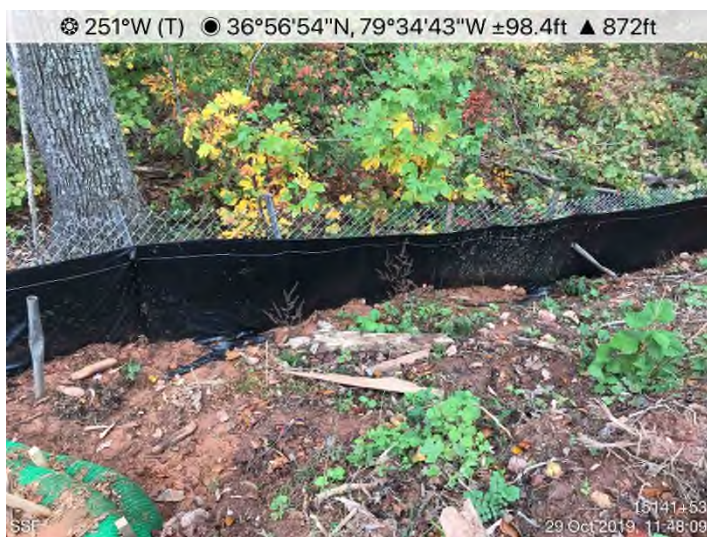
Fig. 11: **STA 15142+00** – SSF undermined.

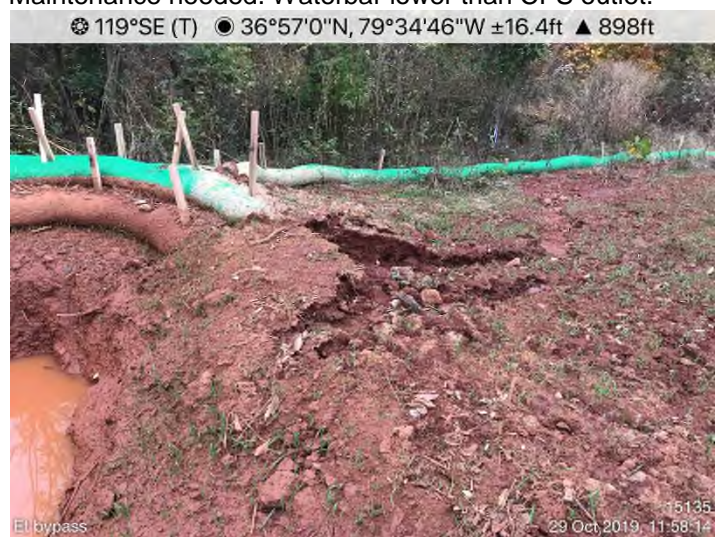
Fig. 12: **STA 15135+00** – CFS end-treatment bypassed. Maintenance needed. Waterbar lower than CFS outlet.
