FIELD INSPECTION

Project Name:	Mountain Valley Pipeline	Inspector:	Marshall Willis
Inspection Date:	Wednesday, October 30, 2019	Project Contact:	Brian Clauto, Cory Chalmers
Spread I: Franklin County	STA 14845+68 – 14928+52	Weather (Wet/Dry/Rain):	Rainy

FIELD INSPECTION PHOTO LOG

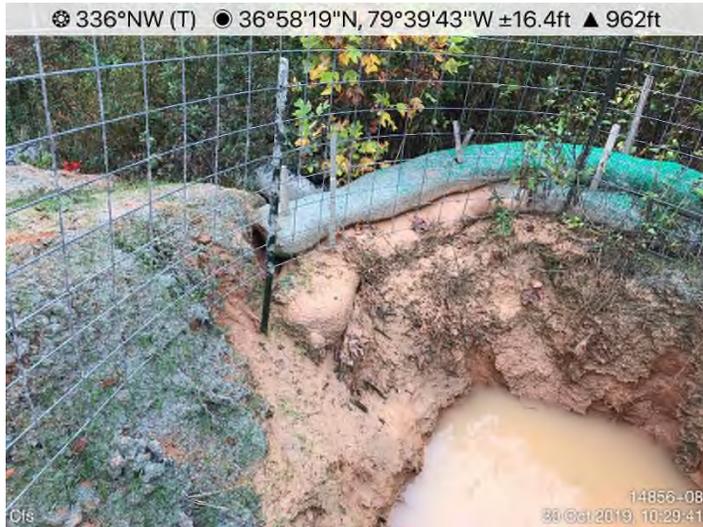
Fig. 1: **STA 14856+08** – End-treatment undermined. Maintenance needed.

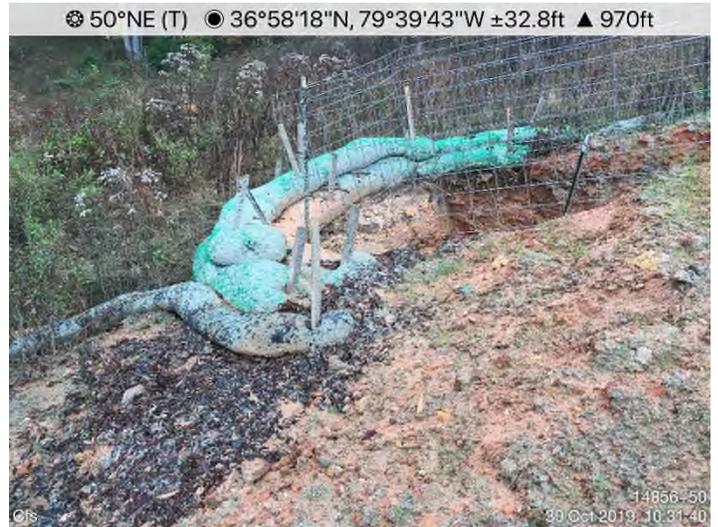
Fig. 2: **STA 14856+50** – Waterbar lower than CFS end-treatment. Discharge unable to get off ROW.

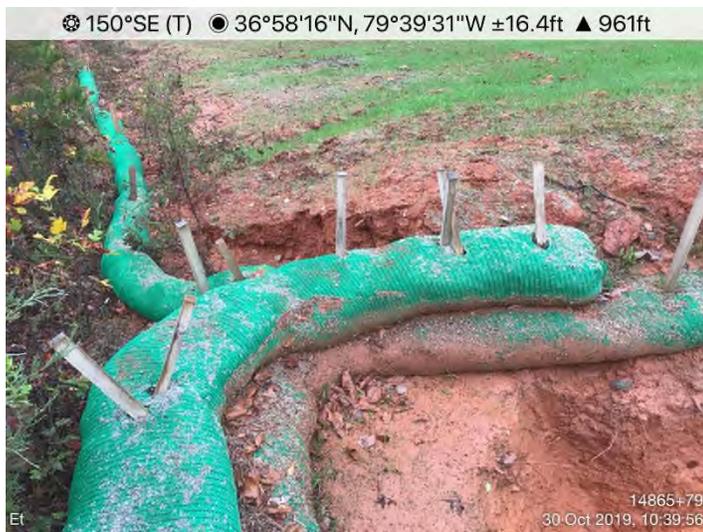
Fig. 3: **STA 14867+00** – End-treatment bypassed. Maintenance needed.

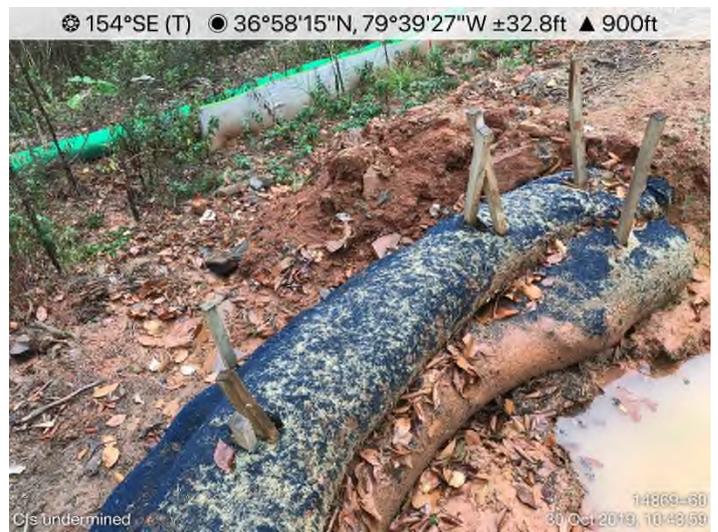
Fig. 4: **STA 14869+60** – End-treatment undermined. Maintenance needed.

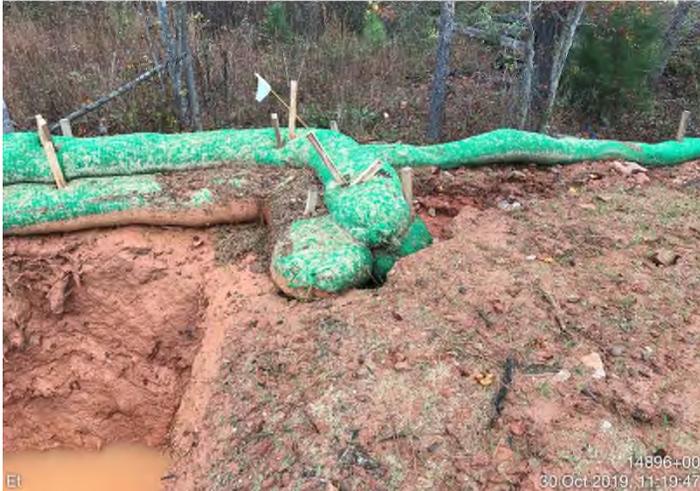
Fig. 17: **STA 14896+00** – Waterbar does not extend length of ROW.

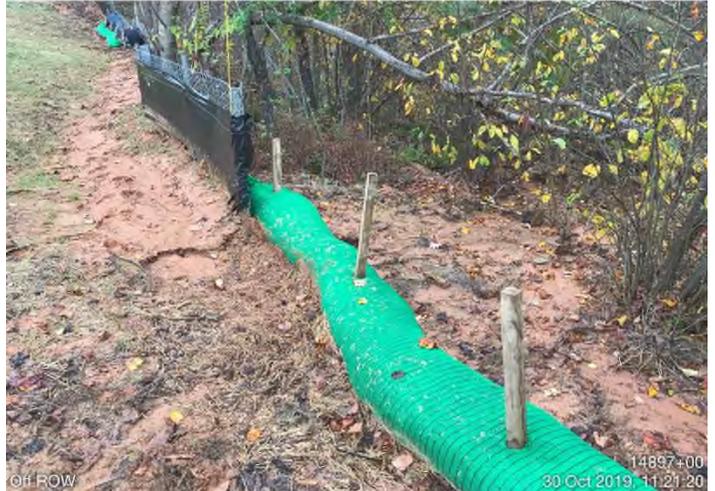
Fig. 18: **STA 14897+00** – Sediment off ROW.

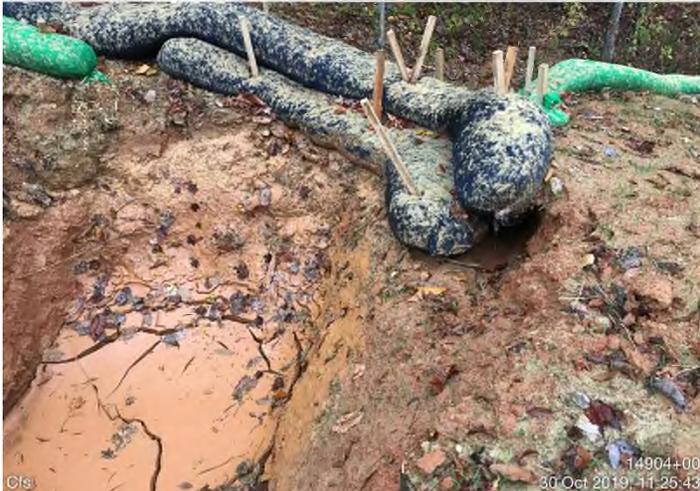
Fig. 19: **STA 14904+00** – CFS undermined. Maintenance needed.

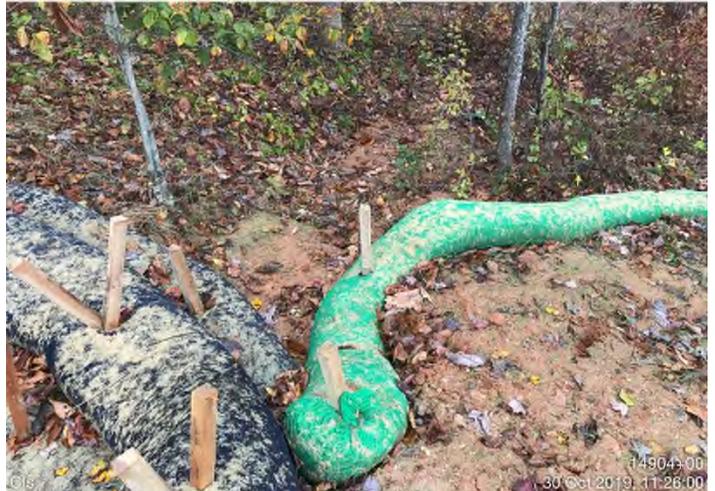
Fig. 20: **STA 14904+00** – Sediment off ROW.

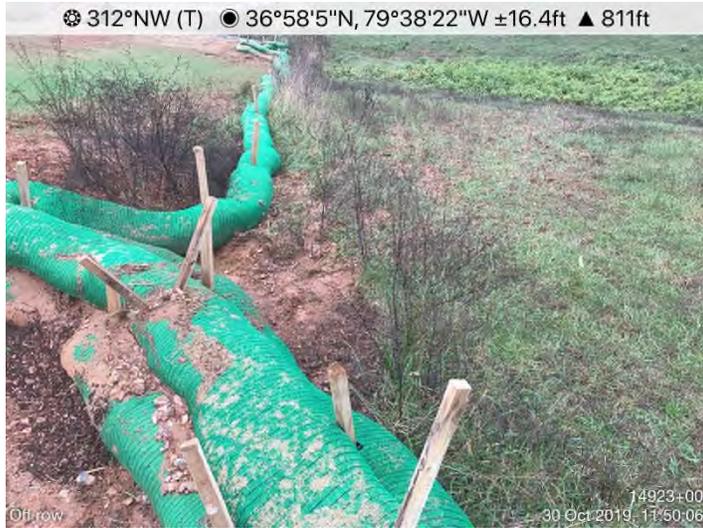
Fig. 25: **STA 14923+00** – Sediment off ROW.

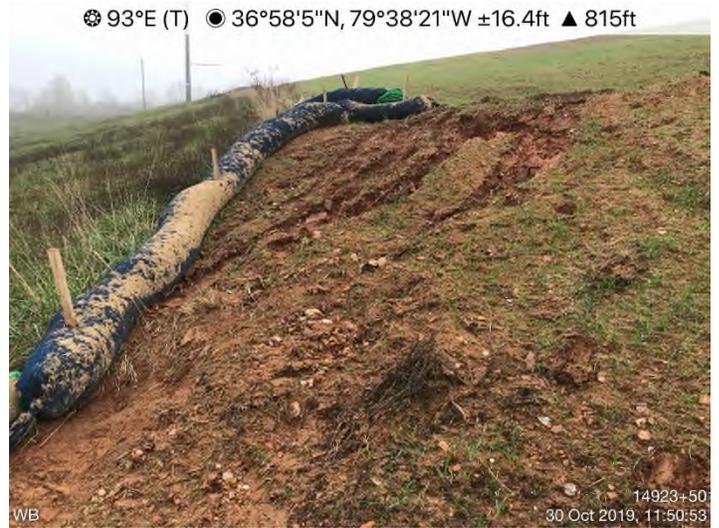
Fig. 26: **STA 14923+50** – Waterbar maintenance needed.
