## FIELD INSPECTION

<b>Project Name:</b>	Mountain Valley Pipeline	<b>Inspector:</b>	Marshall Willis
<b>Inspection Date:</b>	Wednesday, October 9, 2019	<b>Project Contact:</b>	Brian Clauto, Cory Chalmers
<b>Spread I: Franklin County</b>	STA 13892+45 – 13940+00 MVP-FR-305	<b>Weather (Wet/Dry/Rain):</b>	Dry

# FIELD INSPECTION PHOTO LOG

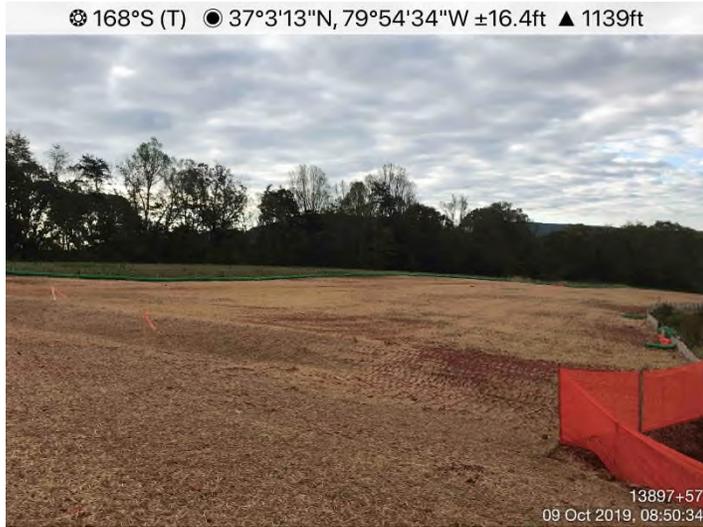
Fig. 1: **STA 13897+57** – Controls in place. Area stabilized with straw.

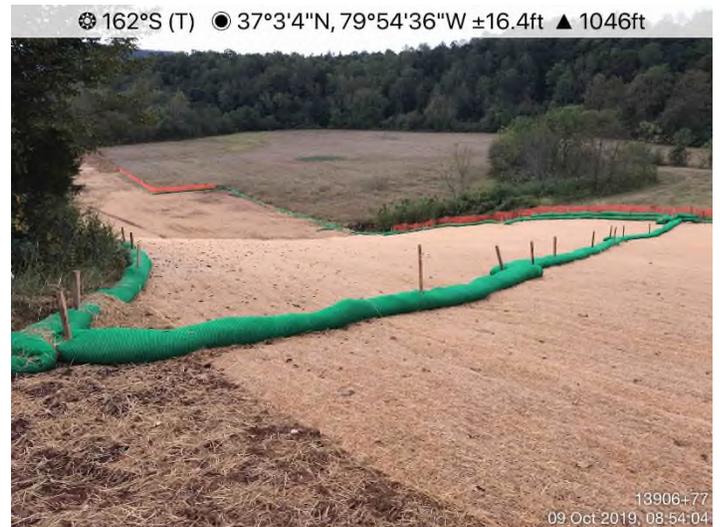
Fig. 2: **STA 13907+00** – Controls in place. Area stabilized with erosion matting and straw.

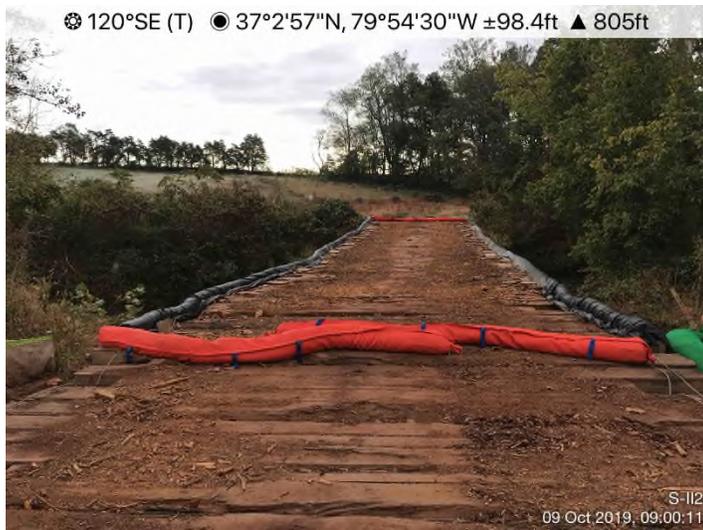
Fig. 3: **Stream S-II2** – Controls in place and functioning properly at stream crossing.

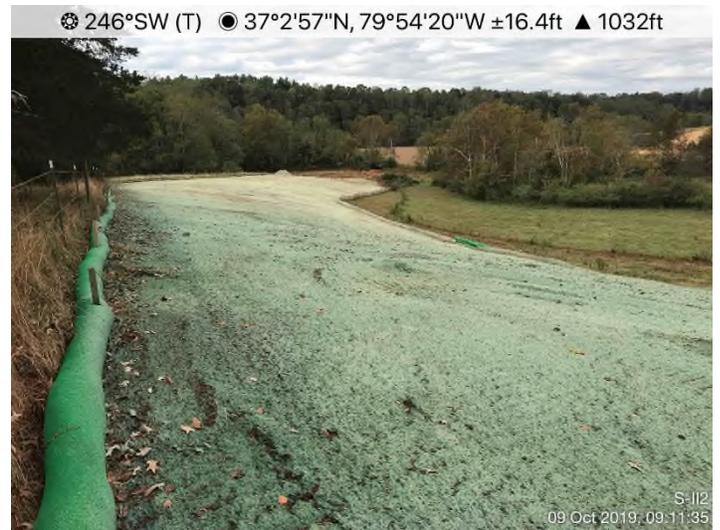
Fig. 4: **STA 13925+00** – Controls in place. Area stabilized with hydro-mulch.
